GRAMPAW PETTIBONE

Close Shave

Home-Field-itis

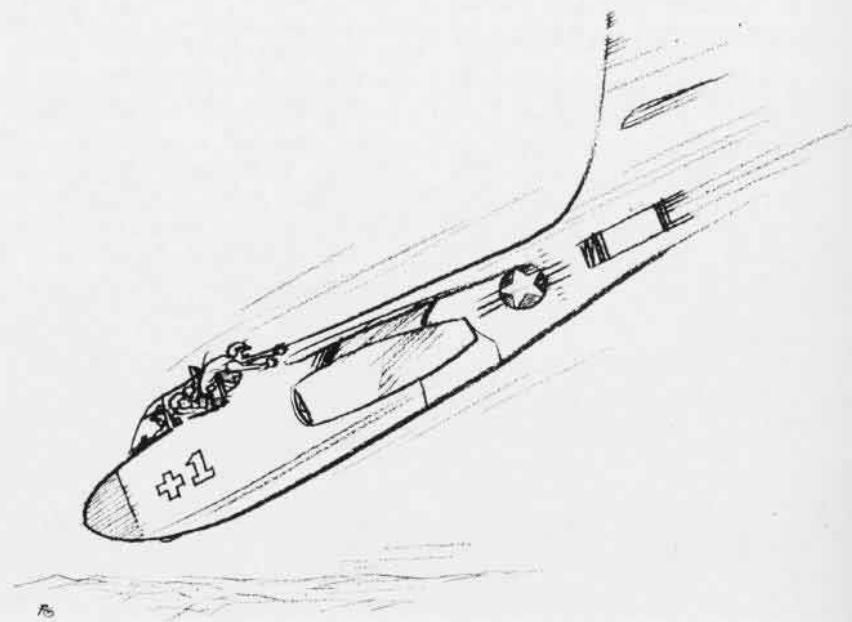
menced the approach to runway 32. (Just prior to this time an F-10 landed and had broken out at 250 feet.) The approach went well initially, but did require several heading changes, made necessary by what the controller described as a wind shear. (The pilot noted that he suffered a slight recurrence of the ear block, a single episode of vertigo, and a feeling that "things were going wrong.")

At about one mile, the final controller called the aircraft for rising slightly above glide path. At three quarters of a mile, he called again for going below glide path. At this point, the RIO, who had been watching for the runway lights, glanced at the altimeter and noted 200 feet. Glancing back out the left side of the aircraft, he saw "bare ground." He was about to tell the pilot to wave off, when he felt a surge of power followed by the crunch of the plane in the trees.
