GRAMPAW PETTIBONE

The Hard Way

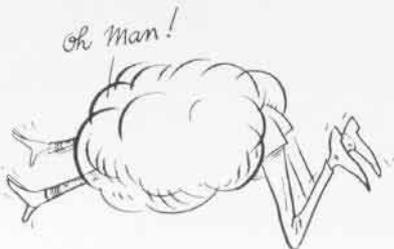
starting the descent to 600 feet at four miles. He called the meatball at 1½ miles with 2,600 pounds and came back on the power in order to start down. The ship appeared to be in a port list. Working for line-up, he dipped the starboard wing, added power to correct and subsequently went high, requiring another power reduction. Paddles heard a rapid deceleration of the engine and called for power. The driver recognized the abnormal sink rate also and added full power as well as retracting the speed brakes. Just as the engine started to respond to the added power, the aircraft struck the ramp on centerline.

Upon impact, the tailhook, landing gear and drop tanks sheared off and the plane burst into flames. The pilot pulled the secondary ejection handle as the aircraft started to cartwheel, but the seat did not fire. The canopy jettisoned, however. The aircraft, decelerated somewhat by protrusions on its bottom surface, and partially arrested by the wires, came to rest on its left side (the port wing sheared off during the cartwheel), 20 feet from the edge of the angled deck and five feet from the port catwalk. The driver pulled the harness release, literally fell out of the cockpit and got clear of the flaming wreck with minor injuries. The wreckage was subsequently jettisoned—a complete loss.

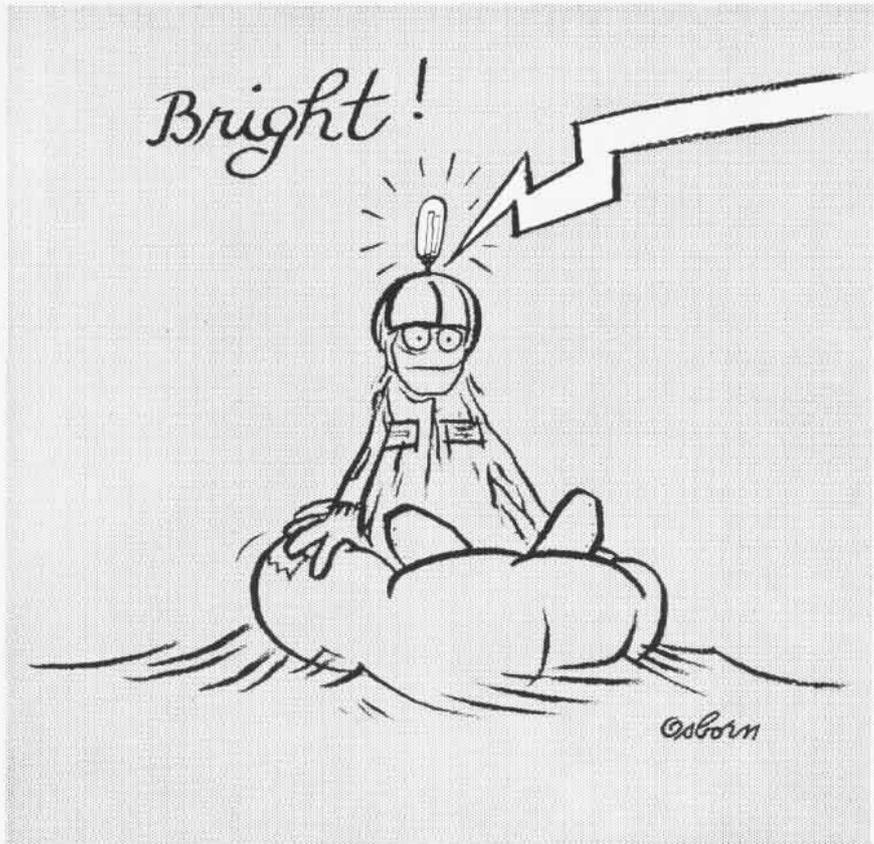
As the *Crusader* pilot selected speed brakes for descent, the generator failed. Using his flashlight, he leveled off and reset the main generator. Still no electrical power. He then turned the main generator off, extended the external power package and waited five seconds for it to come up to speed. This too failed to restore electrical power and he switched to the land position which furnished power to equipment operating off the emergency bus. All attempts to regain the primary generator failed.

At about 2355, the *Crusader* flamed out. The ill-fated driver replaced his helmet and mask, positioned himself in the seat, trimmed the bird in a slightly nose-down attitude and pulled the curtain.
