grampaw pettibone

Night Caper

How Dry I Am

The Door

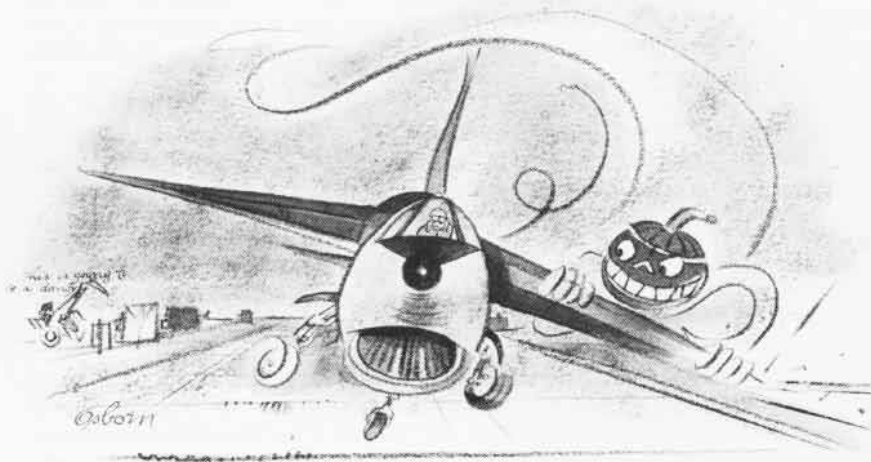
Holy Hannah! Makes common sense to me — if you can't see somethin' because of dim light, turn the blasted switch up. If you have a problem seein' something, you concentrate on it, and the next thing you know you have a breakdown in your scan. Then anything can happen — as it did here!

Additionally, this gent did not utilize the wave-off technique as briefed. Lets face it, the F-8 ain't the easiest bird to bring aboard. You just have to pay attention to the task at hand. Do it!
