GRAMPAW PETTIBONE

Sundown Kid in Flaps-up Fiasco

Misguided Tomcat

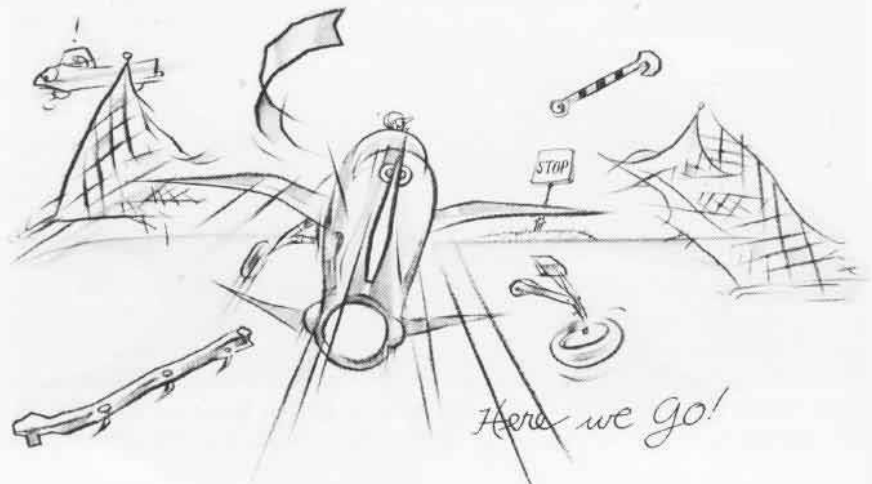
The A-7B Corsair pilot launched on the third leg of an instrument training flight from NAF High Altitude to arrive 45 minutes later at La Gaso Muni. The pilot entered the overhead 1,500-foot traffic pattern just about sundown. He lowered the landing gear and flaps, and touched down at 1,500 to 2,000 from the approach end of the 11,000-foot runway. Runway density altitude was 7,000 feet, aircraft gross weight was 25,000 pounds with 6,000 pounds of internal fuel. He used aerodynamic braking to 110 kias, then lowered the nose to the runway and commenced wheel braking. The brakes felt spongy, so he increased pedal pressure and felt good deceleration. Further down the runway, the brakes became less effective, so he released and reapplied one second later. At the 2,000-foot-runway-remaining marker, he pulled the emergency brake handle, but felt no additional braking. He maintained pedal pressure while using the emergency lever. At 1,000 feet remaining, he secured the engine. The aircraft departed the runway at an estimated 50 kias and traveled across 1,100 feet of firm sandy ground. The aircraft impacted a railroad track, which severed the right main landing gear and pulled the retracted tailhook and part of the keel from the aircraft. It continued through a six-foot chain-link fence, collided with a civilian pickup truck, and came to rest in the median of a four-lane highway. The pilot exited uninjured while the local La Gaso crash and smash crew extinguished fires in the wheel wells.

The trailing-edge flaps were found to be fully up but operated normally after the accident. Apparently, this pilot activated the trailing-edge flaps-up micro switch as he put the flap handle down, thus stopping the trailing-edge flaps extension — a somewhat common mistake. However, he failed to check either the trailing-edge flaps indicator, airspeed indicator, or to compare the AOA with airspeed during the approach. Any one of these gauges would have alerted him that something was amiss. The mishap board calculated the approach airspeed was approximately 166 kias with trailing-edge flaps up. Landing 1,500 to 2,000 feet down the runway left only 9,000 feet of runway remaining for a flaps-up-landing-required roll of 11,400 feet. The pilot remembers seeing only the 2,000-foot-remaining marker during the roll-out but does not recall his airspeed at that point. The mishap board judged the aircraft's speed leaving the runway to be 110 kias vice 50 kias, based upon its final resting position as a smoldering freeway median relic.

Old Gramps humbly requests that, in the future, all static displays be performed on operational rollers inside the confines of the perimeter and, preferably, on the mat area.
