GRAMPAW PETTIBONE

A Knight on the Beach

"Know When to Go"

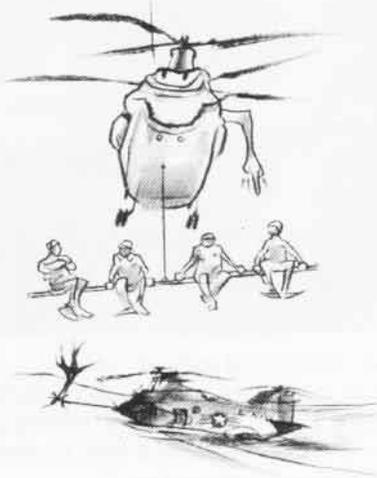
with the rescue hoist cable to prevent the rising tide from floating the helicopter away.

The beached helicopter was retrieved with the help of a Fort Eustis Army CH-47C *Chinook* and returned safely to NAS Patuxent River some 22 hours after the incident.

Due to the aircraft's weight and the proximity of the helicopter to the beach line, about three miles away, LCdr. Sloan made the decision to water-taxi to the beach. En route, there were several engine restart attempts, without success, and a mayday report was made. As the helicopter approached the beach, LCdr. Sloan activated the emergency throttle to get maximum power from the No. 1 engine and taxied the helicopter as far as possible up the beach. Normal shutdown followed, and the crew safely exited the aircraft. The crew then secured the helicopter to a tree
