GRAMPAW PETTIBONE

Slip Sliding Away

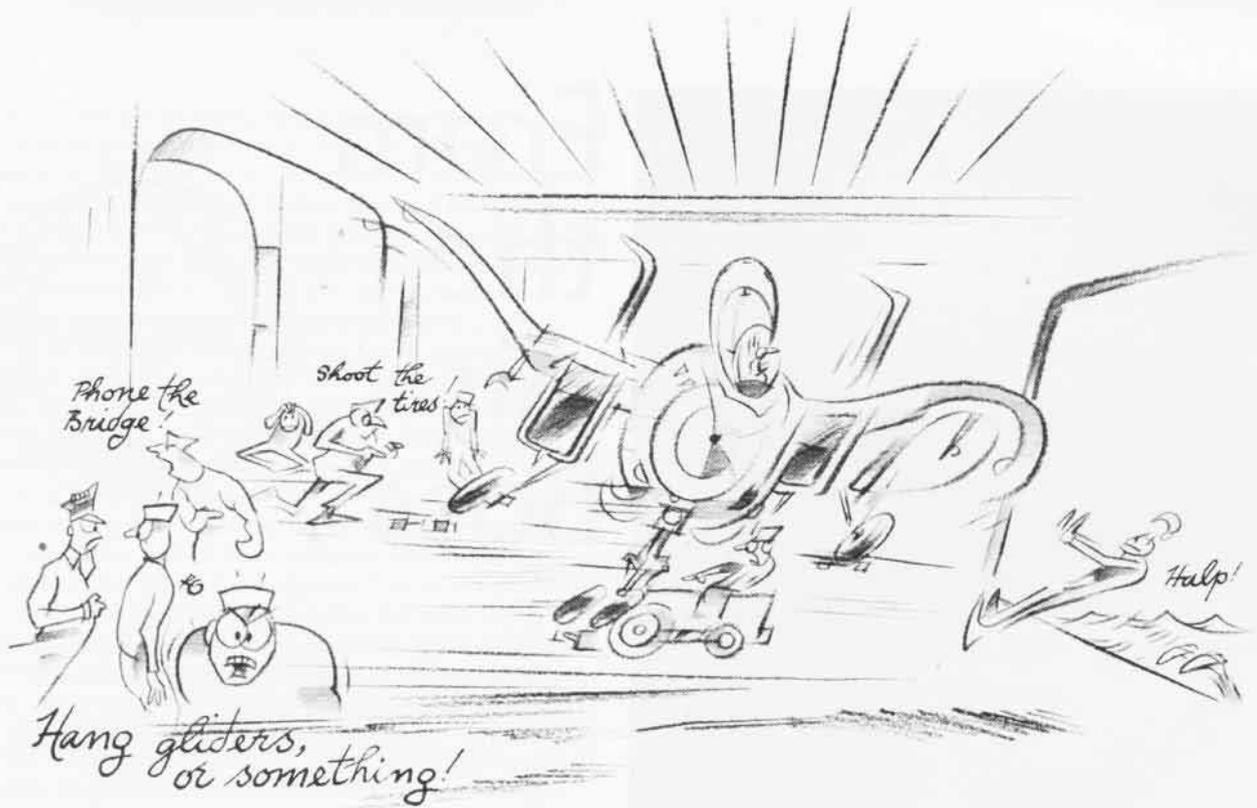
As the 53,000-pound F-14 *Tomcat* was being towed by a spotting dolly from elevator #4 into the hangar bay, the aircraft and dolly began to skid. The director blew his whistle, gave the emergency stop signal and the plane captain quickly applied the aircraft brakes. The aircraft stopped with its main mounts 18 feet inboard of the edge of #4 elevator well. The safety observer then directed the plane captain to ride the aircraft brakes lightly as they again attempted to move forward. After approximately seven feet of roll, the dolly again began to skid. Emergency stop signals were again given by the safety observer and director. The plane captain applied the aircraft brakes and the dolly driver applied his emergency brake, but the aircraft and dolly continued to slide. Fearing brake failure, the plane captain began working the hydraulic hand pump to ensure good brake pressure. The aircraft, with wheels locked, continued to skid and pushed the dolly forward, forcing it to jackknife 90 degrees to the right. The chock walkers had difficulty getting the chocks under the skidding wheels of the moving aircraft. After several tries, the chocks were in place but were merely pushed along in front of the wheels. Several individuals, at considerable personal risk, attempted to stop the aircraft by pushing on the port intake and main mount. The dolly driver tried to pull the nose of the aircraft away from the #3 elevator well. However, the dolly could not gain traction. All attempts to stop the aircraft were futile and the safety observer yelled for all hands to get clear. Blue shirts jumped clear from both main mounts, the driver leaped

off the dolly, and the plane captain jumped from the cockpit as the aircraft and dolly approached the elevator opening. The aircraft and dolly continued sliding, striking an elevator security stanchion, and sliced through the steel restraining cable. The nose wheel continued over the edge, dropping the fuselage onto the elevator well lip. As the F-14 continued to nose over, the vertical stabilizers contacted the top of the elevator well. It balanced there momentarily and then fell, impacting the water inverted, and sank within seconds.

This aircraft traveled a distance of 113 feet across the hangar bay and slid out the opposite elevator door. During the last 90 feet of travel, it was sliding out of control.

The ship was steady on course but had a 1.5-2.0 degree of starboard list, coupled with a one-to-three degree of heel, equating to approximately a five-

degree starboard list.

The overall condition of the hangar deck nonskid was reported to have been satisfactory but just a bit slicker than normal. On the night prior to the mishap, a massive spill of ethylene glycol from the arresting gear machinery occurred just forward of this area, but it had been cleaned with swabs and speedy-dry.

During aircraft movement, there is no good way of predicting the onset of vicious hydroplaning short of sliding an aircraft across the deck, which is exactly what this crew did. Only minutes before, another aircraft was moved from this same spot and experienced sliding. When the F-14 was first pulled into the hangar bay, it began to slide. Maybe this *Tomcat* should have been caged at this point! A couple of lessons learned in this mishap were: (1) As good as they may be, the SD-1D spotting dollies just don't have the power or traction required to move high-gross-weight aircraft about on a slippery deck, and (2) aircraft chocks are ineffective for stopping a sliding aircraft. Old Gramps knows both of these facts to be true as they have been documented many slides and crunches ago. But another fact is also true: Until we have better equipment in hand, we have to rely upon the wisdom of man to overcome the shortfalls of the machines. The problems associated with moving aircraft about a carrier have plagued our Bird Farms for as long as I have been growing a beard and, occasionally, we need reminding. But, dang it all, gang, two such occurrences within a year is a bit of an over (the side) kill!

upon them. If either of these two mishaps occurred under the guise of operational commitments, tempo of operations, can-do attitudes or inadequate support equipment, then perhaps we had better slide the tempo to a halt until we get it all in one sack, mates. Old Singed Whiskers thinks it is high time we made conservation of critical assets a serious partner in today's aviation business.
