PROJECT NUMBER (05-170)

Long-Term Management Strategies for USS ARIZONA, A Submerged Cultural Resource in Pearl Harbor

NATIONAL PARK SERVICE
SUBMERGED RESOURCES CENTER

SEPTEMBER 2008
THIS REPORT IS APPROVED FOR PUBLIC RELEASE

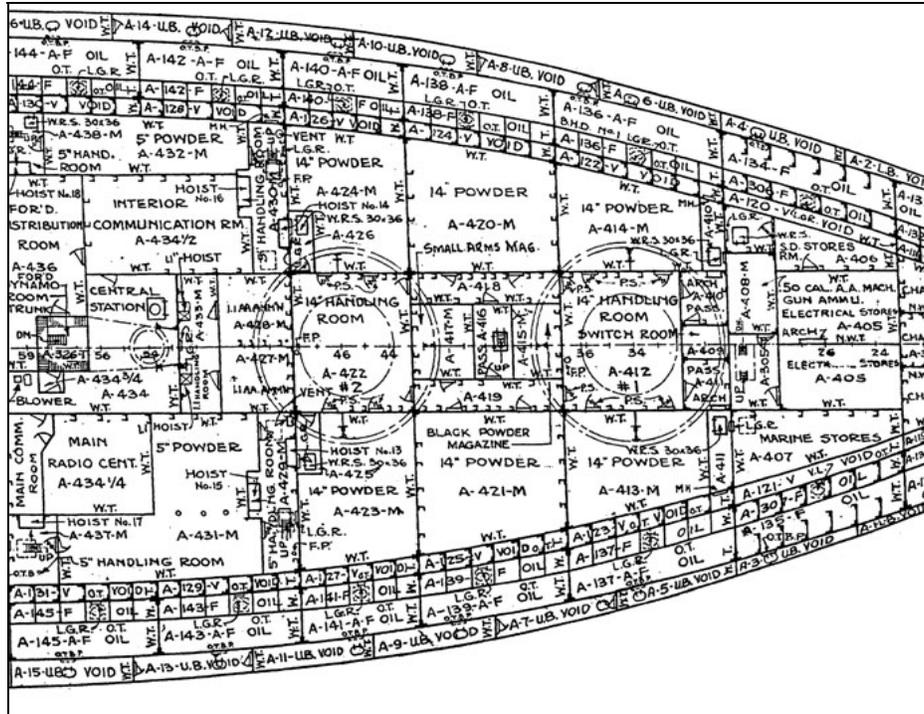
In analyzing the forward magazine explosion, Lott (1978:43) quotes from an October 1943 letter that *Arizona* had on board its full complement of smokeless powder in six magazines between frames 31 and 48 on the first platform (Figures 3.2 and 3.3). There was also 1,075 lbs. of black powder in the black powder magazine, which was also stowed on the first platform, centerline between frames 37–39 (Figure 3.2) between the six smokeless powder magazines. Close to the black powder magazine is the small arms locker (Figure 3.2).

Figure 3.2. Arizona blueprint of forward magazines on first platform deck (USS Arizona Memorial Archives).

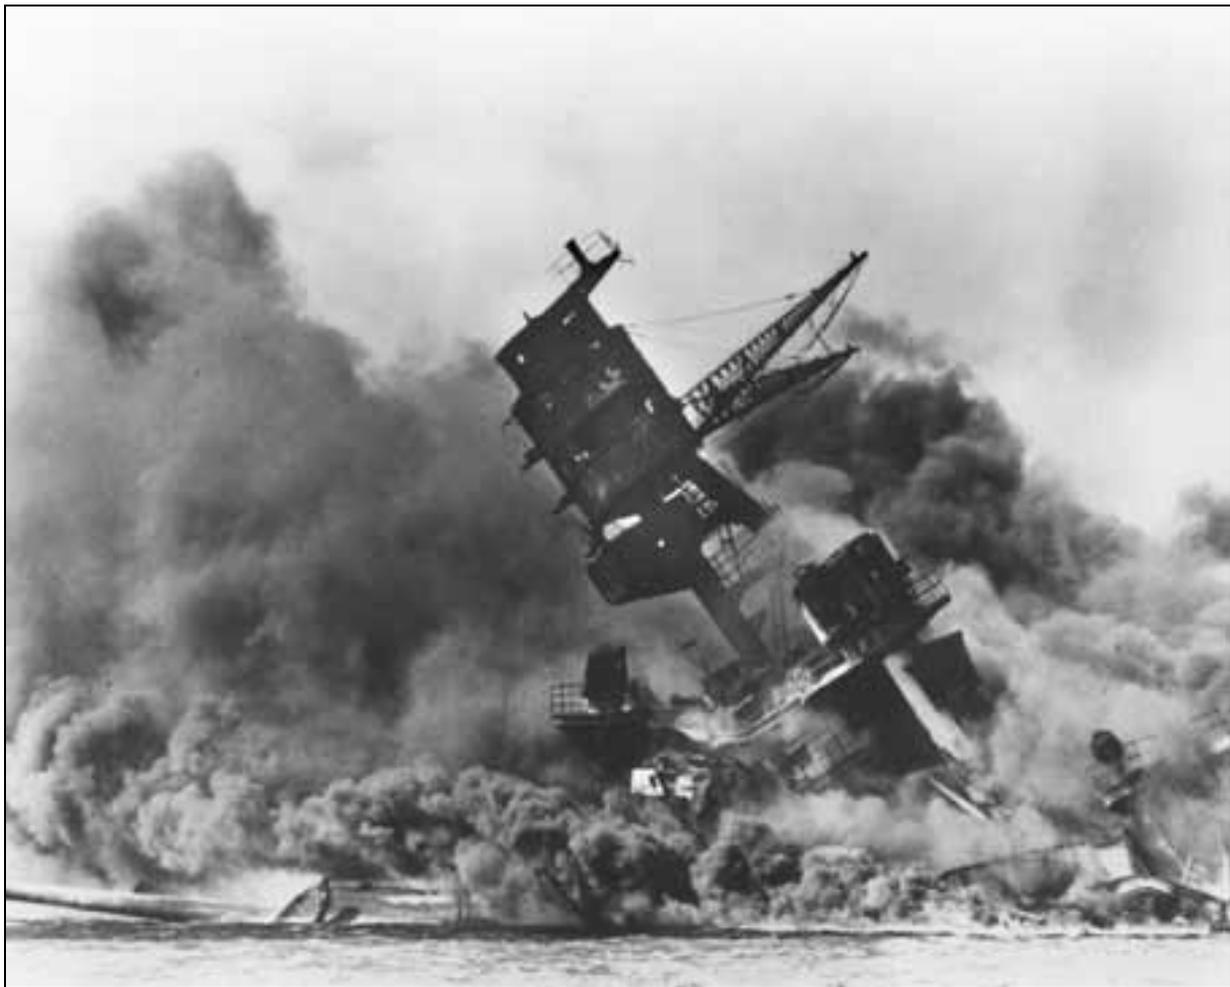
Homer N. Wallin, Battle Force Material Officer, at 1345 December 7, he states: “The *Arizona* is a total wreck, she is resting on the bottom without much list, and is still burning forward. The foremast has fallen forward about 45°” (Wallin 1941:1)(Figures 3.4 and 3.5). *Arizona*’s hull was reported to have settled for days (Madsen 2003:81), releasing air bubbles from the interior. In Memorandum No. 7, December 9, 1941, from the United States Pacific Fleet Battle Force, USS *California*, Flagship, *Arizona* and *West Virginia* were declared “total wrecks” (p.3).

Figure 3.4. *Arizona* burning, forward mast toppled, December 8, 1941 (USS *Arizona* Memorial Photo Archives).

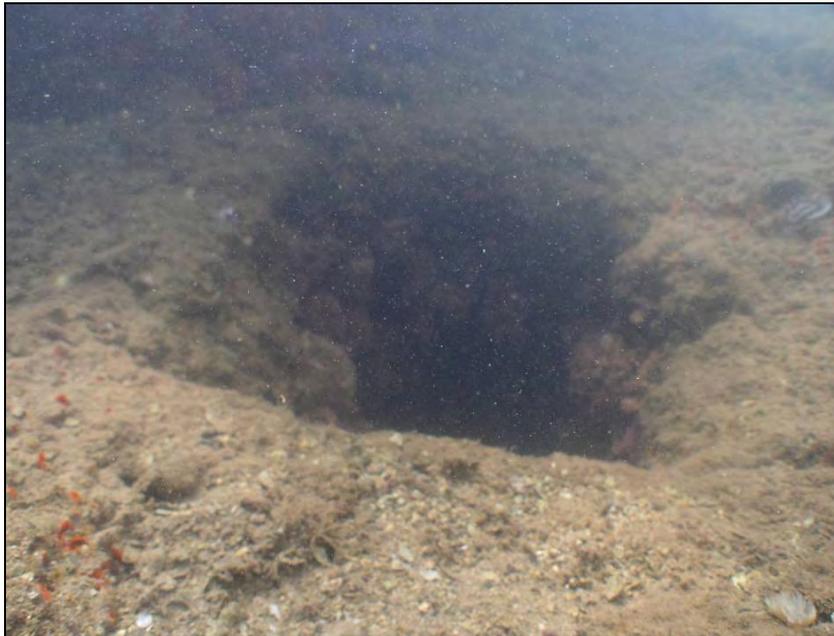
Frame 78-90: A bomb hole was discovered on the second deck between frames 78 and 90 on the port side. A diver traced its path down two decks to where it was located in the walk-in meat freezer (Raymer 1996:76). This bomb hole is depicted in Figure 3.6.

Figure 3.6. Bomb hole, forward of the galley, port side, near frame 78 (NPS Photo by Patrick Smith).

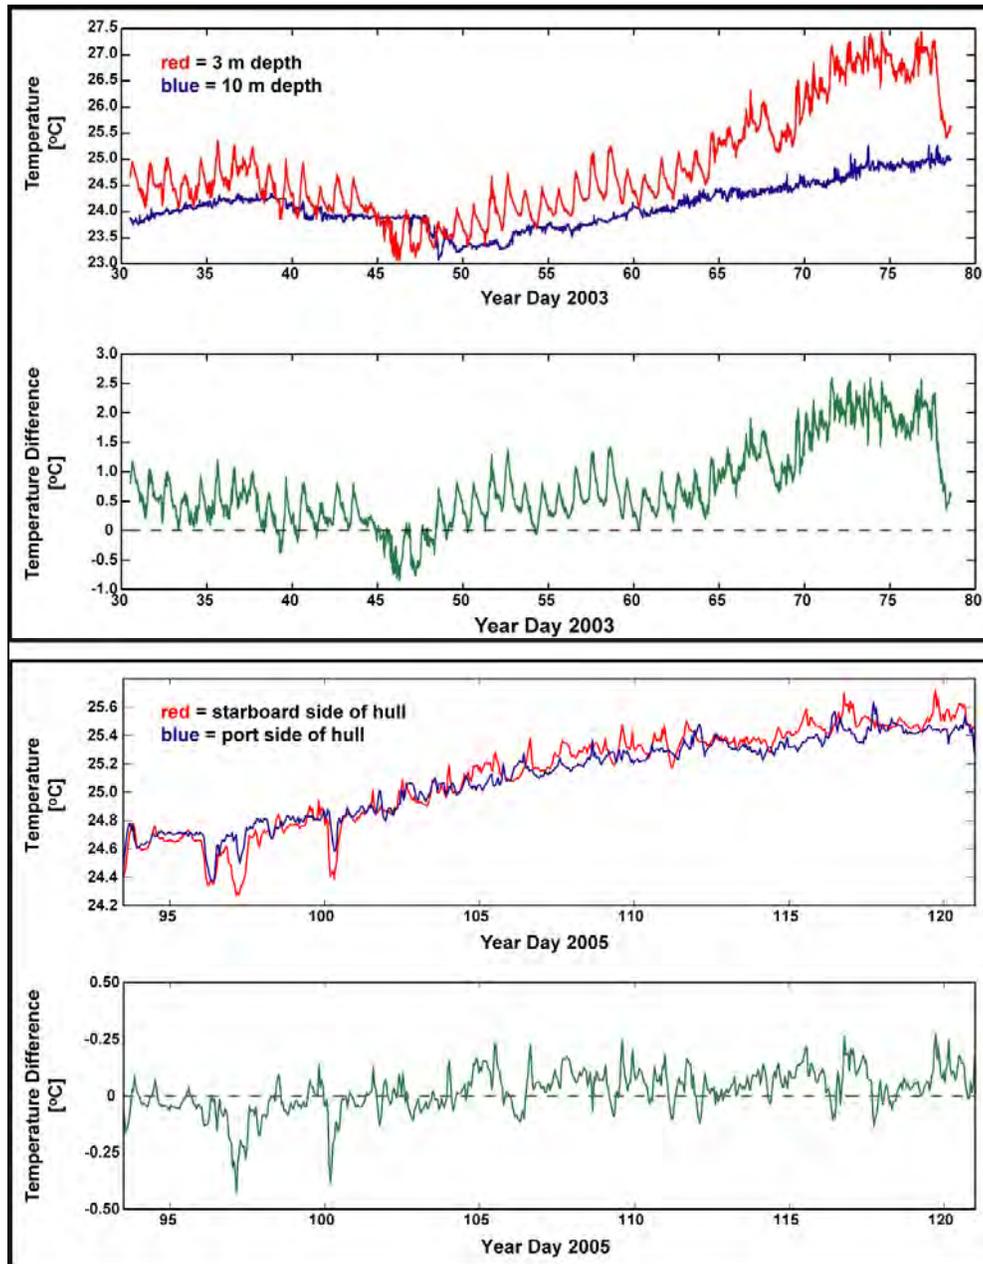
Along the 10-m isobath, the variability in water temperature was greater off the starboard (northwestern) side of the hull between the USS *Arizona*'s hull and Ford Island. In general, the near-bed water off the starboard (northwestern) side of the hull was slightly (0.02 ± 0.10 °C) warmer than off the port (southeastern) side of the hull (Figure 4.10). The greater stability off the port (southeastern) side of the USS *Arizona*'s hull is likely caused by greater mixing due to currents, which act to minimize temperature fluctuations caused by insolation or submarine groundwater discharge. We do not have information at this time that indicates that these processes are the cause of the temperature differences between the two sites.

Figure 4.9. Differences in water temperature around the USS Arizona. TOP: Near-bed (10 m) and near-surface (3 m) temperatures and the resulting thermal stratification. BOTTOM: Concurrent water temperatures off the port and starboard sides of the hull and the resulting thermal gradient. While both the port and starboard temperatures both follow the same long-term trends, note the greater fluctuations in water temperature off the starboard side; this likely results from less mixing of the water column off the starboard side.

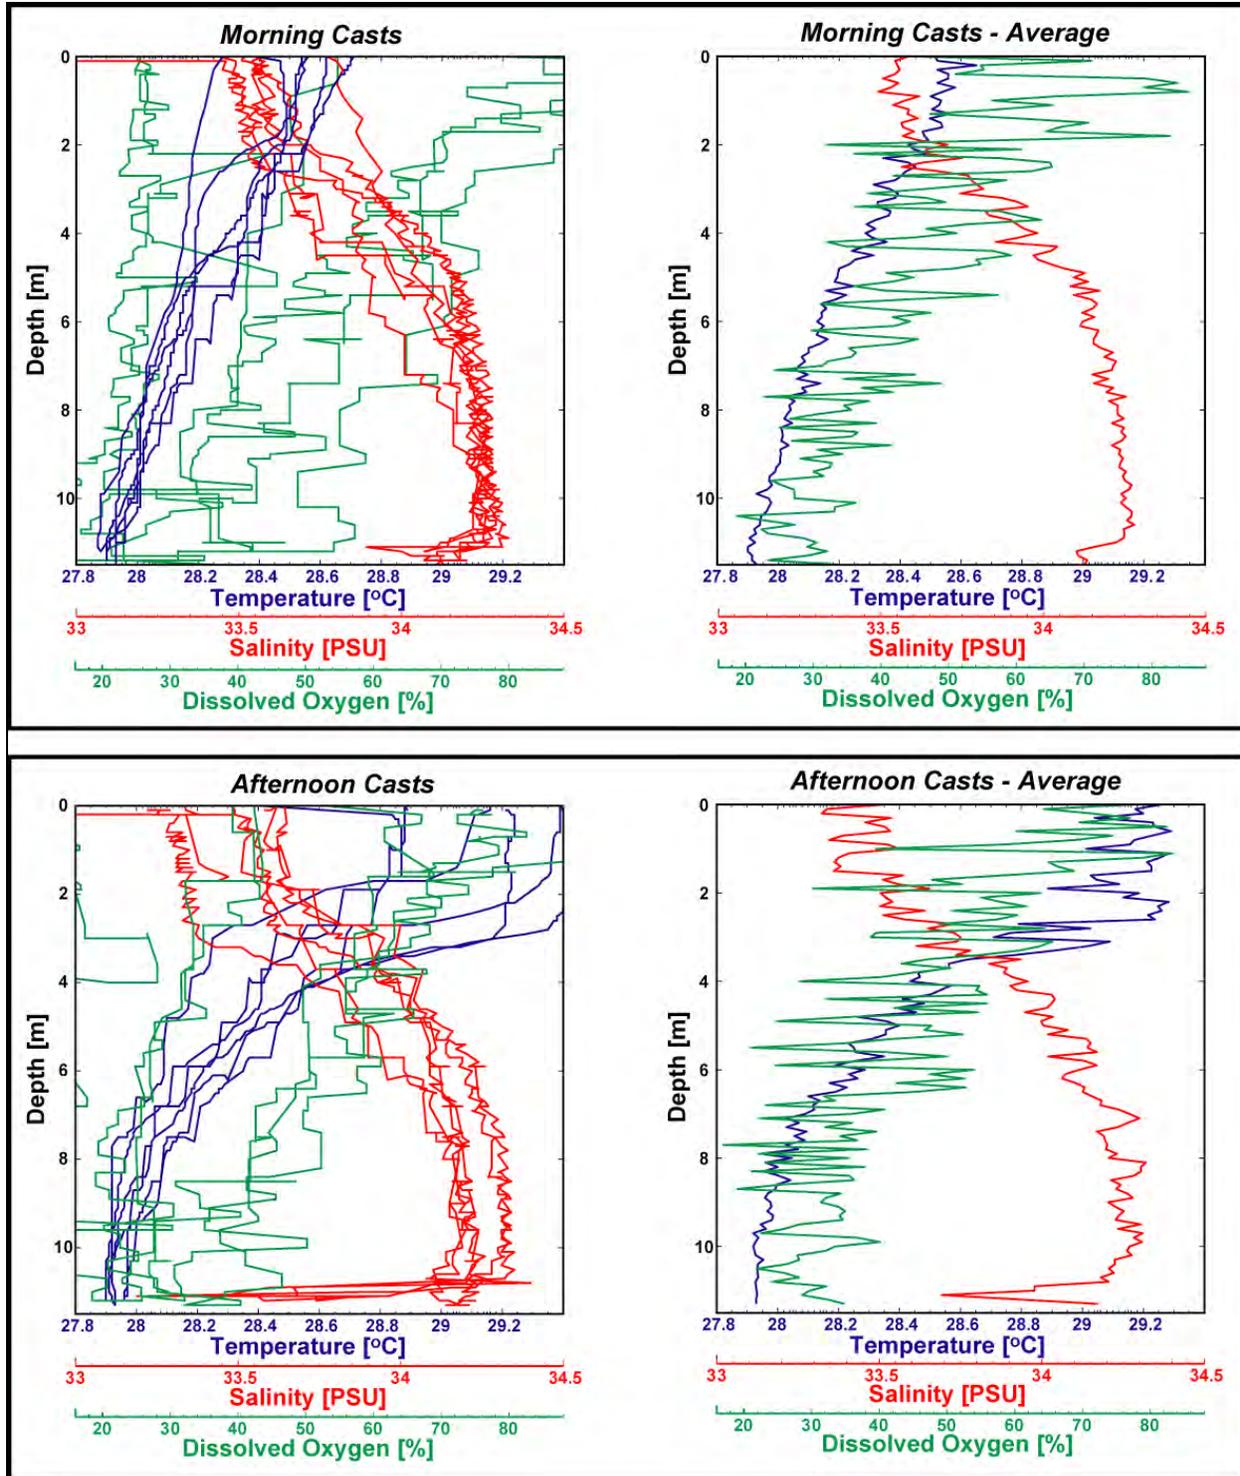
The temperatures during the vertical profiles taken in the early morning varied between 27.83 °C and 28.72 °C, with the near-surface temperatures on average roughly 0.74 °C warmer than the near-bed temperatures. The salinities during these profiles varied between 33.47 PSU and 34.38 PSU, with the near-surface temperatures roughly 0.79 PSU less saline on average than the near-bed salinities. The dissolved oxygen levels during these profiles varied between 15.3% and 91.2%, with the near-surface dissolved oxygen levels on average roughly 41.1% higher on average than the near-bed dissolved oxygen levels (Figure 4.12). The temperatures during the

vertical profiles taken in the late afternoon varied between 27.85 °C and 29.51 °C, with the near-surface temperatures roughly 1.32 °C warmer on average than the near-bed temperatures. The salinities during these profiles varied between 33.21 PSU and 34.35 PSU, with the near-surface temperatures roughly 0.91 PSU less saline on average than the near-bed salinities. The dissolved oxygen levels during these profiles varied between 11.7% and 104.4%, with the near-surface dissolved oxygen levels roughly 46.6% higher on average than the near-bed dissolved oxygen levels (Figure 4.12).

Figure 4.12. Vertical profiles of temperature, salinity and dissolved oxygen off the USS Arizona dock. These plots show how these parameters vary vertically from just below the water's surface down to the sea floor and how the vertical variation in these parameters changes over the course of a day.

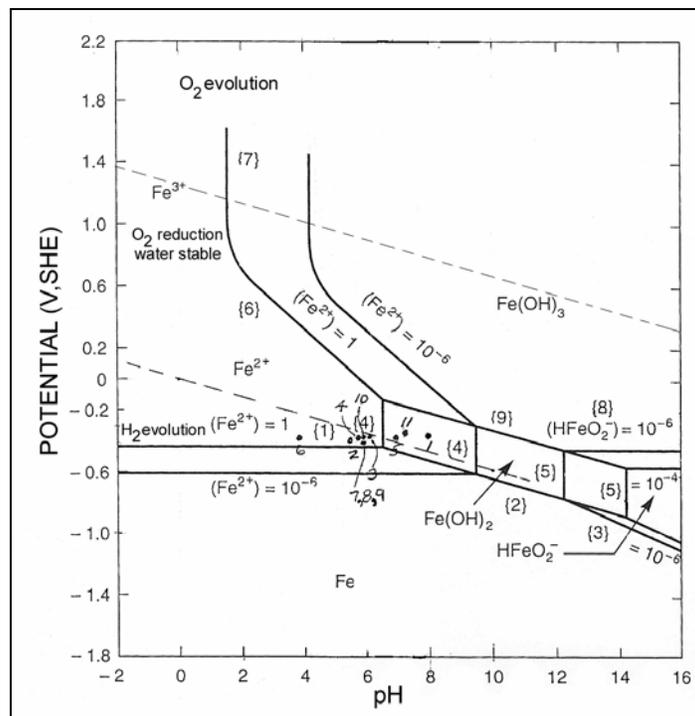
As an example of how the Pourbaix diagram for the iron-water system can be used, consider the solid lines on the diagram first (Figure 5.3). Superimposing typical pH and E_{corr} field measurements as small solid dots, all points that appear in the area labeled Fe^{+2} indicate active corrosion. The points are well below the region of Fe^{+3} stability, so ferrous ions (Fe^{+2}) dominate. Below the line identified by $(\text{Fe}^{+2}) = 10^{-6}$, steel is said to be immune because the concentration of iron is extremely low corresponding to a region of insignificant corrosion. The concentration of (Fe^{+2}) continues to decrease as the potential decreases. In addition to the large cross-hatched region to the left, there is a small triangular cross-hatched region to the right in which corrosion occurs. The region defined as passivation means that corrosion product oxides form on the surface and become protective. Passivation only occurs under specific conditions for selected iron-based alloys but does not normally occur for steel in seawater. Consider next the two dotted lines labeled (a) on the bottom and (b) above it. On line (a), reaction [8] occurs:

Figure 5.3. Pourbaix diagram for iron in water with E_{corr} / pH data taken on the USS Arizona, September 2000 (modified from Jones 1996:59).

Above line (b), oxygen is stable and oxygen evolution takes place, although it seldom does because E_{corr} normally does not reach such a high potential. As will be noted later, the points appear to follow closely along the lower dotted line, hence, hydrogen evolution or oxygen consumption dominates the cathode reaction. At the lower pH values observed at the metal/concretion interface, the cathode reaction at or near the interface in the concretion involves hydrogen evolution as noted above (which explains the observation that initial penetration of the concretion sometimes releases gases and divers occasionally observe bubbles emerging from concretions in isolated locations on *Arizona's* hull). The Pourbaix diagram for the carbon-water system (Figure 5.4) is also useful in identifying gases observed during diving operations. For example, at an E_{corr} of -400 mV, methane gas is stable in solution at a pH below about 6, carbon is stable between pH 6 to 8, and carbon dioxide is stable above pH 8. At E_{corr} of -300 mV, methane is stable below pH 4, carbon is stable between pH 6 to 7 and carbon dioxide is stable above pH 7. As will be discussed later, this diagram may be useful to explain why potentials suddenly rise in some interior compartments. While Figure 5.4 applies only at atmospheric pressure and temperature, extreme high pressure and low temperature at great depths result in very high solubility of methane gas. The result is solid hydrate, a stable form of methane under such conditions.

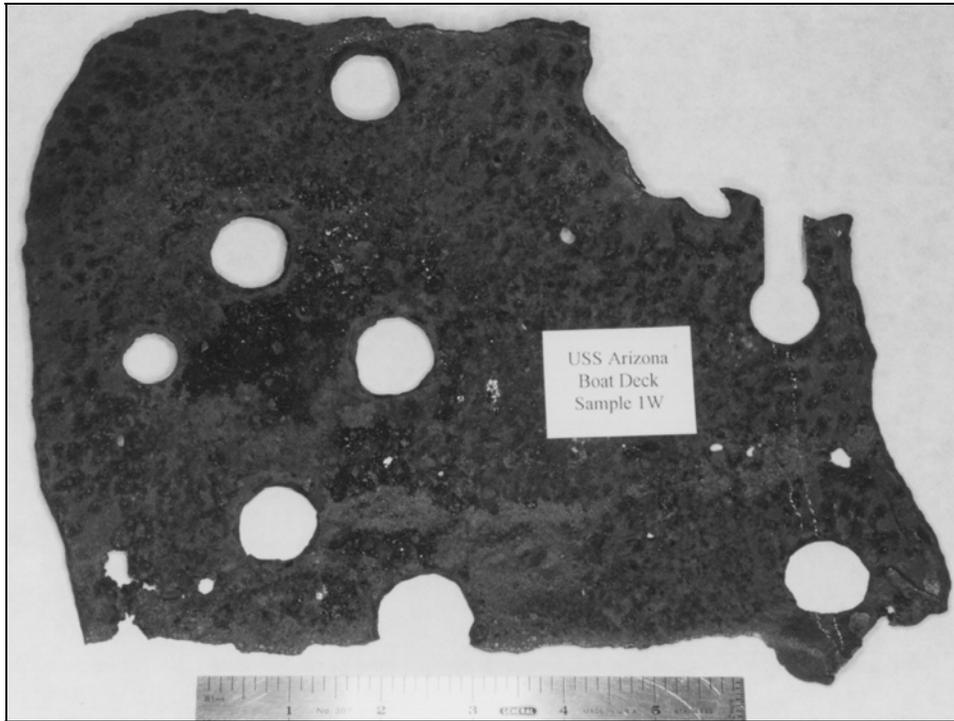
Conventional metallographic methods were used to prepare specimens obtained from Waipio Point in March 1999 and again during a second field operation in September 2000 (Figures 5.5 and 5.6). Etching was done with 2% Nital after grinding and polishing. The microstructure of sample W1 consists of ferrite and pearlite, and the carbon content is estimated to be around 0.2%. The microstructure shows evidence of heavy banding—banded microstructure such as this is typical of plate steels from this time period (Figure 5.7).

Figure 5.5. Sample W1, plate from boat deck with rivet holes.

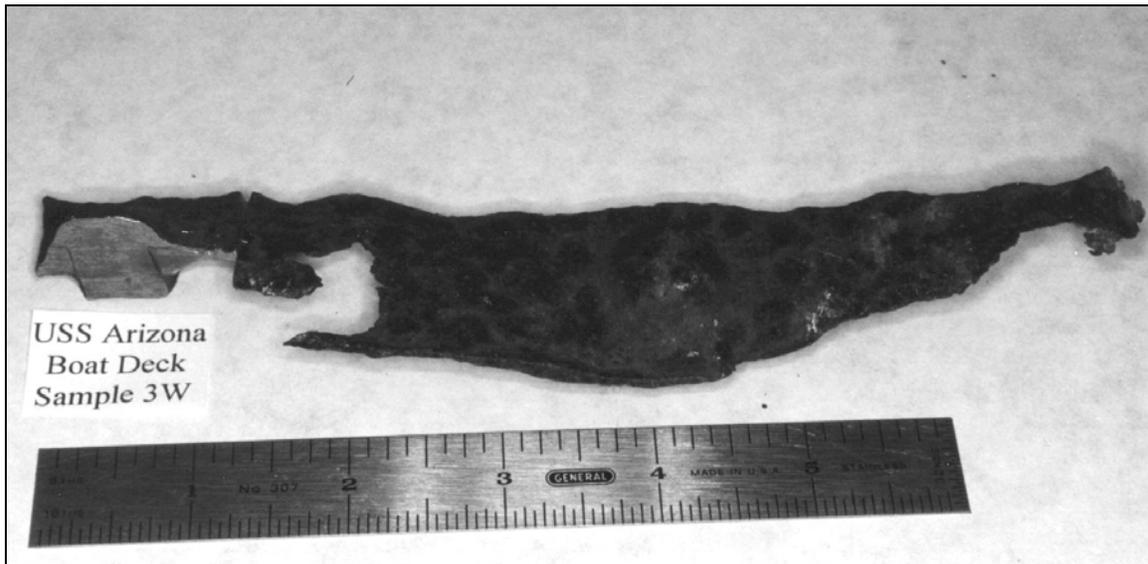
Banding is a result of the solidification practices used for the ingot from which the steel was rolled and appears as a segregated structure of nearly parallel bands aligned in the direction of working (Yiming, et al. 1992). Photomicrographs of Sample W3 in the area around the rivet show the microstructure of both the rivet and the plate (Figure 5.8) and the plate (Figure 5.9) separately. The plate shows the same basic microstructure as W1, but the banding is less severe. The rivet has a microstructure which indicates that it was cooled rather quickly from the austenite range (Figure 5.10). The microstructure of the rivet consists of primary grain boundary ferrite and very fine pearlite interspersed with Widmanstatten ferrite. This microstructure would

Figure 5.6. Sample W3, section with rivet in place from boat deck.

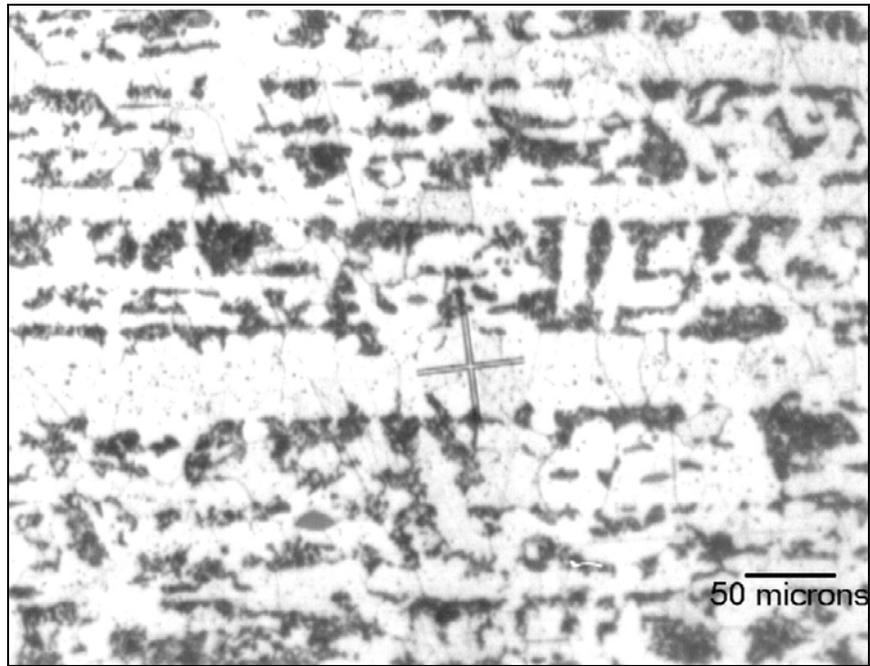
Figure 5.7. Microstructure of W1, 175X, 0.2% Nital etch.

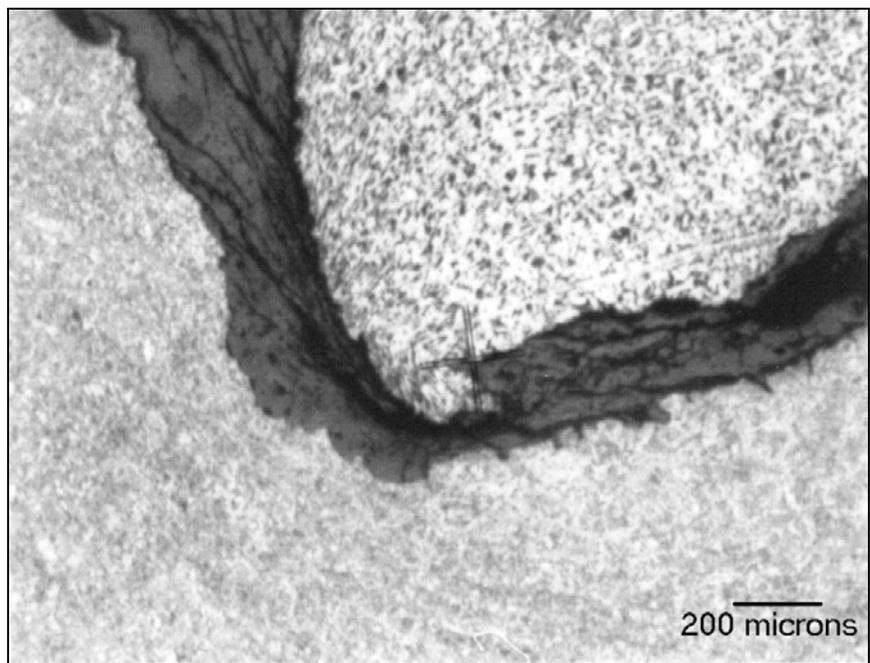
Figure 5.8. Microstructure of W3. Plate is at top right, rivet is at lower left. 45X, 2% Nital etch.

be typical for hot riveting processes in which the rivets are heated red hot and swaged into place. The carbon content of the rivet is believed to be slightly higher than that of the plate.

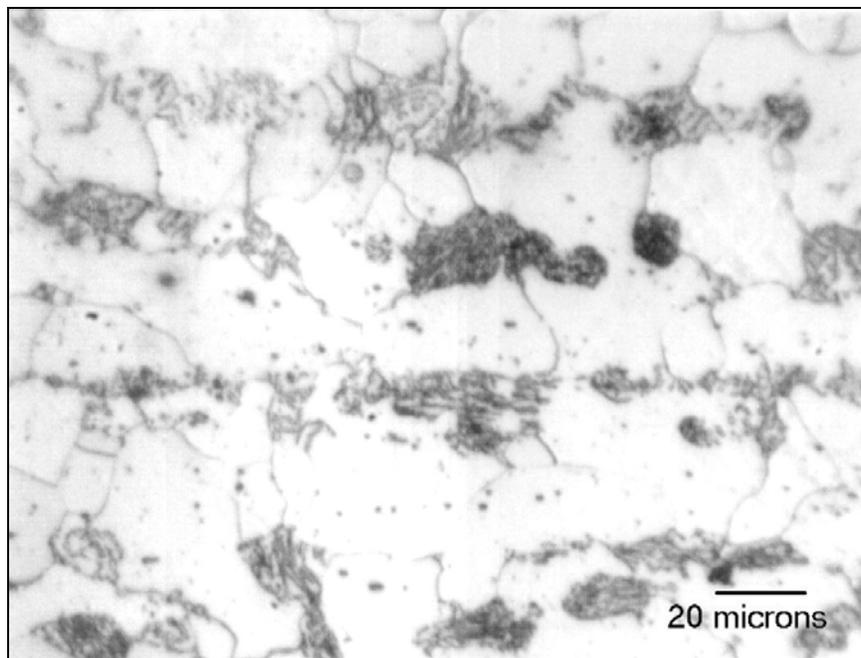
A longitudinal section of boat deck channel member WB5 shows elongated MnS inclusions and oxide particle alignment clearly evident and also pronounced banding (Figure 5.14).

Figure 5.14. Microstructure of boat deck channel, sample WB5, longitudinal, 450X, 2% Nital etch.

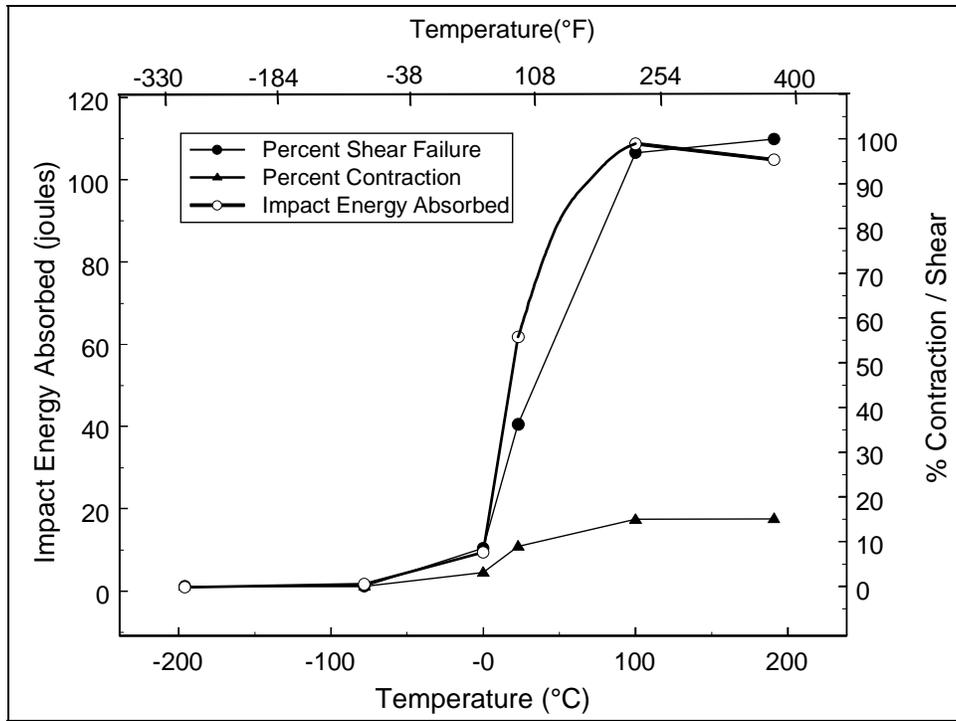
tester using a Dynaup data acquisition system. Tests were run at temperatures of -196, -100, 25, 100 and 200 °C. Results from the Charpy impact testing are plotted using three commonly used reporting methods: temperature vs. energy absorbed, percent shear (ductile failure), and percent contraction at the fracture surface (Figure 5.15). Charpy impact curves for longitudinal plate from *Titanic*, *Arizona*, and A-36 grade were also compared using three common methods for comparing ductile vs. brittle fracture: the temperature at which the average of the upper and lower shelf occur at, the upper shelf energy and the temperature at which the material will absorb 20 J (15 ft.-lbs.) of energy (Figure 5.16)(Table 5.3) (Felkins, et al. 1998). Several factors are known to have significant effects on the toughness of steels, and in particular on the ductile to brittle transition behavior (Anonymous 1975:49).

The carbon content has the largest effect and raises the ductile to brittle transition temperature as measured by (DBTT) by 25 °F (14 °C) for every additional 0.1%. Manganese lowers the transition temperature by 10 °F (5.5 °C) for every 0.1% added whereas P raises it by 13 °F (7 °C) for every 0.1% added. Transition temperature is lowered as the grain size decreases by $D^{-1/2}$. These factors will also raise the upper shelf energy in conjunction with a lowering of the transition temperature. Using these guidelines for the effects of C, Mn, P and grain size, it can be calculated that the DBTT for *Arizona* and *Titanic* steels compared to the A-36 steel, measured by the average between the upper and lower shelf energies, should vary predictably (Table 5.4)—note that the A-36 and USS *Arizona* materials have essentially identical S contents (0.037% and 0.039% respectively) and P contents (0.012% and 0.013% respectively) whereas *Titanic* material has higher contents of 0.069% S and 0.045% P. The differences in transition temperature as computed between *Arizona* steels and A-36 grade can be explained through the C, Mn, P and grain size, whereas the differences between *Titanic* and A-36 grades takes into account of the higher S content in order to explain the differences. This is a direct result of the use of acid open hearth steelmaking practices which understandably were state-of-the art at that time in Europe. The mainmast steel from *Arizona* was of the same general quality from the metallurgical aspect as was the modern A-36 grade, with the differences being noted that the DBTT data were obtained from the mainmast steel manufactured in the late 1920s when cage masts were replaced with tripods.

Figure 5.15. Charpy impact results plotted as temperature vs. energy absorbed, % shear failure, and % contraction for longitudinal steel samples taken from the mainmast of the USS Arizona.

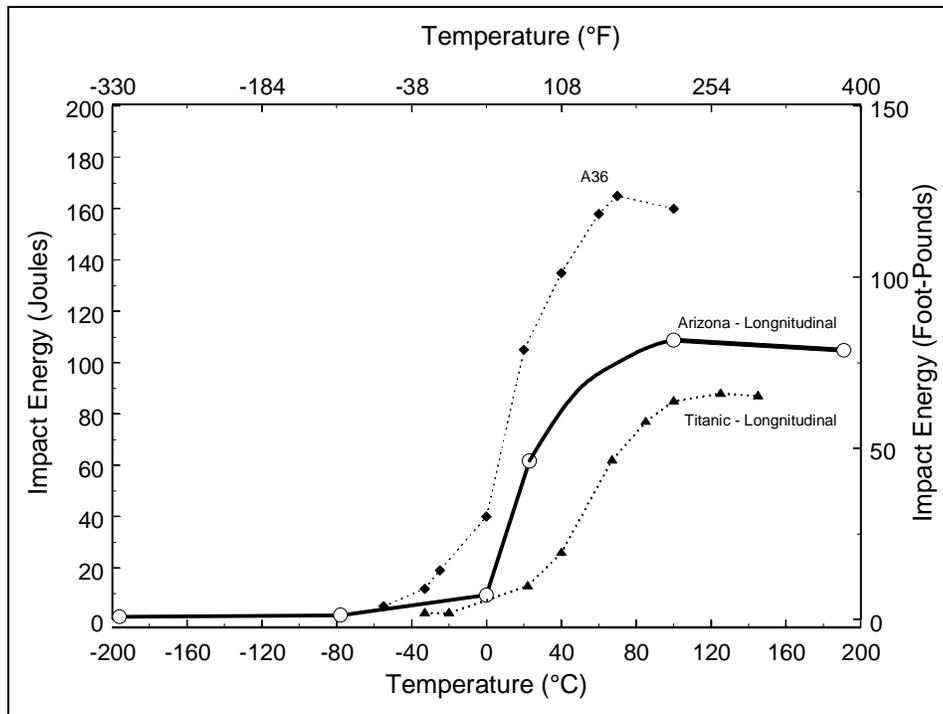
Figure 5.16. Charpy impact energy vs. temperature for longitudinal specimens from USS Arizona, HMS Titanic, and A36 steels.

Steel used to fabricate USS *Arizona* battleship during original construction, 1913–1915 and reconstruction, 1929–1931 were consistent with the best steel available during each time period. Due to the force of the forward magazine detonation, the best steel available today would not have had any impact on the outcome. Heavy banding in steels from both periods could adversely affect the corrosion resistance under anaerobic conditions that prevail during a corrosion cycle that developed under hard concretion layers that began to develop when the ship sank. Banding would have no effect on corrosion rate under aerobic conditions that may occur on local areas on the hull. In the part of the ship from which samples for this report were obtained, high temperatures above 1,340 °F (727 °C) did not occur.

The structural steel used in original construction was of surprisingly good quality for a basic open hearth steel technology that was only about 25 years old at the time the first materials were ordered for delivery to the New York Navy Shipyard. The somewhat lower quality of the early steel in terms of chemistry and microstructure had no measurable consequences on the damage that occurred on December 7, 1941 or on the results of the present investigation into the deterioration of the *Arizona*'s hull. Typical analysis and comparison with present day ASTM A-36 (Table 5.5) show minor differences in chemistry between the USS *Arizona*-era steel and present-day ASTM A-36 steel, however they are not considered significant with regard to corrosion response.

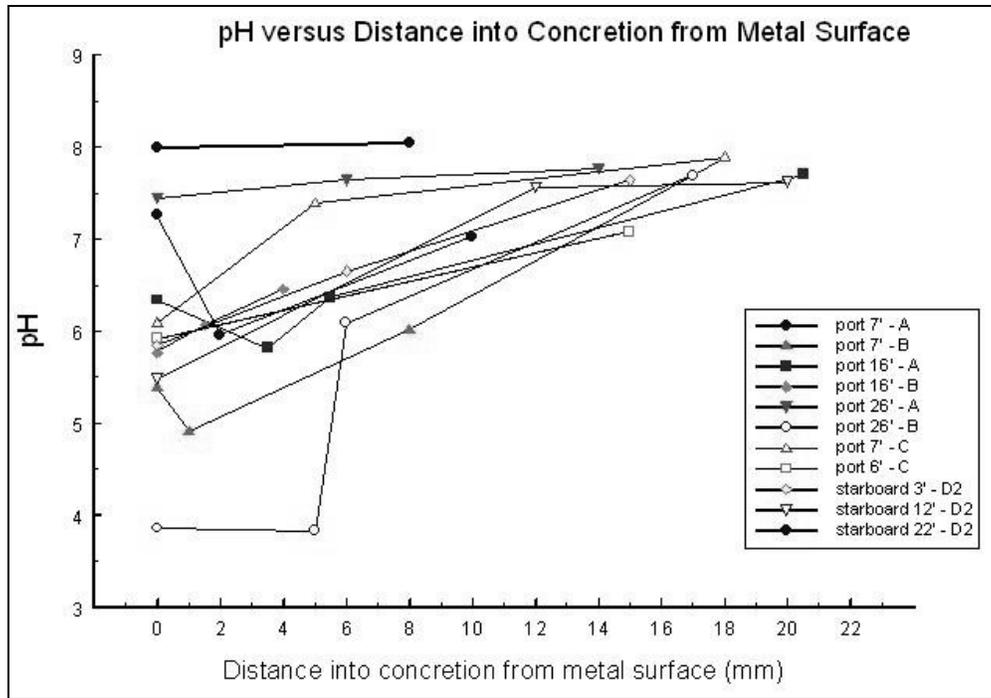
Data from the 2000 field season are tabulated (Table 5.7) and plotted in various graphs. A plot of pH vs. concretion depth shows that pH consistently decreases from a maximum at the exterior surface of the concretion to a minimum at the steel surface (Figures 5.21 and 5.22). The observation that pH decreases through the concretion from exterior to steel surface is consistent with reports on wrought and cast iron marine artifacts that note the cause for the decrease as similar to the crevice effect common in corrosion processes. Depletion of oxygen occurs as the concretion thickness increases and the low porosity of the concretion does not allow the oxygen to be replenished as fast as it consumed in the corrosion process (North 1976; North and MacLeod 1987). Chloride ions (Cl^-), with relatively high transport rates, migrate more rapidly than molecular oxygen through the concretion to the metal surface. The pH drops to as low as 4 at the metal surface as a result of hydrolysis reactions (equation [7]). The anodic reaction

Figure 5.21. Relationship between pH and concretion thickness, based on September 2000 data in Table 5.7.

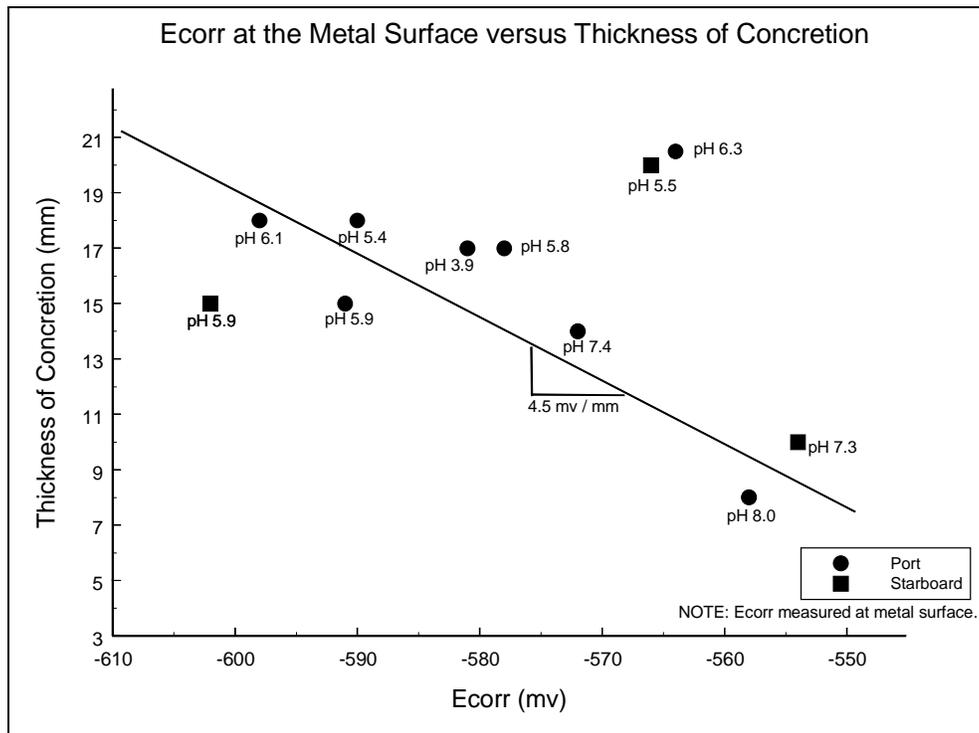
Figure 5.22. Relationship between E_{corr}, pH and concretion thickness, from data in Table 5.7.

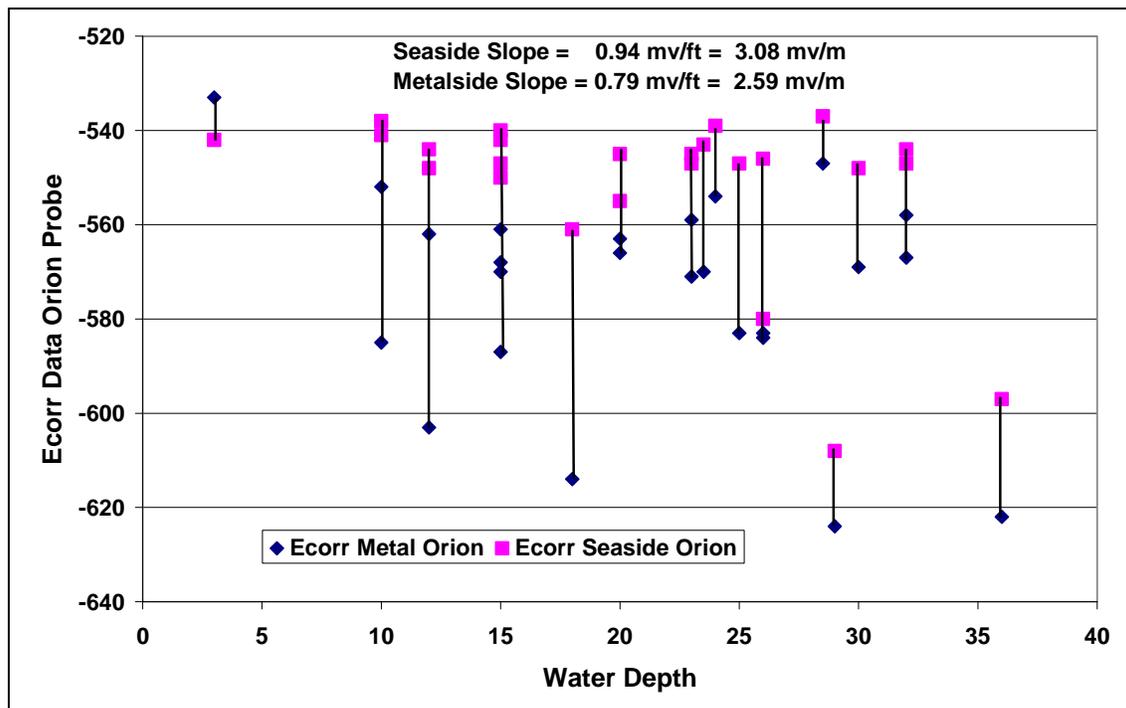
Data from the June 2001 field season were again tabulated (Tables 5.8–5.17) and plotted graphically. The most important observation from this data set is that E_{corr} is inversely proportional to water depth; that is, E_{corr} decreases (becomes more negative) as water depth increases (Figure 5.24). Figure 5.24 displays two values for each drill hole, appearing at the two ends of a vertical line—the top of the line corresponds to values taken at the steel hull surface, while the bottom of the line corresponds to values taken on the concretion's exterior surface. Visual observation indicates that E_{corr} decreases as the water depth increases. E_{corr} also decreases from the exterior surface of the concretion inward toward the steel hull, with the lowest E_{corr} value occurring at the steel surface (Figure 5.25). E_{corr} is most negative at the steel surface and the most positive at the concretion's exterior surface, as observed by North and MacLeod (1987).

Figure 5.24. Corrosion potential as function of water depth, typical frames from June 2001 data set.

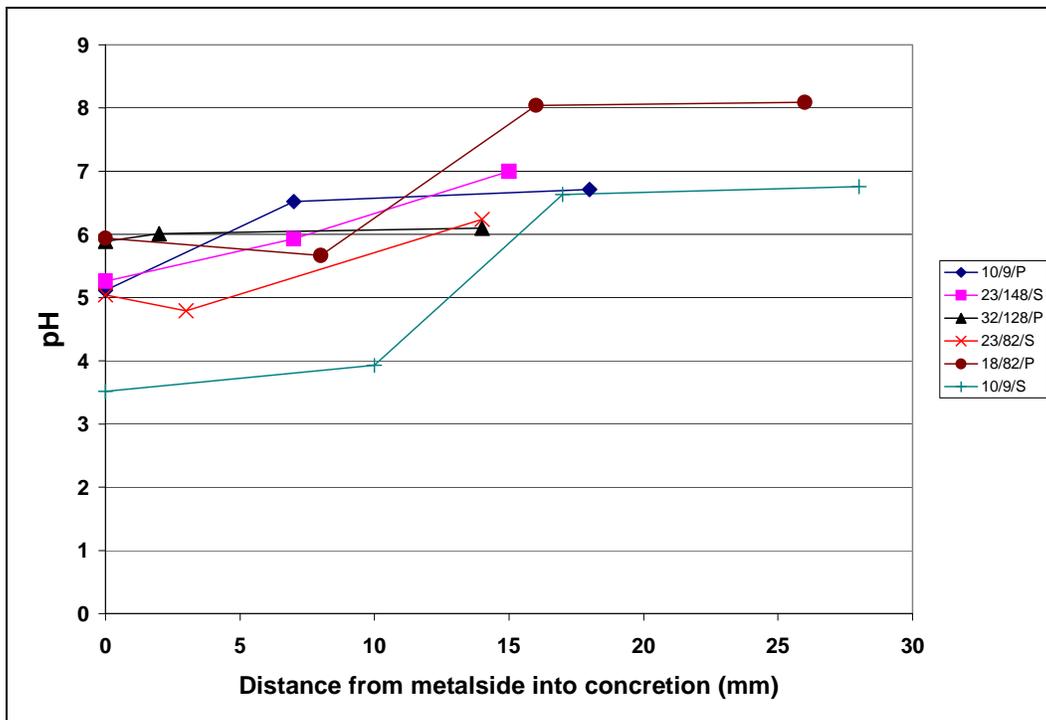
Results of the June 2001 field season also clearly confirm that a decrease in pH, caused by reduced oxygen and increased chloride ion, occurs as the steel surface is approached through the concretion (Figures 5.26 and 5.27). While this result is consistent at each location measured on *Arizona*'s hull, the effect is random with respect to water depth and frame location on the hull.

Figure 5.26. pH as a function of distance from hull surface, typical frames from June 2001 data set.

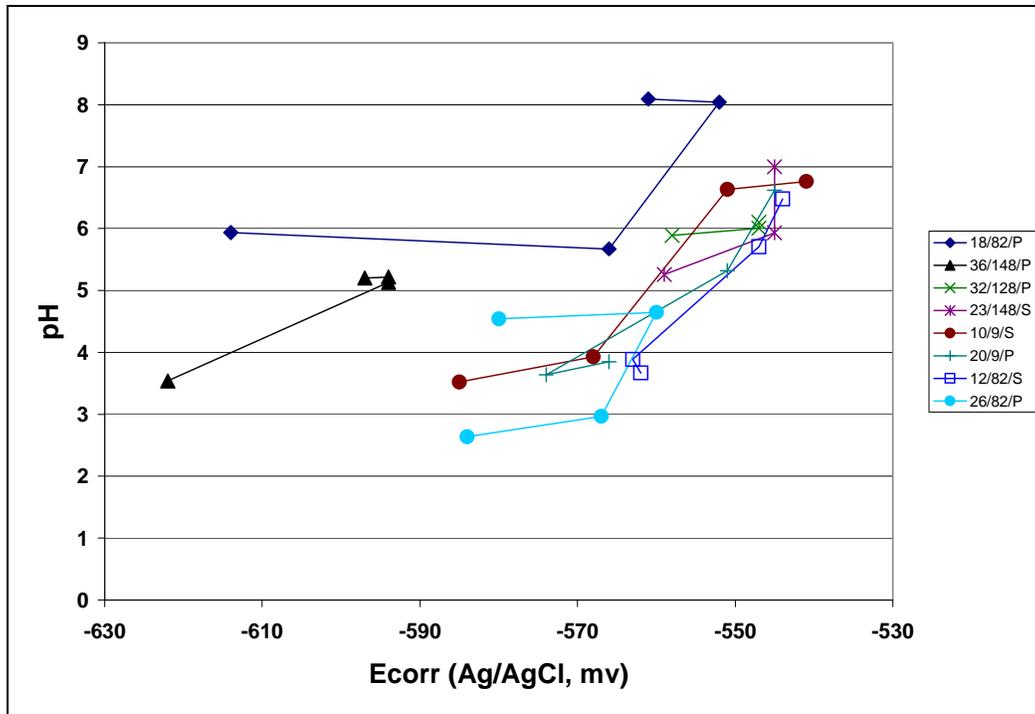
Figure 5.27. pH as a function of E_{corr} , typical frames from June 2001 data set.

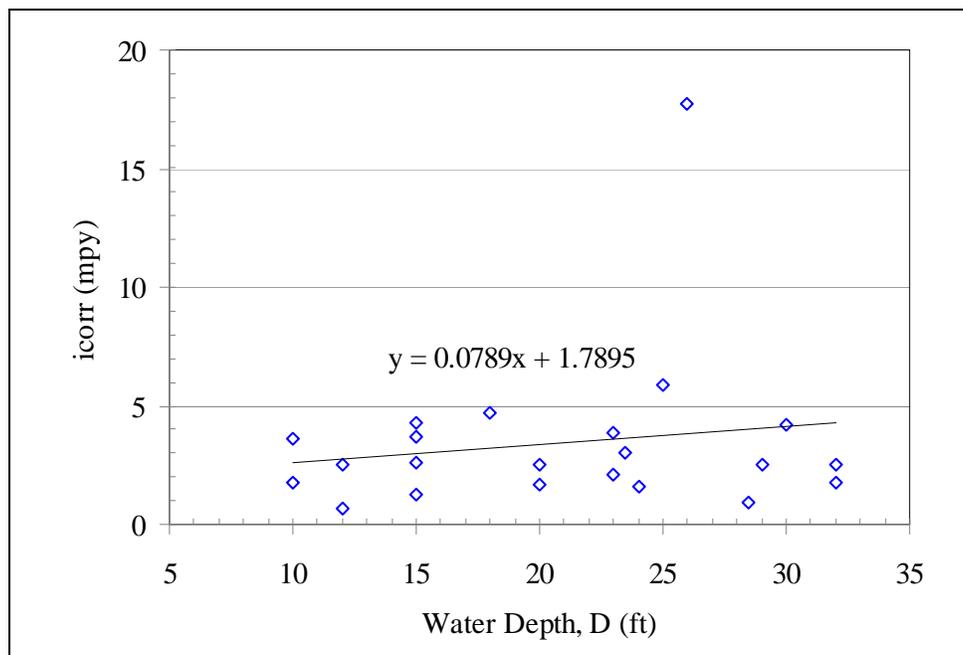
Computation of $i_{(\text{corr}, \text{IR drop})}$ for all of data in Tables 5.8–5.17, including E_{corr} values taken inside the concretion, resulted in a wide scatter of data. Figure 5.28 shows a plot of $i_{(\text{corr}, \text{IR drop})}$ as a function of water depth after eliminating internal E_{corr} readings obtained from 22 sites over the entire hull. The trendline shows increasing $i_{(\text{corr}, \text{IR drop})}$, just the opposite of i_{corr} obtained from metal samples taken from the hull. It is concluded that current distribution inside the concretion is complex and creates a voltage gradient across the concretion that cannot be related to i_{corr} in simple terms. Furthermore, the electrical resistivity of the concretion is not a constant as assumed in equation [15]. This observation is confirmed from x-ray diffraction results showing that the concretion is not homogeneous.

Figure 5.28. i_{corr} (IR Drop across concretion) as a function of water depth.

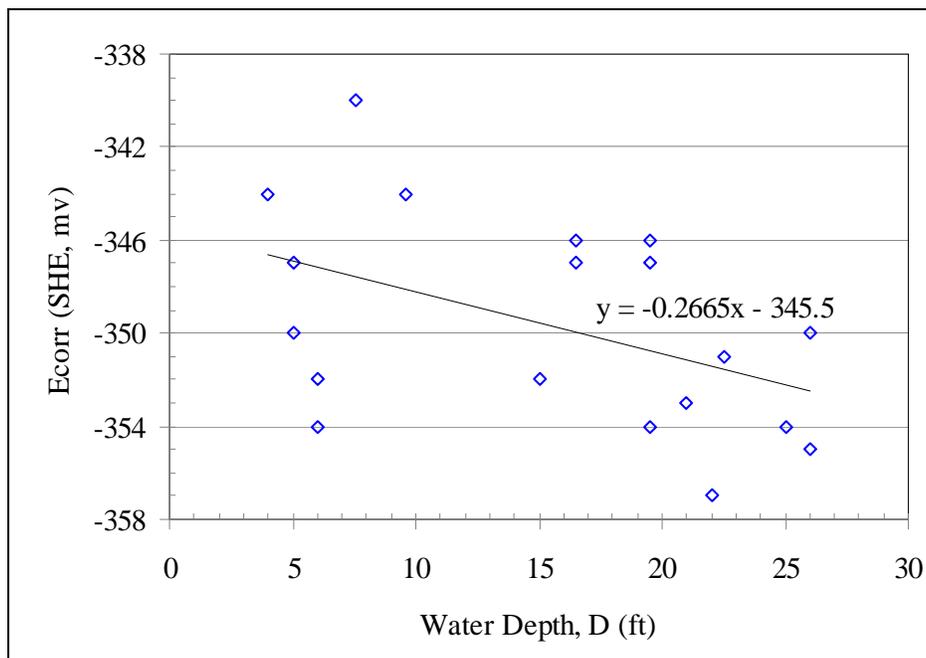
Finally, in 2004 a final E_{corr} /pH data set was collected during expansion of the ultrasonic thickness survey (Table 5.20). These data continued to confirm earlier findings regarding E_{corr} and pH variability. E_{corr} as a function of water depth from Tables 5.19 and 5.20 are combined and plotted in Figure 5.29.

Figure 5.29. E_{corr} as a function of water depth for *in situ* data collected in 2003 and 2004.

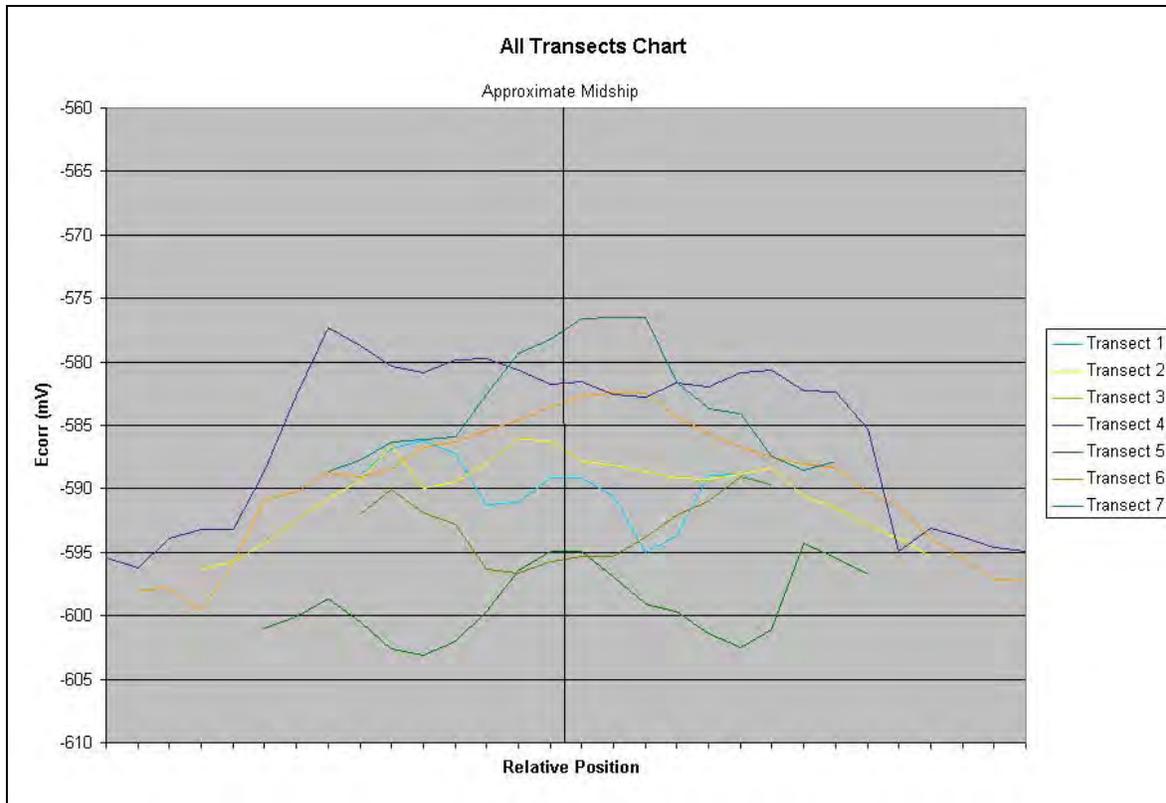
Figure 5.31. Compilation of E_{corr} data from all seven transects from June 2001, plotted from harbor bottom on left, up and over Arizona's hull every 6 ft., to harbor bottom on right.

The final transect, transect 7, is near the bow, approximately frame 9, forward of the area of maximum damage, where the intact upper deck is in shallow water. As expected, E_{corr} values are relatively high along the exposed upper deck, near -575 mV, and drop to near -590 mV at the harbor bottom (Table 5.27)(Figure 5.38). E_{corr} transects with the GMC probe confirm the overall pattern produced by the sequential drilling and data collection through the concretion, that is that E_{corr} decreases with increased water depth. E_{corr} profiles generally tend to drop to lower potentials from stern (Frame 148) to bow (Frame 9) with maximum E_{corr} near -330 mV (SHE) or -575 mV (Ag/AgCl, GMC) to a minimum approaching -360 mV (SHE) or -605 mV (Ag/AgCl, GMC)(Figure 5.31).

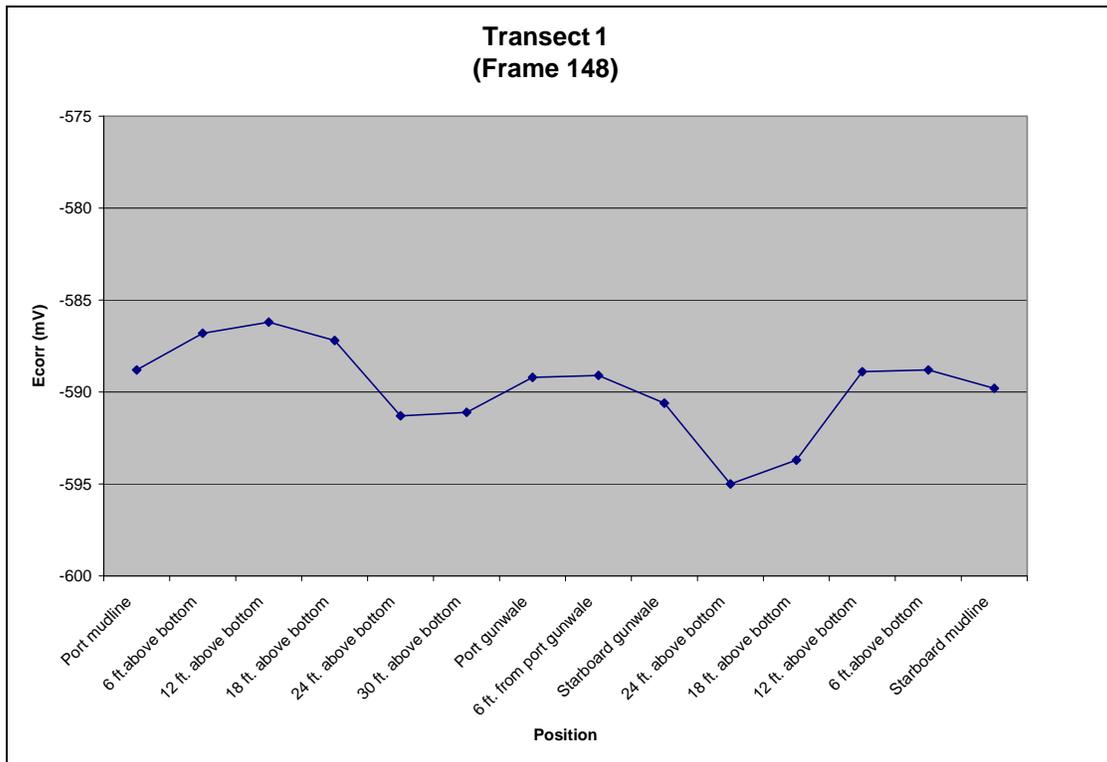
itself (Table 5.21)(Figure 5.32). Proximity to cuprous propellers may promote less negative readings at 12 ft. above the harbor bottom, port and starboard. The decrease near 24 ft. on both sides of the ship may reflect the initial drop off to the harbor bottom prior to the rise resulting from influence of the propellers. The drop in E_{corr} as the transect approaches the harbor bottom is consistent with E_{corr} data obtained from the ThermoOrion instrument inserted in holes drilled in concretion.

Figure 5.32. Graph of GMC data E_{corr} taken from Table 5.21, relative to hull position.
