PROJECT NUMBER (05-170)

Long-Term Management Strategies for USS ARIZONA, A Submerged Cultural Resource in Pearl Harbor

NATIONAL PARK SERVICE
SUBMERGED RESOURCES CENTER

SEPTEMBER 2008
THIS REPORT IS APPROVED FOR PUBLIC RELEASE

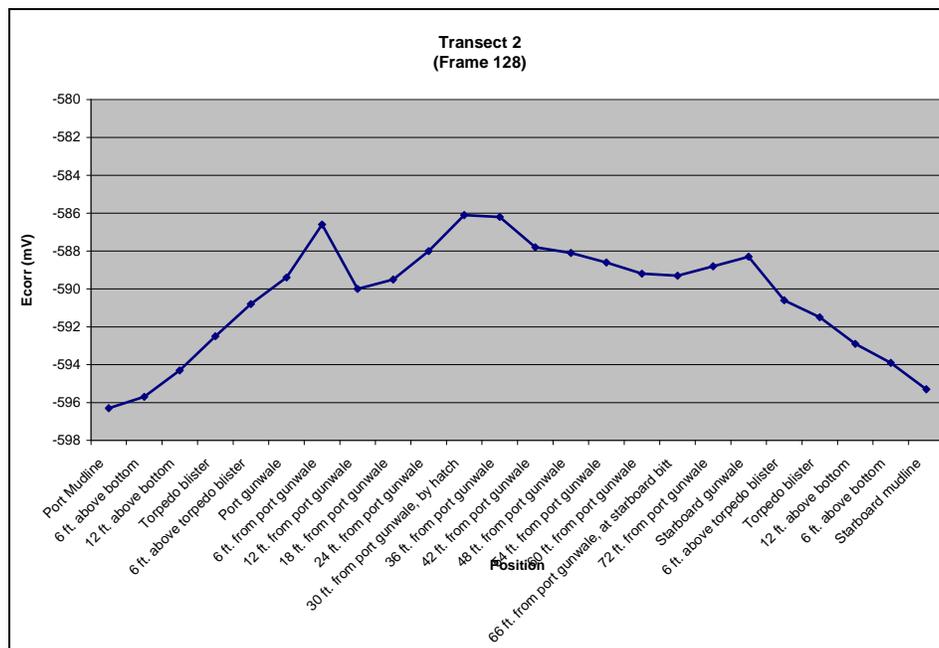
The next transect forward, transect 2, taken at approximately frame 128, shows a similar pattern in which from the gunwales to the harbor bottom E_{corr} decreases on both sides but holds fairly steady across the main deck (Table 5.22)(Figure 5.33). The decrease to the harbor bottom is again attributed to the reduction in oxygen availability.

Figure 5.33. Graph of GMC data E_{corr} taken from Table 5.22, relative to hull position.

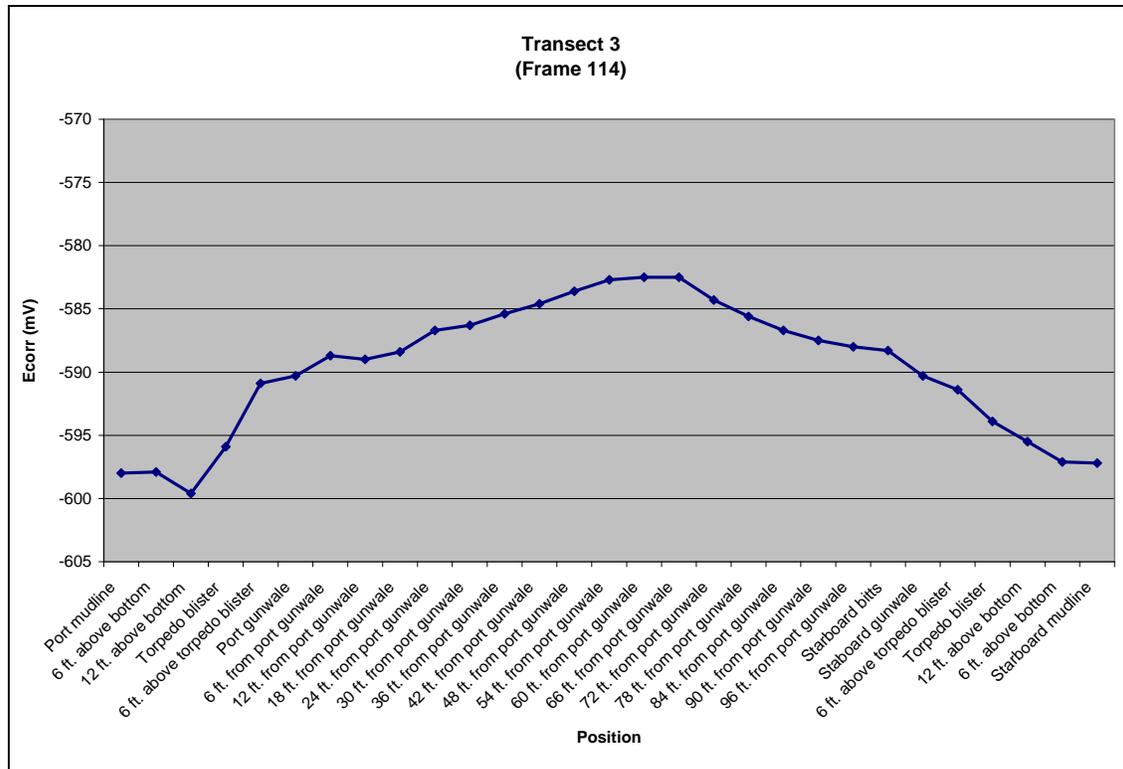
Transect 3, approximately frame 114, cuts across the main deck just forward of barrette no. 3, which extends about 6 ft. above the water surface and has accelerated water line corrosion vertically on its side. Because of this, E_{corr} amidships on this transect is higher as compared to transects 2, 5, 7, and 6 (Table 5.23)(Figure 5.34).

Figure 5.34. Graph of GMC data E_{corr} taken from Table 5.23, relative to hull position.

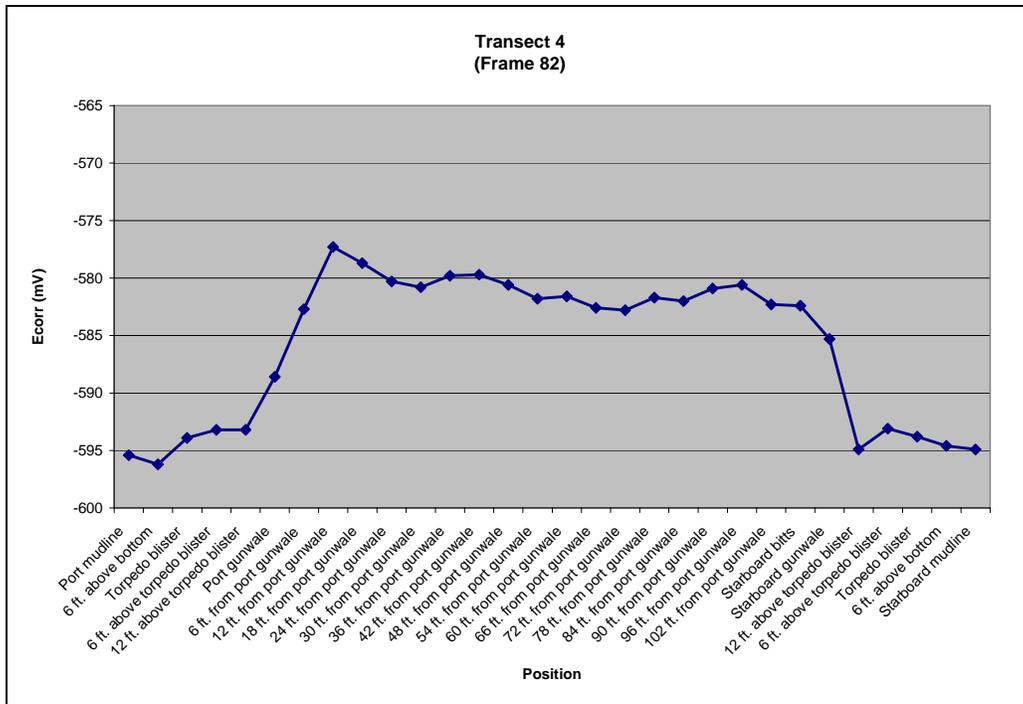
Transect 4 crosses the upper deck in the crew galley area in shallow water forward of the Memorial, at approximately frame 82. E_{corr} is -583 mV or higher over nearly the entire deck area—recent structural corrosion is consistent with higher E_{corr} in this area (Table 5.24)(Figure 5.35).

Figure 5.35. Graph of GMC data E_{corr} taken from Table 5.24, relative to hull position.

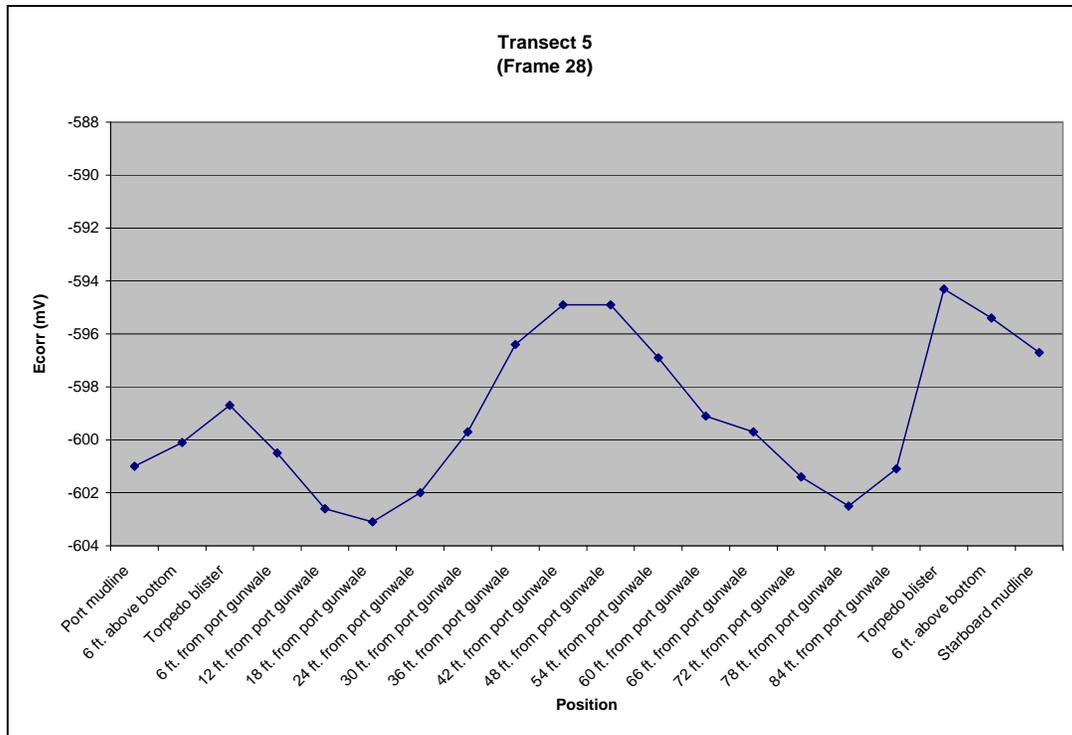
Figure 5.36. Graph of GMC data E_{corr} taken from Table 5.25, relative to hull position.

Moving forward along the hull, transect 5, at approximately frame 28, has the lowest overall E_{corr} values, which may be due to the fact that the deck is buried by several feet of sediment along the entire transect (Table 5.25)(Figure 5.36). The close proximity and exposure of the gun barrels of turret no. 1 above the harbor bottom may reflect a rise in E_{corr} near the centerline of the hull. A drop in E_{corr} from the torpedo blisters on either side to the harbor bottom is typical. Because the deck is collapsed in this area, the top of the torpedo blister and the gunwale are at about the same elevation.

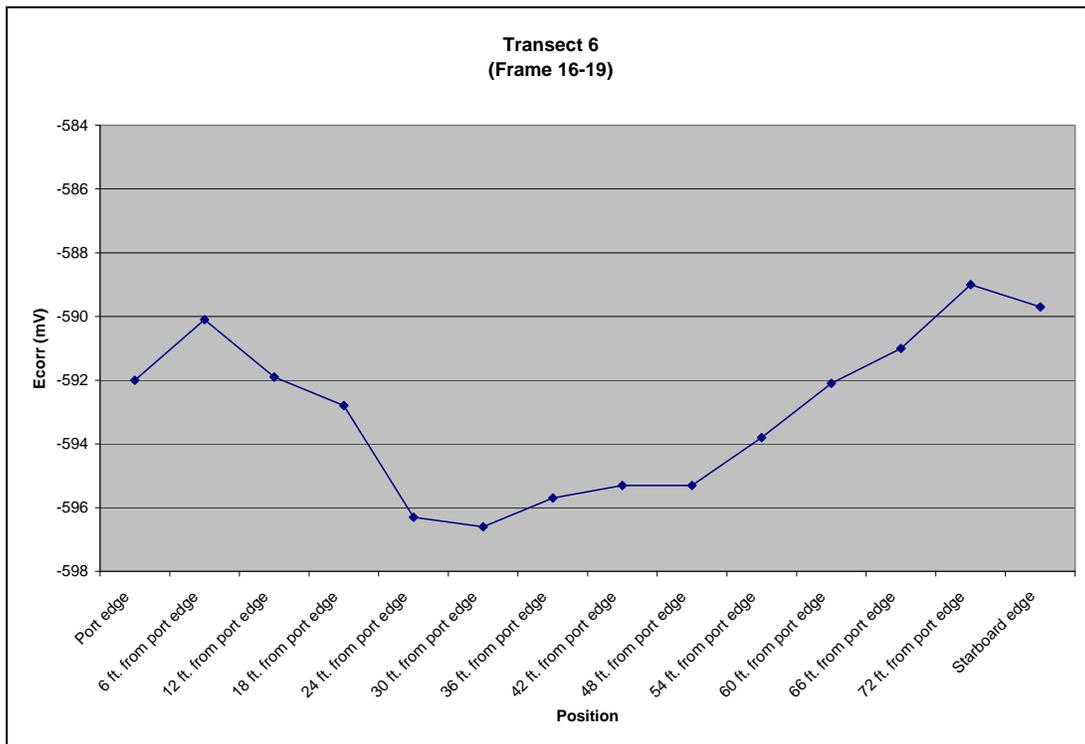
Figure 5.37. Graph of GMC data E_{corr} taken from Table 5.26, relative to hull position.

availability. Because the plates flare out so much in this area, transects could not be taken to the harbor bottom. The lowest E_{corr} appear near the centerline where silt has accumulated (Table 5.26)(Figure 5.37).

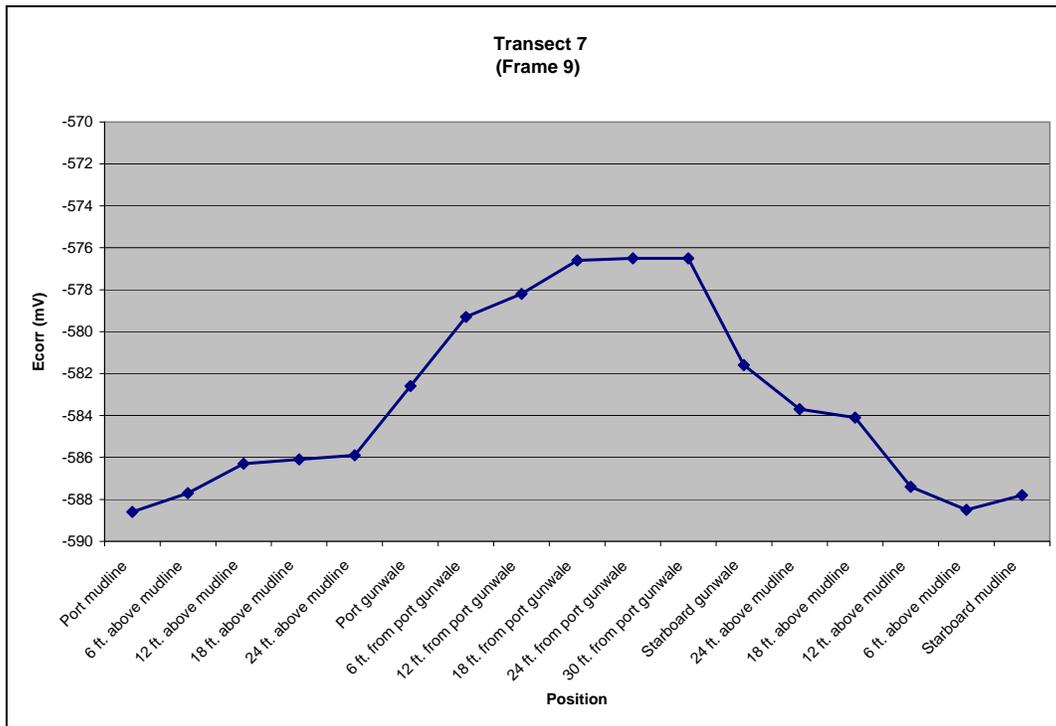
Figure 5.38. Graph of GMC data E_{corr} taken from Table 5.27, relative to hull position.

The final transect, transect 7, is near the bow, approximately frame 9, forward of the area of maximum damage, where the intact upper deck is in shallow water. As expected, E_{corr} values are relatively high along the exposed upper deck, near -575 mV, and drop to near -590 mV at the harbor bottom (Table 5.27)(Figure 5.38). E_{corr} transects with the GMC probe confirm the overall pattern produced by the sequential drilling and data collection through the concretion, that is that E_{corr} decreases with increased water depth. E_{corr} profiles generally tend to drop to lower potentials from stern (Frame 148) to bow (Frame 9) with maximum E_{corr} near -330 mV (SHE) or -575 mV (Ag/AgCl, GMC) to a minimum approaching -360 mV (SHE) or -605 mV (Ag/AgCl, GMC)(Figure 5.31).

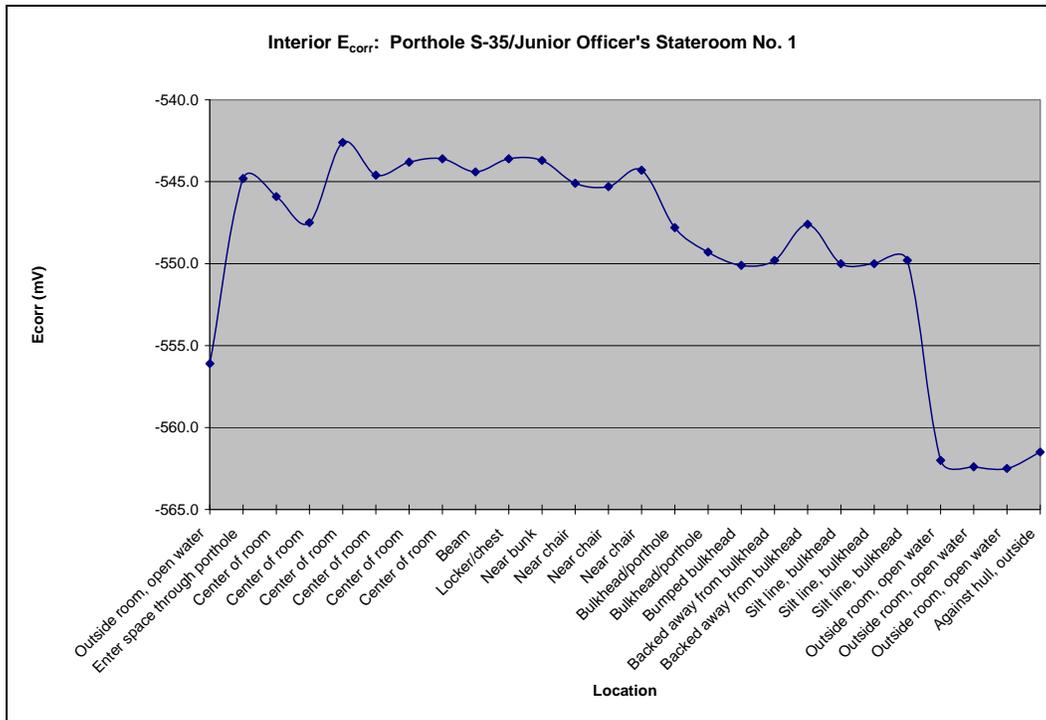
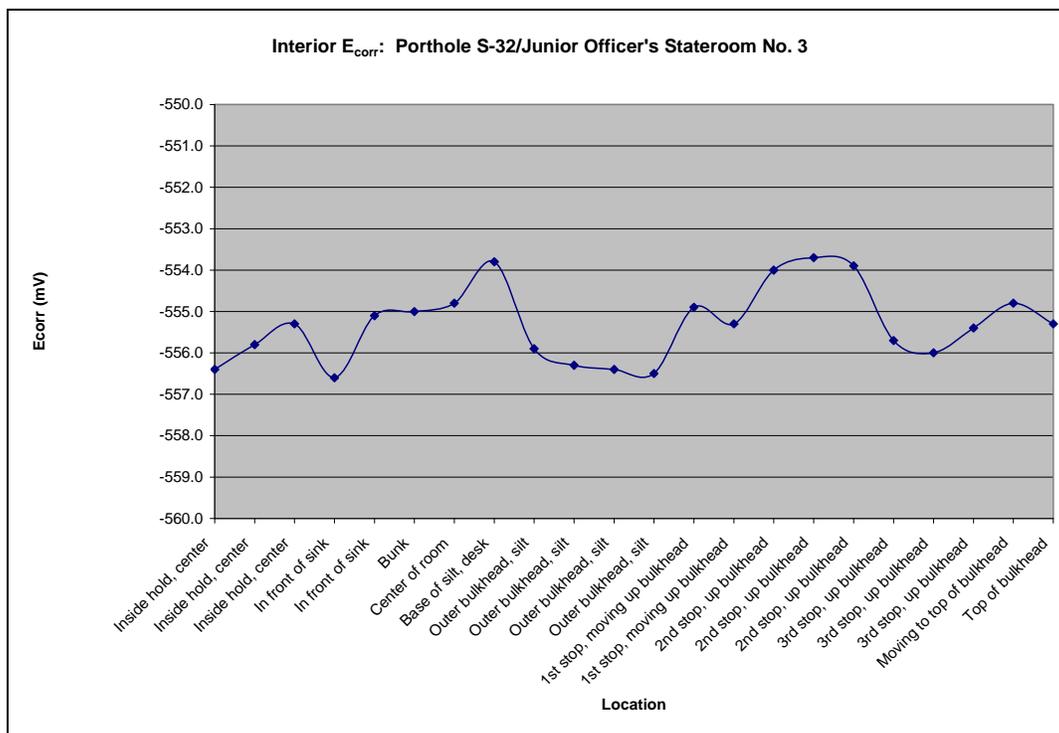
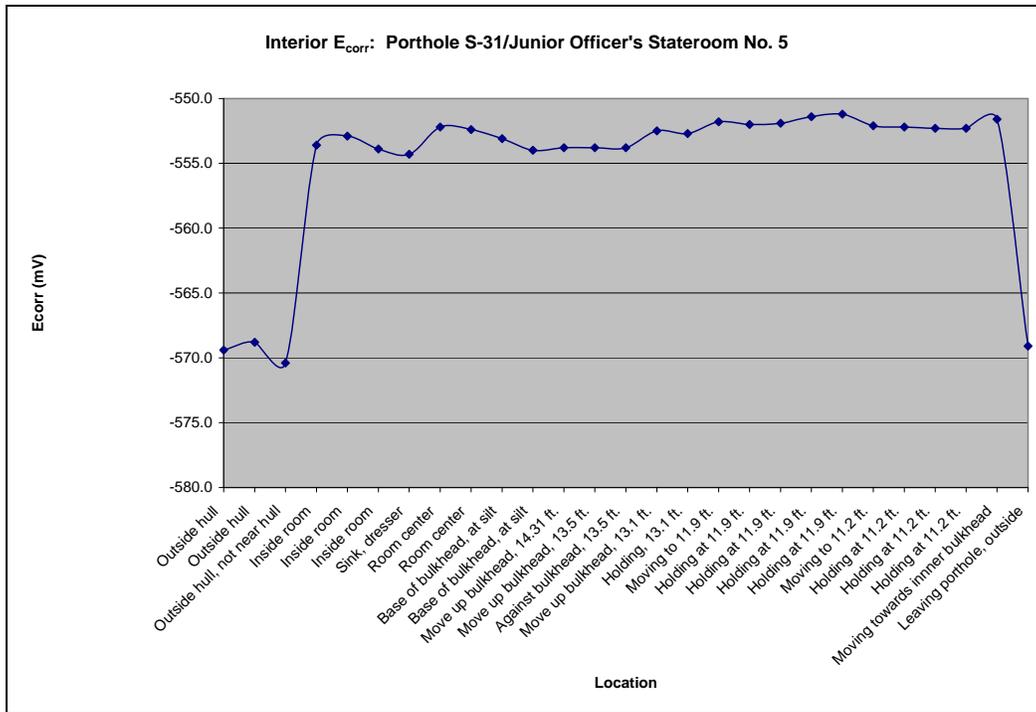
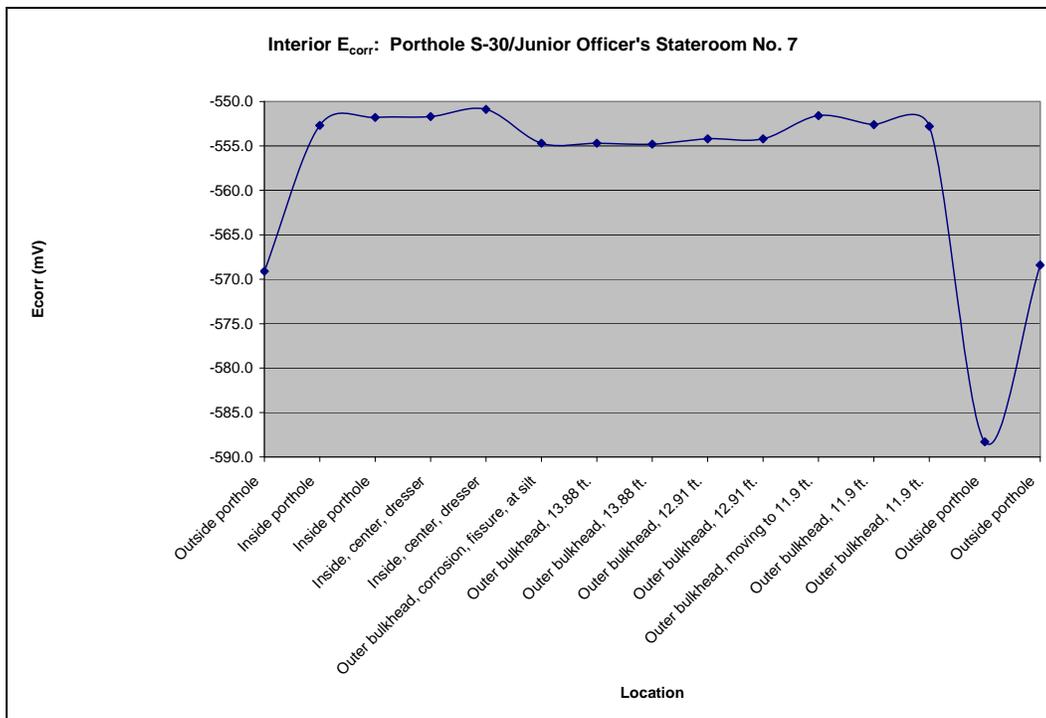
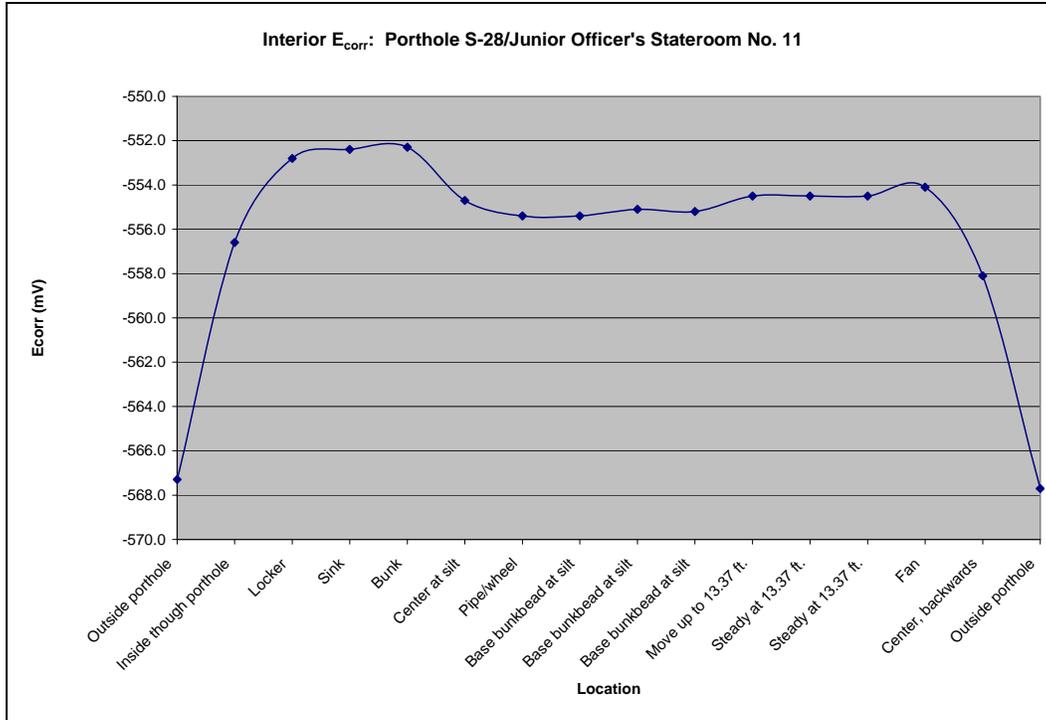
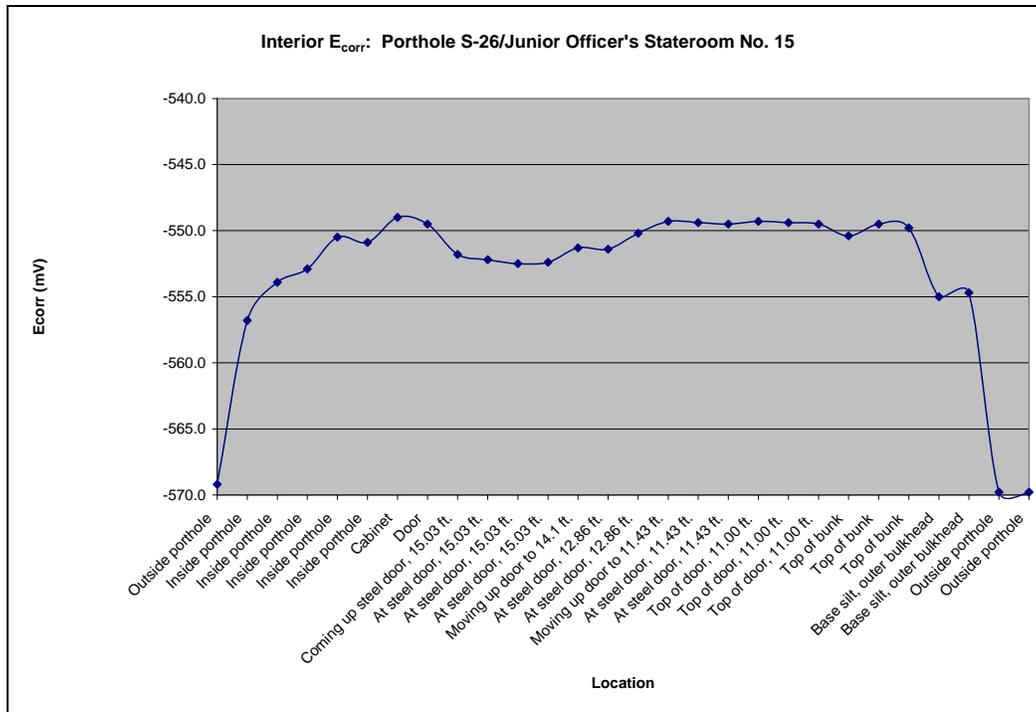
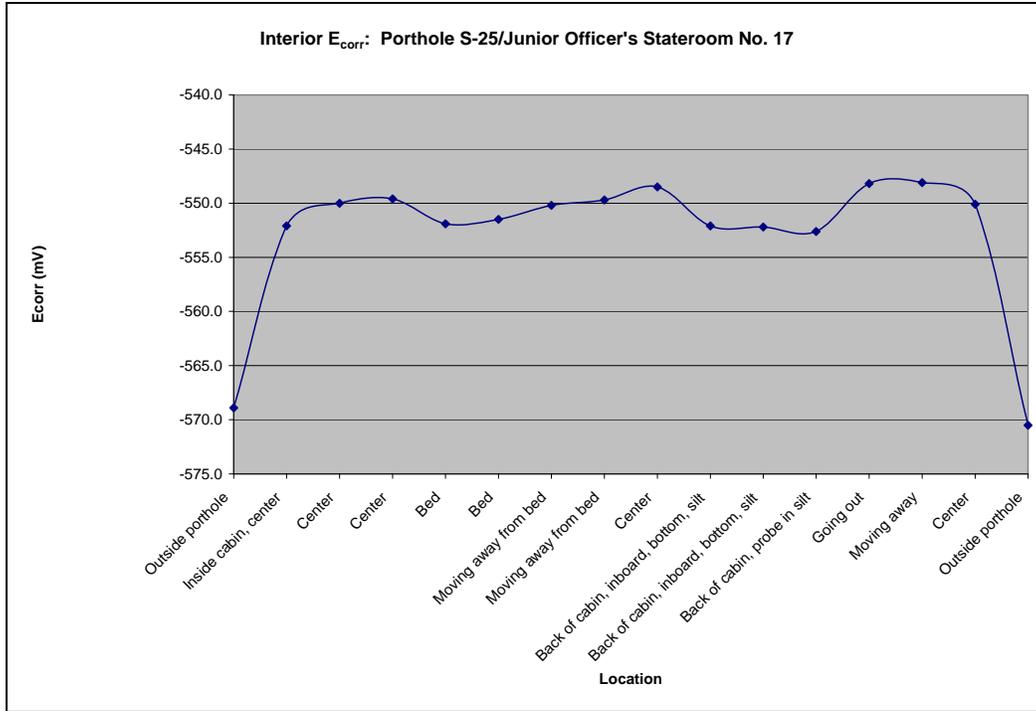
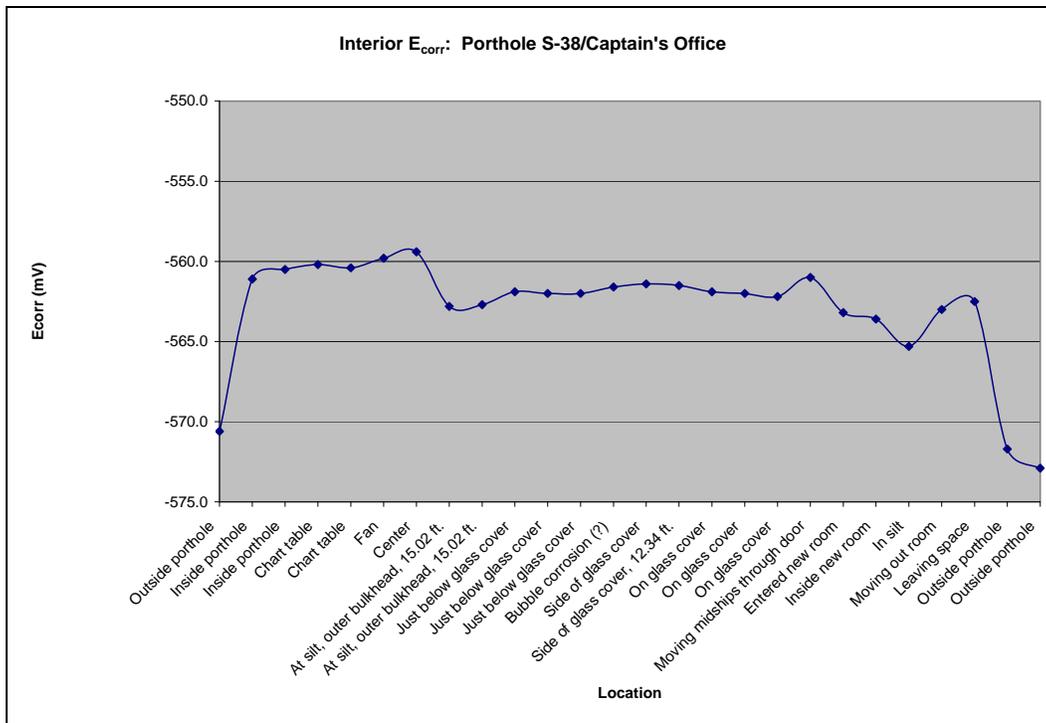
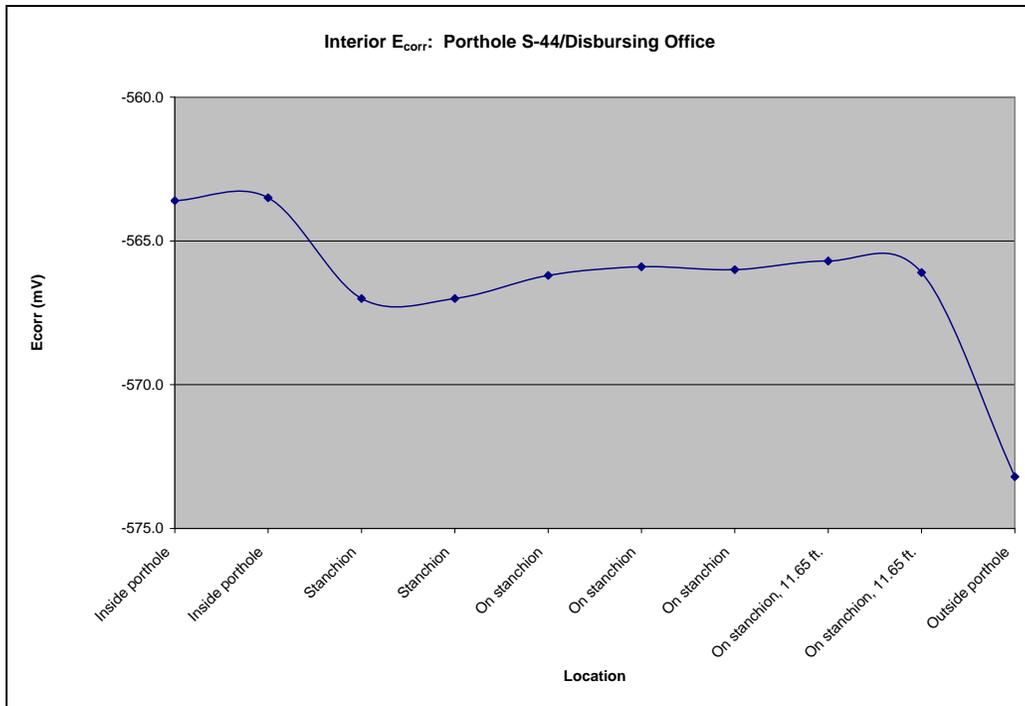
On entry through open port holes, E_{corr} increased from 8 to 18 mV, an average 13 mV; that is interior values are 8–18 mV more positive than baseline readings outside each cabin (Figures 5.39–5.47). This could indicate a slightly higher corrosion rate; however there are many variables at work. Translated to the Fe/H₂O Pourbaix diagram (Figure 5.2) this difference suggests that the corrosion potential is higher depending upon the pH in the compartments and the thickness of the concretion on interior surfaces. Knowledge of temperature, salinity, pH and oxygen concentration in interior compartments is important for contextualizing these results. Descent into hatches starboard of barbette no. 3 and barbette no. 4 to the third deck showed a similar increase in E_{corr} , though not as great (Figures 5.48 and 5.49).

The reason for the rise in E_{corr} inside interior compartments is not fully understood. Perhaps the concretion, or what there is of it, is thin enough to change the balance between available oxygen and oxygen diffusion resistance in favor of higher effective oxygen availability at the interior surface. On the other hand, increased carbon or sulfur availability from overhead fuel oil may be the cause for the higher E_{corr} readings. These and other possible explanations for the rise in E_{corr} in interior compartments come from further examination of the carbon-water Pourbaix diagram (Figure 5.4). At a pH of 7 or lower, elemental carbon from oil trapped in the overheads is at equilibrium with water at slightly higher potentials. For example, carbon

whether or not this environment is more corrosive than exterior seawater and confirm the presence of carbonates and/or methanol predicted in the Pourbaix diagram (Figure 5.4). At greater depths and pressures in interior spaces, it may be possible that E_{corr} is lower, suggesting the presence of methane dissolved as methanol. The report of solid methane as hydrate at great ocean depths draws some interesting parallels. Chemical analysis of interior water would help clarify this issue. Another factor causing a potential increase in interior compartments is the existence of thermoclines (see Chapter 4 and above) and associated variation in oxygen content across them. Temperature or oxygen cells may also be operative.

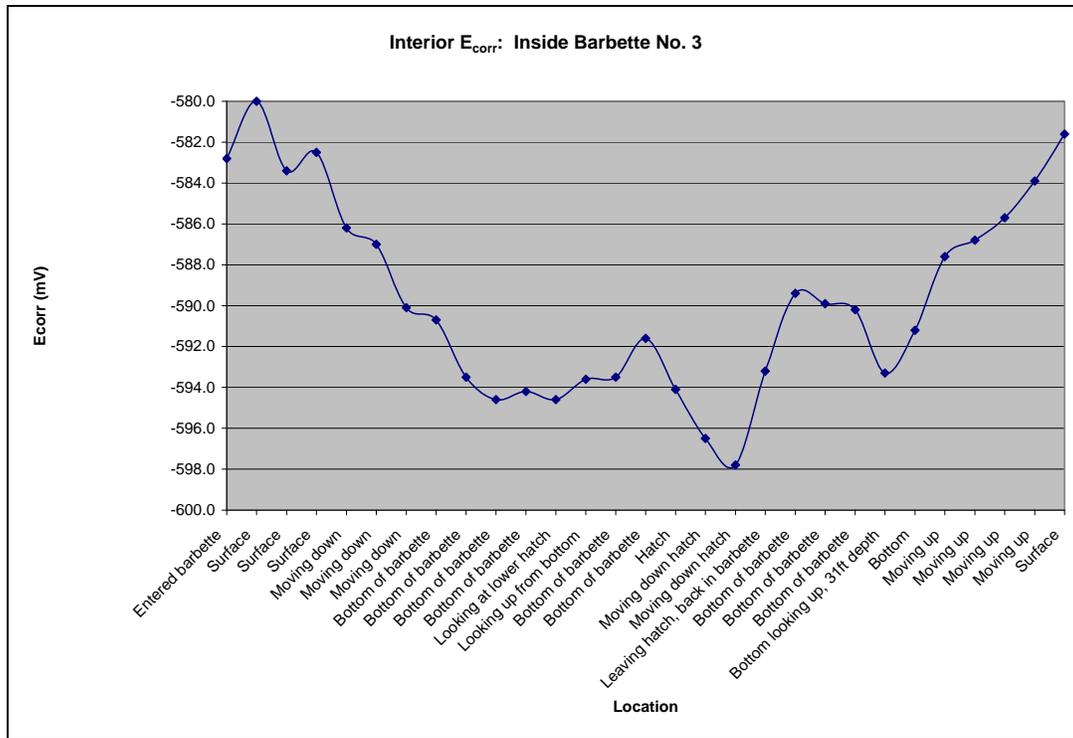
Figure 5.50. Graph of interior E_{corr} relative to location inside Barbette No. 3

The trend showing increasing (more positive) E_{corr} in interior compartments was not observed inside barbette no. 3 (Figure 5.50). A descent from the surface to 31 ft. below the surface to the bottom of the barbette (roughly equivalent to the harbor bottom outside the ship) showed a decrease in E_{corr} , similar to the trend for E_{corr} on the external hull. The E_{corr} values inside the barbette are consistent with readings on the external hull in that E_{corr} values decrease with depth. Both observations are consistent with a reduced tendency to corrode. In both cases, the water column is directly open to the atmosphere and gases such as carbon dioxide and methane would dissociate from water and outgas to the atmosphere. In interior compartments, with egress only at open port holes, outgassing is limited.

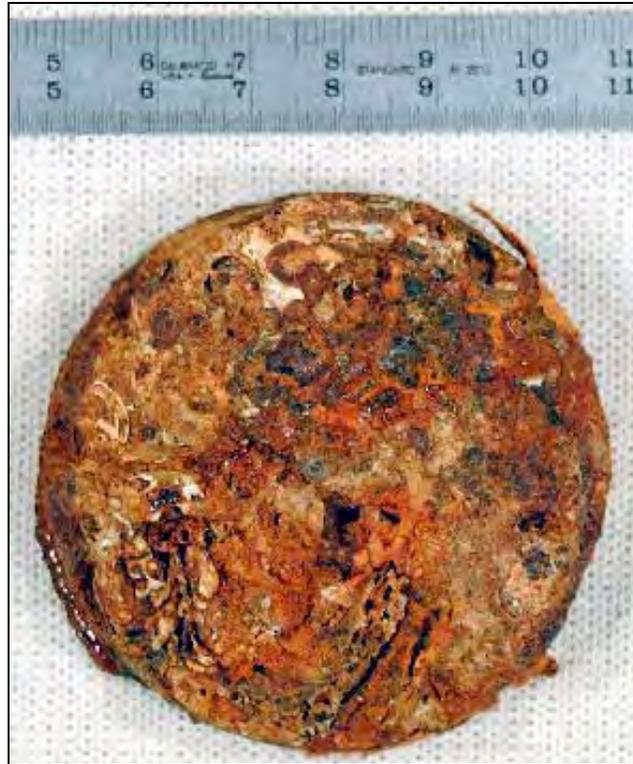
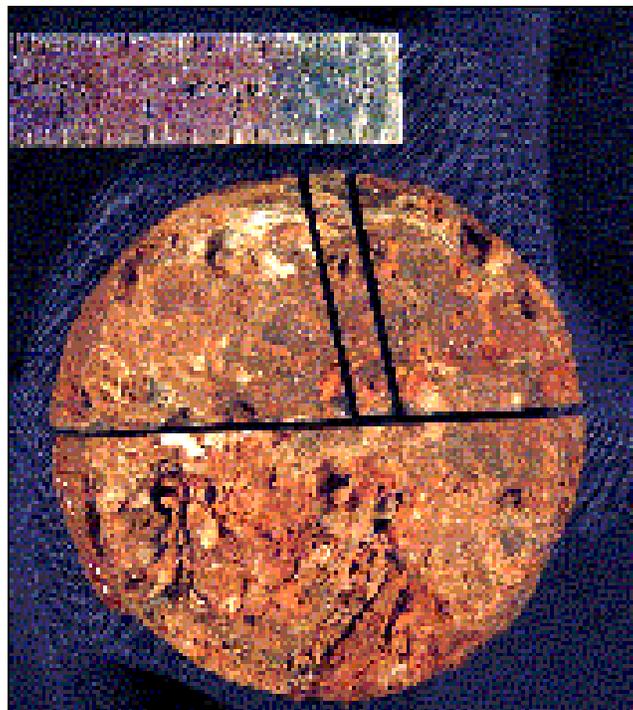
A 2.2 in. (5.5 cm) diameter concretion sample (USAR-01-045) was used for XRD and ESEM. The concretion was collected by using an air-powered hole-saw and sectioned on a diamond saw using water containing a 3% TRIMSOL solution to produce the XRD and ESEM sample, which was from the upper half of the disc (Figures 5.51 and 5.52).

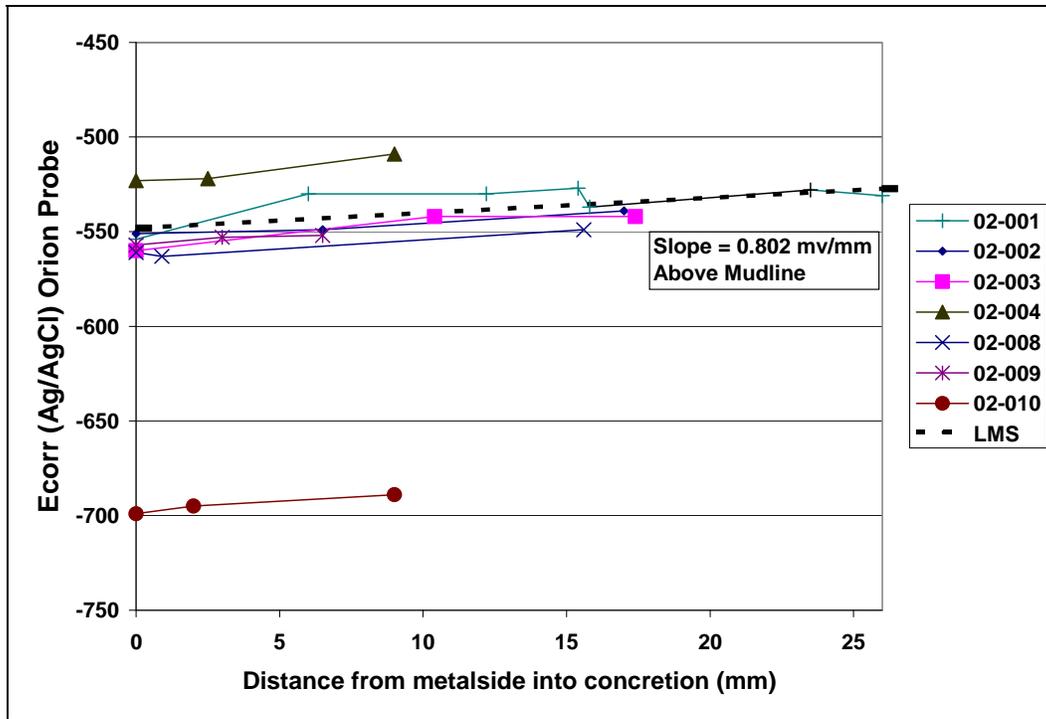
Figure 5.72. Corrosion potential as a function of distance from hull surface into concretion, August 2002.

The E_{corr} gradient across the concretion for each of the hull coupon sites varies depending on the coupon site, but is typically about 1 mV/mm (Figure 5.72). pH also decreases through the thickness of the concretion (Figure 5.73)(Makinson, et al. 2002), the cause related to hydrolysis given by equation [7]. Bacterial activity may also be a cause of reduced pH, but the extent that each contributes is complex and variable from one site to another (Brenda Little, personal communication, 2003). As mentioned earlier, SRB accelerates the formation of hydrogen gas and hence has been shown to accelerate corrosion at low pH. Applying equation [14] to a typical set of data corresponding to coupon #USAR-02-008:

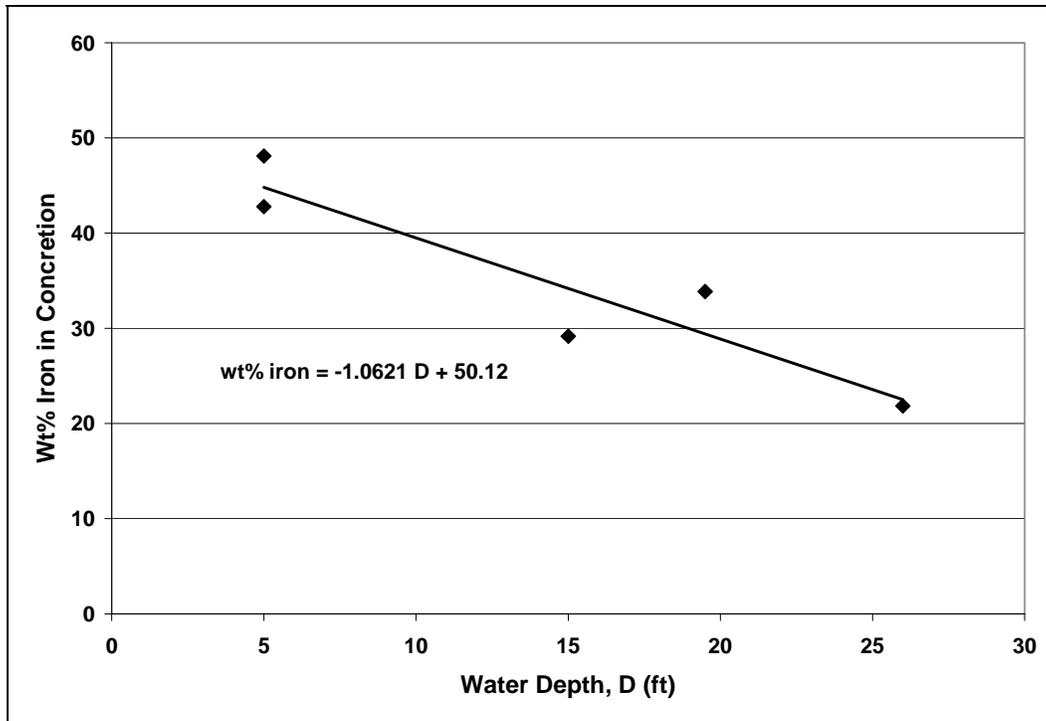
Figure 5.75. Weight % iron vs. water depth.

Because determining hull corrosion rate through direct measurement as described above is destructive and impractical, and because determining steel hull thickness with ultrasonic technology has proved unreliable, alternative indirect indicators of steel hull corrosion rate have been sought. The most promising indirect method for determine *Arizona*'s steel hull corrosion rate is correlation between hull iron loss and concretion iron gain, as measured through concretion analysis. External hull concretion analysis and its relationship to corrosion on USS *Arizona* began in the late 1980s. Henderson (1989) scraped samples of concretion from the hull, dried and weighed them, and separated the magnetic corrosion products with a bar magnet. In 1998, Johnson converted the data generated by Henderson (1989) to corrosion rate in mpy to illustrate that analysis of the concretion may have merit as a way to determine corrosion rate (Johnson, et al. 2003). Based on these observations, x-ray diffraction (XRD) and environmental scanning electron microscopy (ESEM) studies on USS *Arizona* concretion were initiated in 1999 at UNL to better understand in what form the iron exists in the concretion and how the metal hull and the concretion interact. Subsequently, x-ray studies were continued at Eglin Air Force Base, Florida and the University of Florida. Using XRD data, De Angelis (2002) identified the iron minerals siderite (FeCO_3), with lower residuals of aragonite (CaCO_3) and magnetite (Fe_3O_4), as the primary constituents in the concretion (Johnson, et al. 2003:91-92; Johnson, et al. 2006a, 2006b)(see above). Measuring distribution of iron in the concretion cross-section using ESEM and x-ray fluorescence (XRF), Johnson used graphical integration to determine the mean (total) iron content, the result, 40% to 50% by weight, was close to the same iron content obtained from chemical analysis of a sample representing the total thickness of the concretion (Johnson, et al. 2003:96-97). Data from *Arizona* concretion analysis revealed that the specific weight of the concretion per unit area (density x thickness) and total iron in concretion in weight percent (%Fe) decreases with water depth (Figure 5.75). The equation expressing the relationship between weight %Fe and water depth is given by:

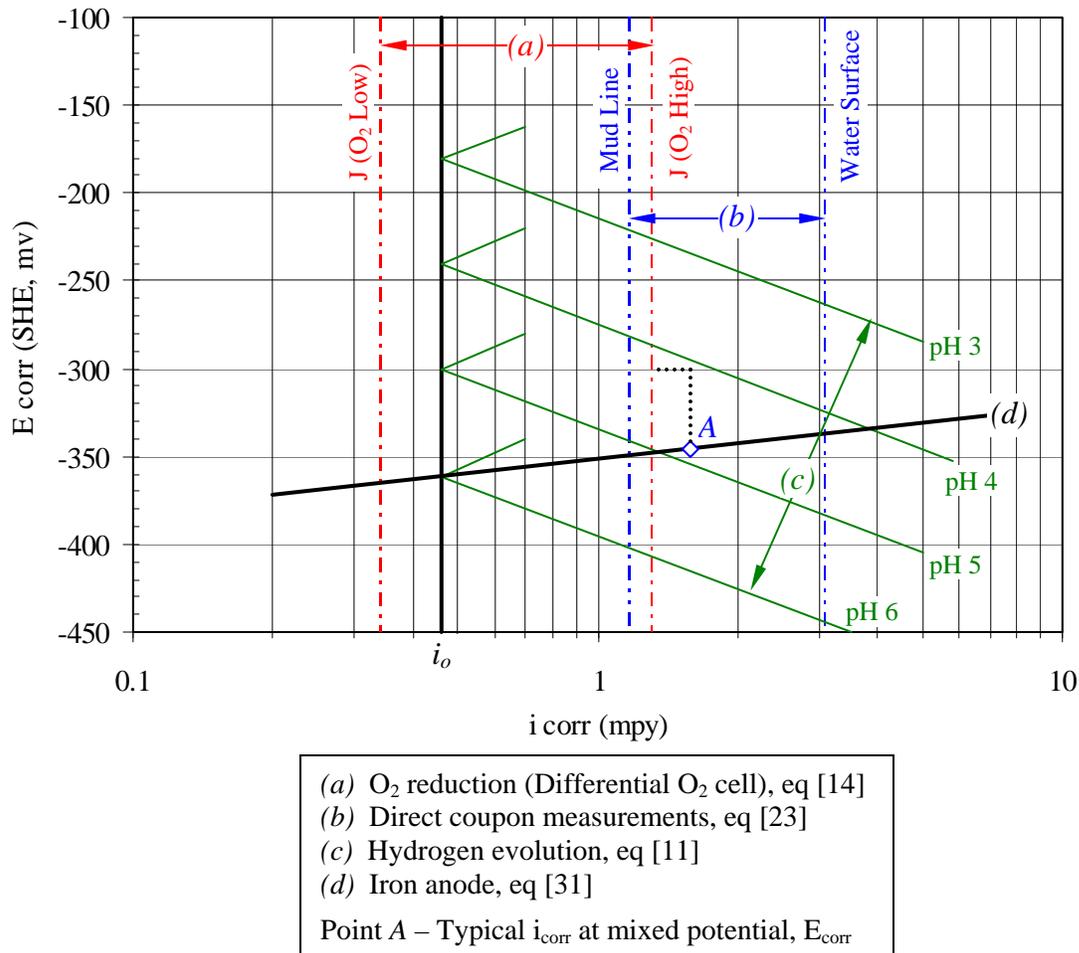
These theoretical considerations are summarized in Figure 5.77, a polarization diagram that characterizes Model 1, in which potential (E , SHE, mV) is plotted versus corrosion current or rate (mpy). Anodic polarization ($\text{Fe to Fe}^{+2} + 2e$) is derived from a composite of Tafel expressions (Table 5.35). The composite expression is given by equation [31] and plotted as line (d):

Figure 5.77. A polarization diagram plotting corrosion potential versus corrosion rate.

lines at near 1.2 and 3 mpy. Two cathodic reactions support corrosion and mixed potential theory shows a typical corrosion rate at point A. Point A lies on the dotted line representing interaction between oxygen reduction and hydrogen discharge at its point of intersection with anodic polarization, line (d). At the mixed potential, resulting typical values of E_{corr} and i_{corr} are shown in span (b). There is a wide variation in concretion thickness from the surface to the harbor bottom (Figure 5.78). According to equation [14], $i(L)$ is inversely proportional to concretion thickness, hence oxygen concentration at the surface is highly variable from point to point promoting differential oxygen cell corrosion. As a result, oxygen flux (J) is identified corresponding to low and high availability of oxygen (Figure 5.77). The result is differential oxygen cell corrosion as discussed in an earlier section. There is a wide variability in pH at the

In review, oxygen consumption alone does not support the actual corrosion rates of between 1 and 3 mpy. The result concluded from this analysis is that hydrogen discharge is significant in controlling the rate of corrosion at a majority of sites on *Arizona*, although the driving force is the availability of oxygen at the concretion/metal interface as dictated by the oxygen concentration and thickness of the concretion at a particular location on the hull. The evidence for hydrogen discharge is quite evident from on-site observations of gaseous bubbles emerging from concretion and from the low pH values obtained from *in situ* data collected at numerous sites around the hull. During one field operation, a drill hole through concretion resulted in a significant flow outward of water as the bit was withdrawn. As the water poured out of the hole, it made contact with surrounding water at a pH of approximately 8. The result was immediate precipitation of iron as iron hydroxide (discussed above).

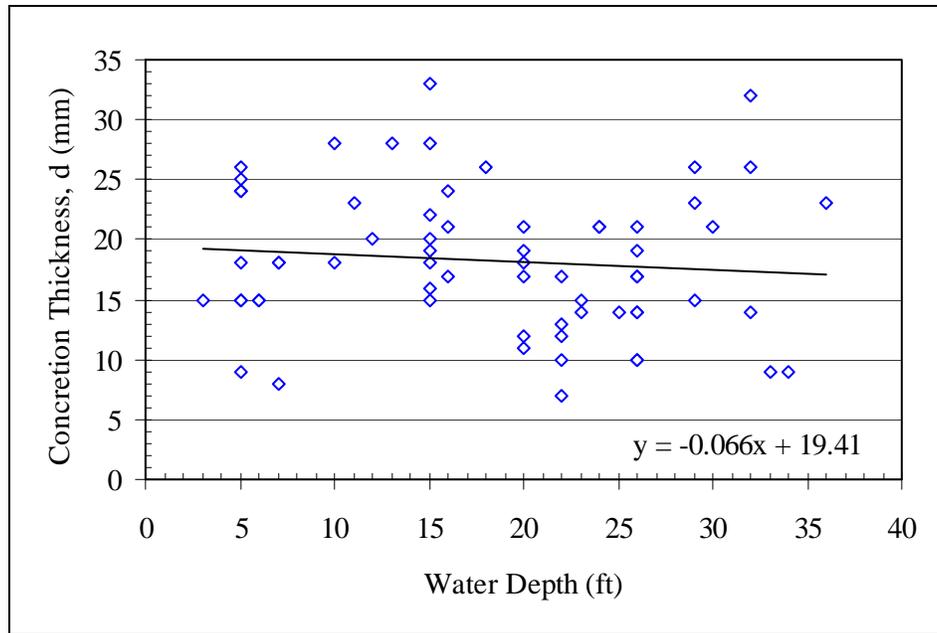
Figure 5.78. Concretion thickness as a function of water depth.

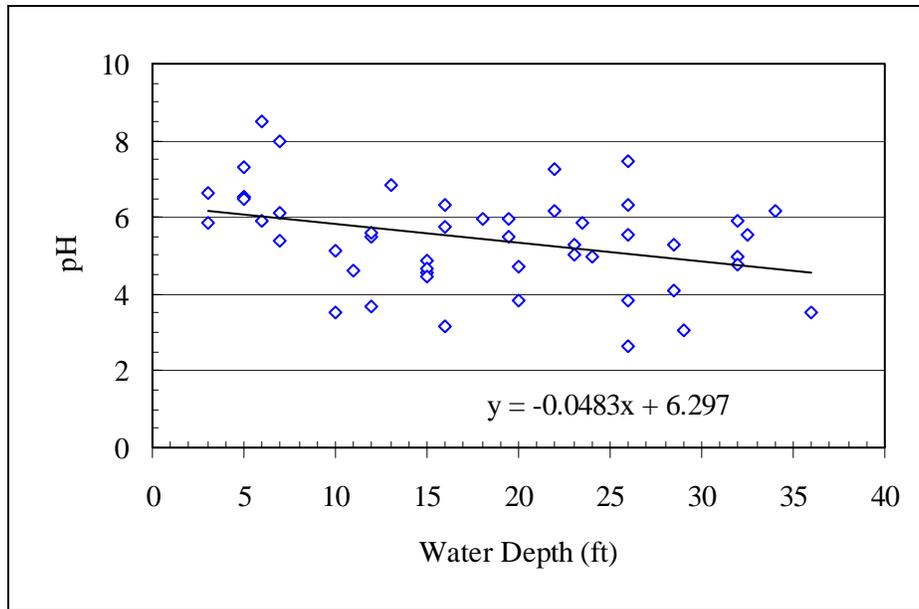
metal concretion interface with minimum pH at the sites where the concretion thickness is greatest (Figure 5.79). As oxygen consumption continues, the net oxygen level remains low on the metal surface and hydrolysis continues to maintain acidic conditions at the metal surface.

Figure 5.79. pH at metal/concretion interface as a function of water depth.

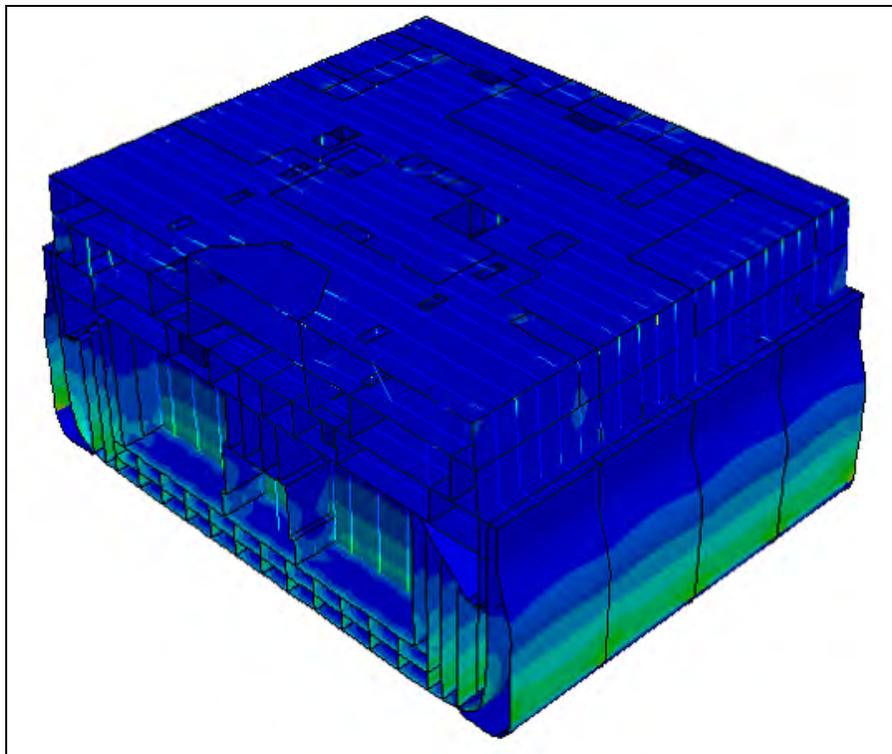
Figure 6.23 shows the computed stresses in the model when dimensions of the ship are taken directly from the design blueprints, and thus as the ship was built. The stresses everywhere are very low, which is to be expected as this is a warship and it was considerably overbuilt to be able to withstand battle damage. The stresses are higher in the vertical walls in the lower levels, as expected, since these walls are supporting much of the weight of the ship above.

Figure 6.23. Self-weight stresses in as-built condition (NIST Graphic).

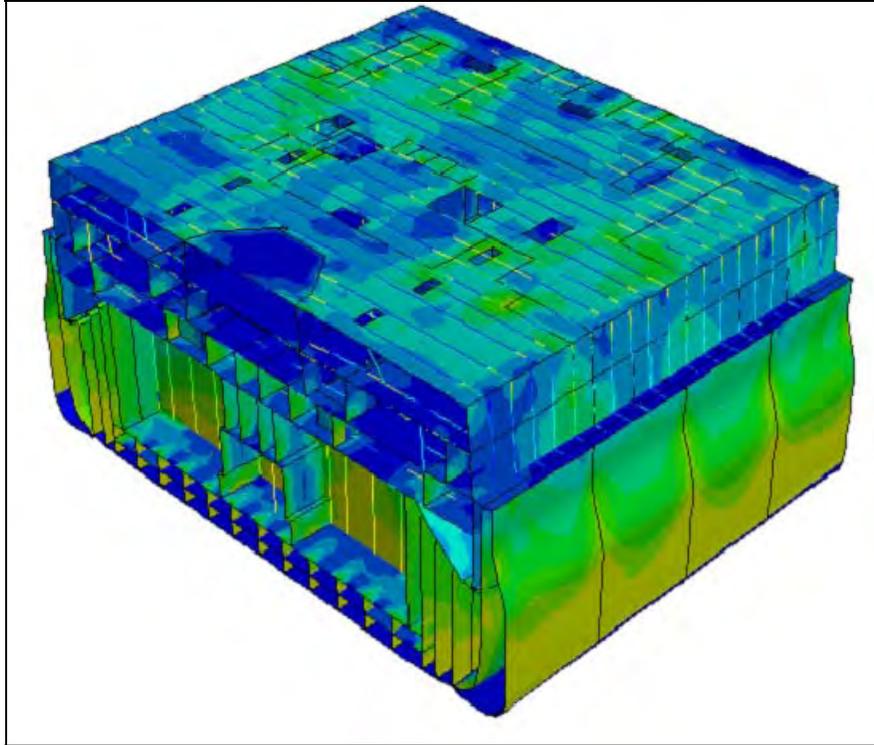
Overall the stress distribution is very similar to the as-built condition, with the overall stress levels somewhat higher. It is noteworthy that the deck beams in the upper deck have jumped significantly in stress, and the second, first and main decks remain almost unstressed (Figure 6.24).

Figure 6.24. Self-weight stresses after 10% thickness loss due to corrosion, approximate date = 1980 (NIST Graphic).

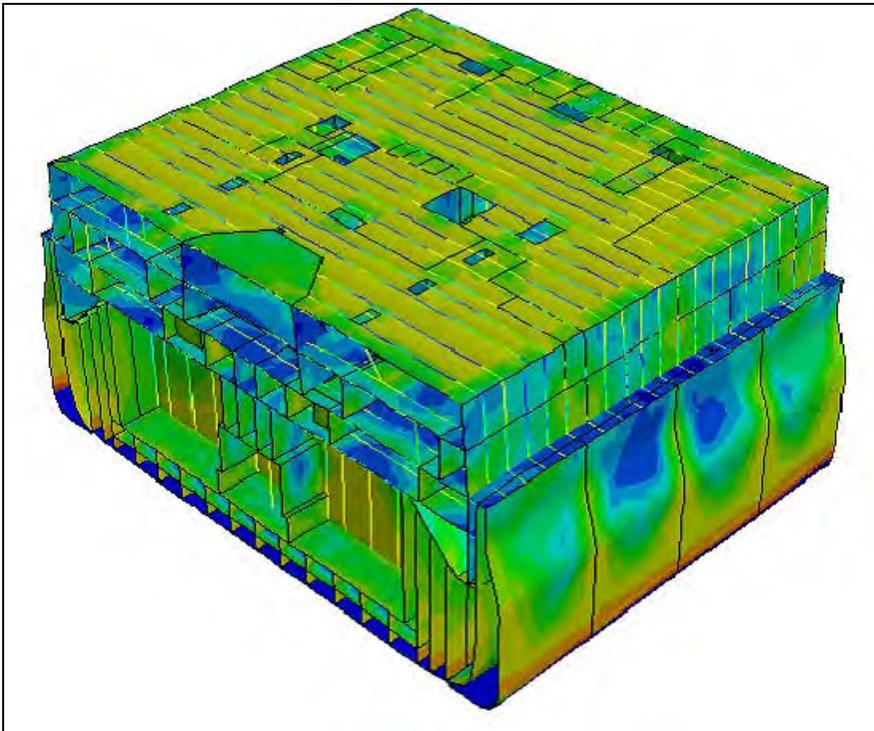
The upper deck is now showing sagging of the beams and deck plates as they continue to thin. Stresses at the turn of the bilge of the torpedo blisters are approaching the tensile strength of the steel. Stresses in the vertical members continue to increase (Figure 6.25).

Figure 6.25. Self-weight stresses after 20% thickness loss due to corrosion, approximate date = 2020 (NIST Graphic).
