PROJECT NUMBER (05-170)

Long-Term Management Strategies for USS ARIZONA, A Submerged Cultural Resource in Pearl Harbor

NATIONAL PARK SERVICE
SUBMERGED RESOURCES CENTER

SEPTEMBER 2008
THIS REPORT IS APPROVED FOR PUBLIC RELEASE

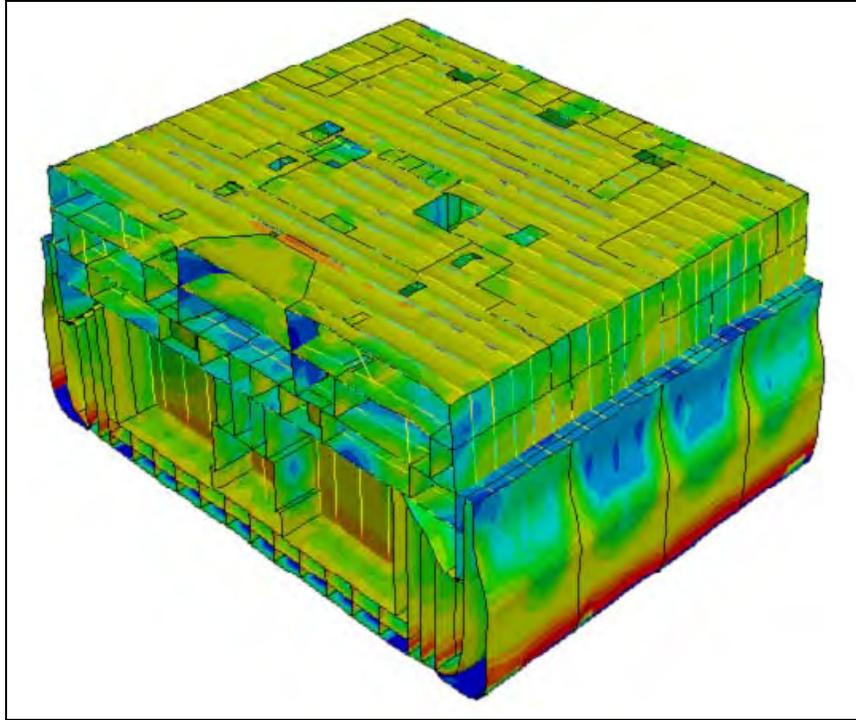
The turn of the bilge area of the torpedo blister, as well as the connections of the lower bulkheads to the hold platform are very close to critical. There is additional sagging in the upper deck, as well as increased stresses in the bulkheads of the lower deck (Figure 6.26).

Figure 6.26. Self-weight stresses after 30% thickness loss due to corrosion, approximate date = 2050 (NIST Graphic).

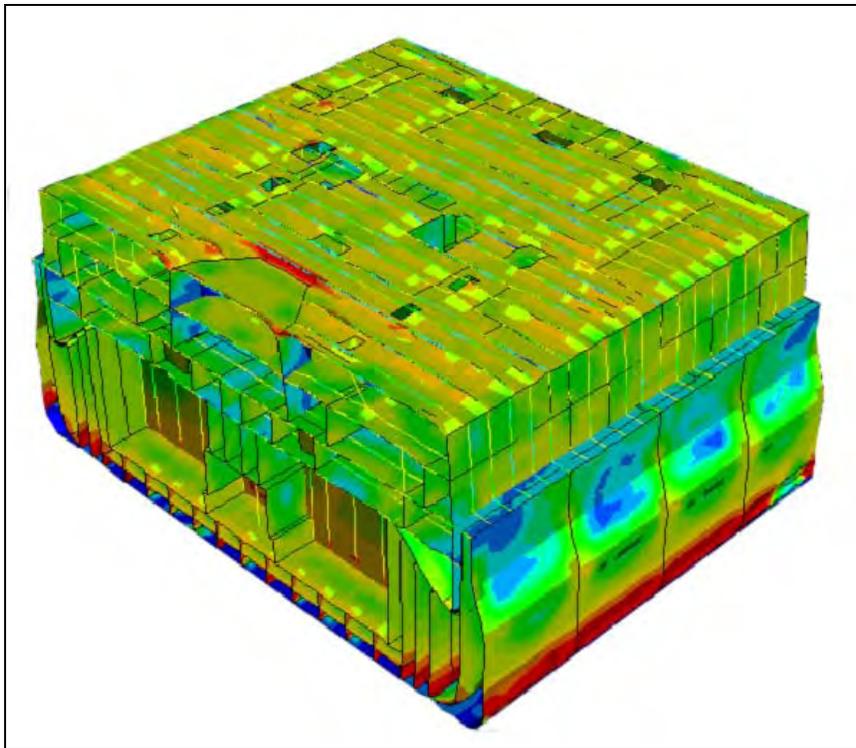
Localized collapse events have begun to appear, including the torpedo blisters, double bottom vertical wall segments, upper deck beams and the region around the stack armor, undoubtedly collapsing under the weight of this very thick steel (Figure 6.27).

Figure 6.27. Self-weight stresses after 50% thickness loss due to corrosion, approximate date = 2120 (NIST Graphic).

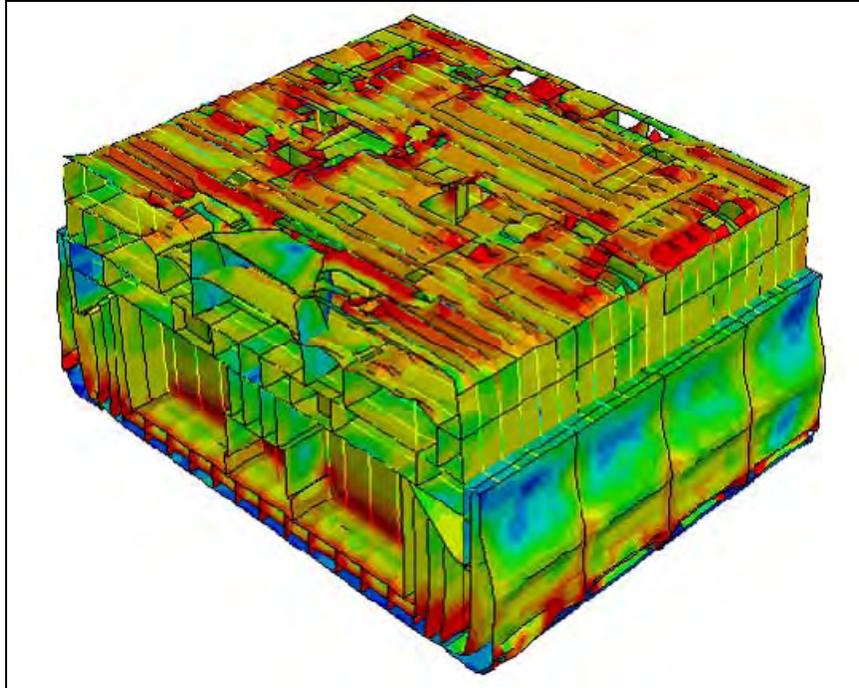
There is general collapse of the deck plating on the upper and main decks, collapse of the outer hull plating and torpedo blisters, very high stresses in the bulkheads at the hold platform in the engine spaces. Buckling of the hull shell plating has begun (Figure 6.28).

Figure 6.28. Self-weight stresses after 60% thickness loss due to corrosion, approximate date = 2150 (NIST Graphic).

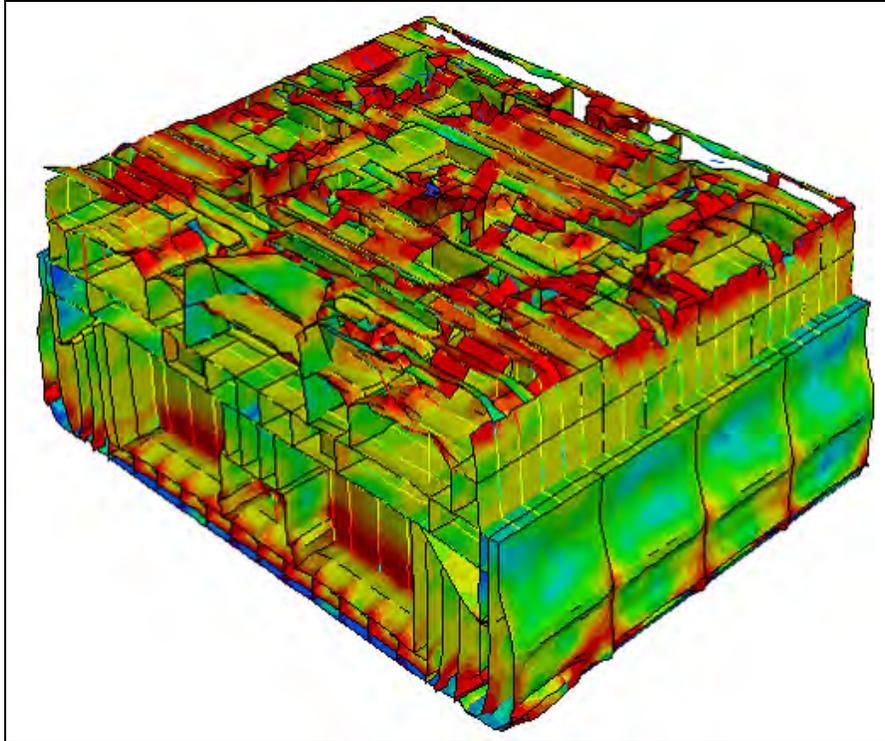
The upper deck is now unrecognizable, and much of the deck plating and deck beams will have fallen onto and accelerated the collapse of the main deck and those further below. The hull shell and torpedo blister continue to collapse, as does now the double bottom (Figure 6.29).

Figure 6.29. Self-weight stresses after 70% thickness loss due to corrosion, approximate date = 2180 (NIST Graphic).

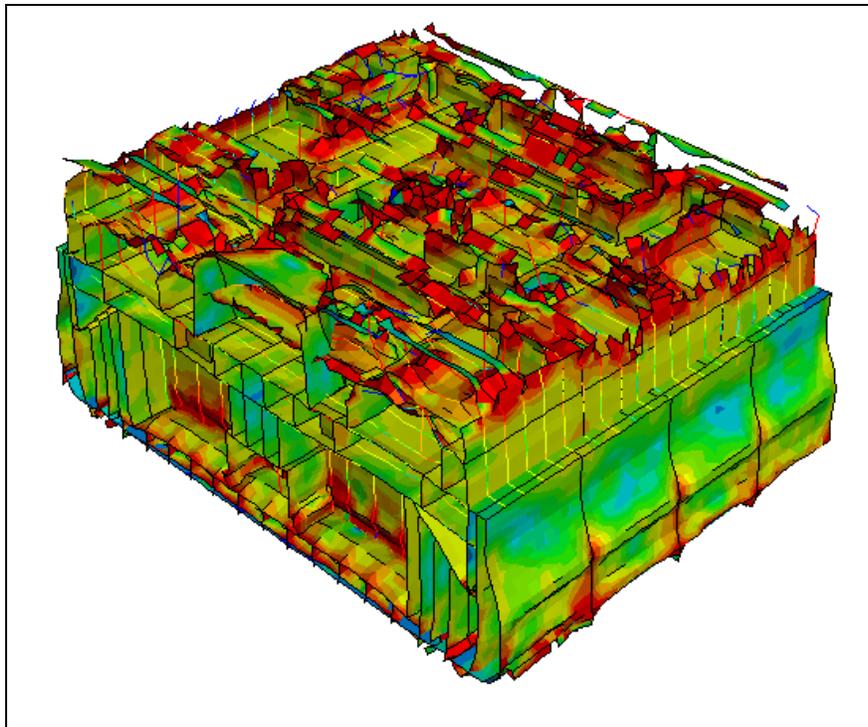
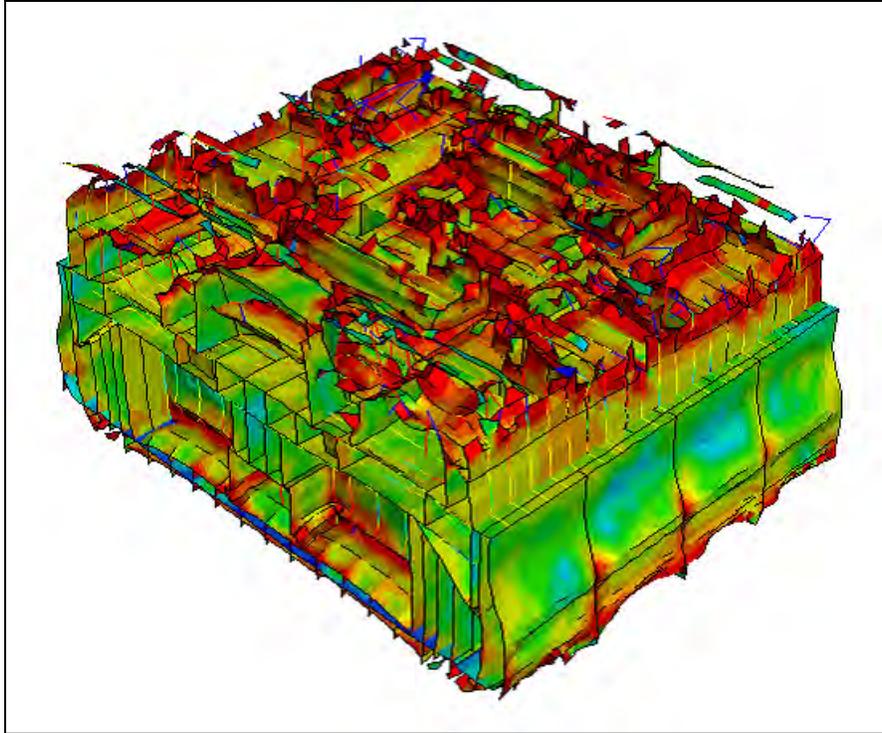
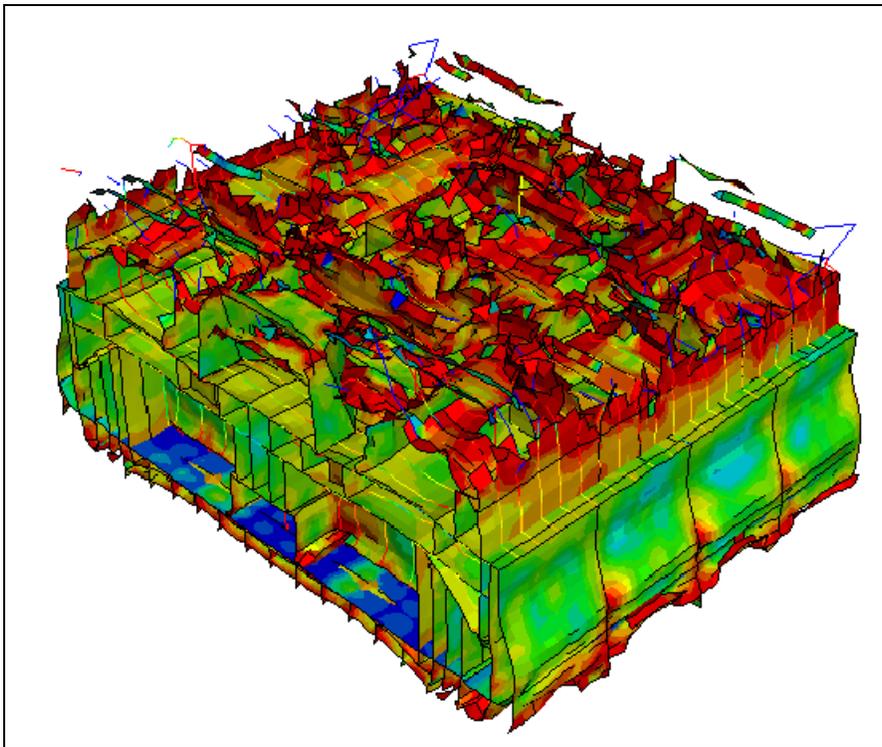
The decks of the superstructure (upper, main, and second) can be expected to further collapse and pancake onto the third deck. The double bottom has now completely collapsed. Note however that the core cylinder of the wreck, consisting of the volume bounded by the third deck, the inner bottom and the side oil tanks is still relatively intact (Figure 6.30–6.32).

Figure 6.30. Self-weight stresses after 80% thickness loss due to corrosion, approximate date = 2210 (NIST Graphic).

Figure 6.31. Self-weight stresses after 90% thickness loss due to corrosion, approximate date = 2240 (NIST Graphic).

Figure 6.32. Self-weight stresses after 95% thickness loss due to corrosion, approximate date = 2250 (NIST Graphic).

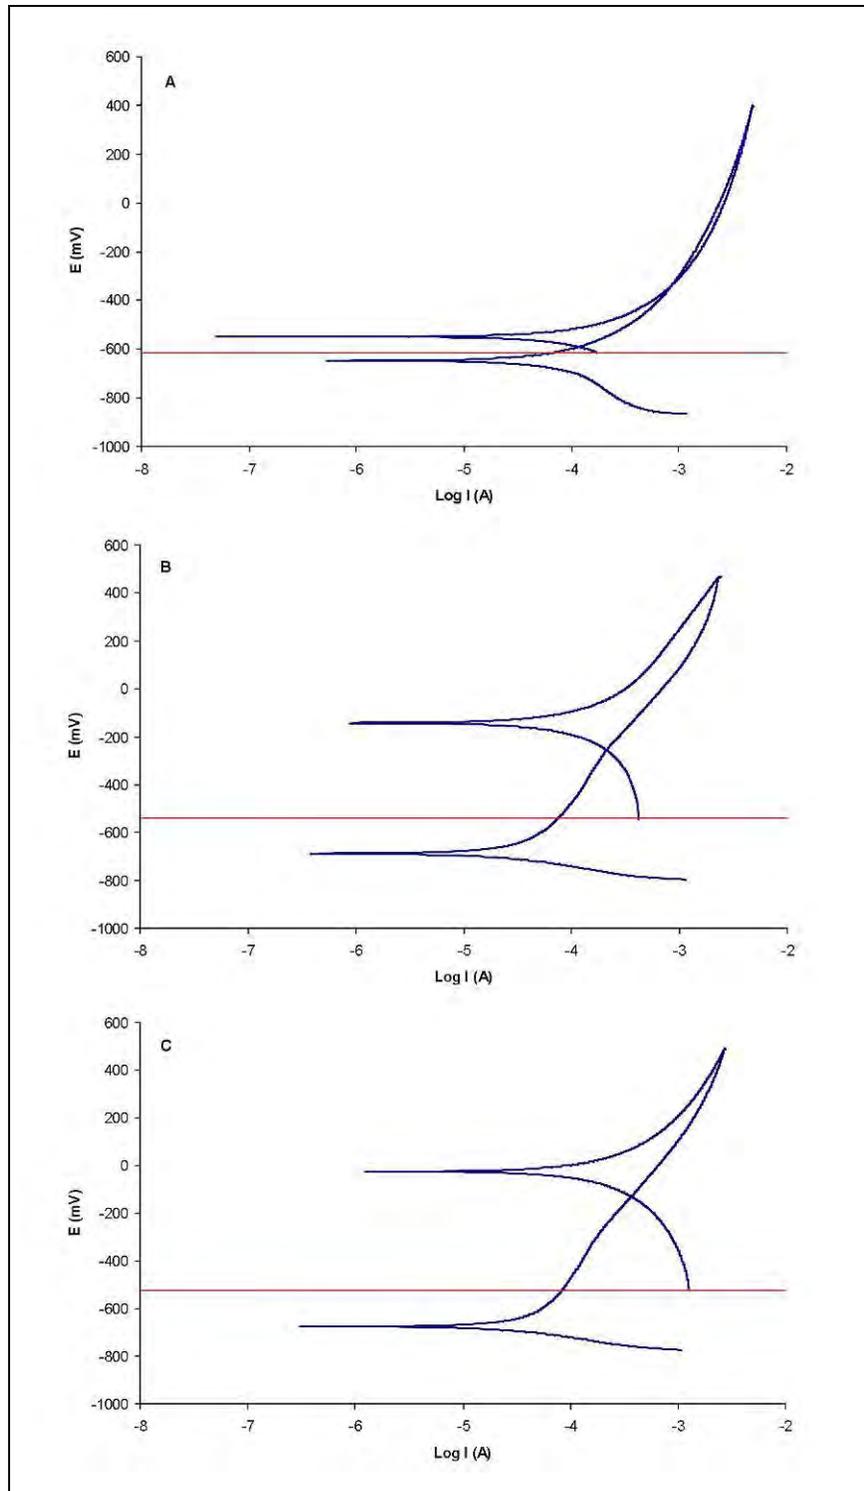
Initial CP scans of the A36 stainless steel coupons were similar (Figures 7.4A and 7.5A). After 1 week incubation inoculated and uninoculated cells are still similar (Figures 7.4B and 7.5B). Hysteresis of the curves is negative, there is no distinct primary passivation potential (E_{pp}), and there appears to be a transpassive region and a breakdown potential (E_b). In addition, the OCP is located within the passive region and is lower than the repassivation potential (E_{rp}). After 3 weeks, differences between cyclic polarization (CP) scans for the inoculated and uninoculated cells are apparent. The uninoculated cell did not change substantially from week 1 (Figure 7.4C). However, in the inoculated cell the E_{rp} decreased ~ 200 mV and while the hysteresis was still negative, it was shifted in the positive direction. A passive film is damaged when the potential is raised into the transpassive region. Negative hysteresis indicates that the film repairs itself and pits do not initiate, while positive hysteresis indicates that the film is not repaired and may indicate pit formation. Additionally, when the OCP is less than E_{rp} it is believed that pits will not grow, while in the opposite case it is believed that pits will continue to grow. Movement of the hysteresis in the positive direction and the decrease in the E_{rp} in the inoculated cell may indicate a trend toward pitting corrosion caused by the biofilm.

Figure 7.4. Cyclic polarization scans of uninoculated cells after 0 (A), 1 (B), and 3 (C) weeks. The open circuit potential is indicated by the horizontal line.

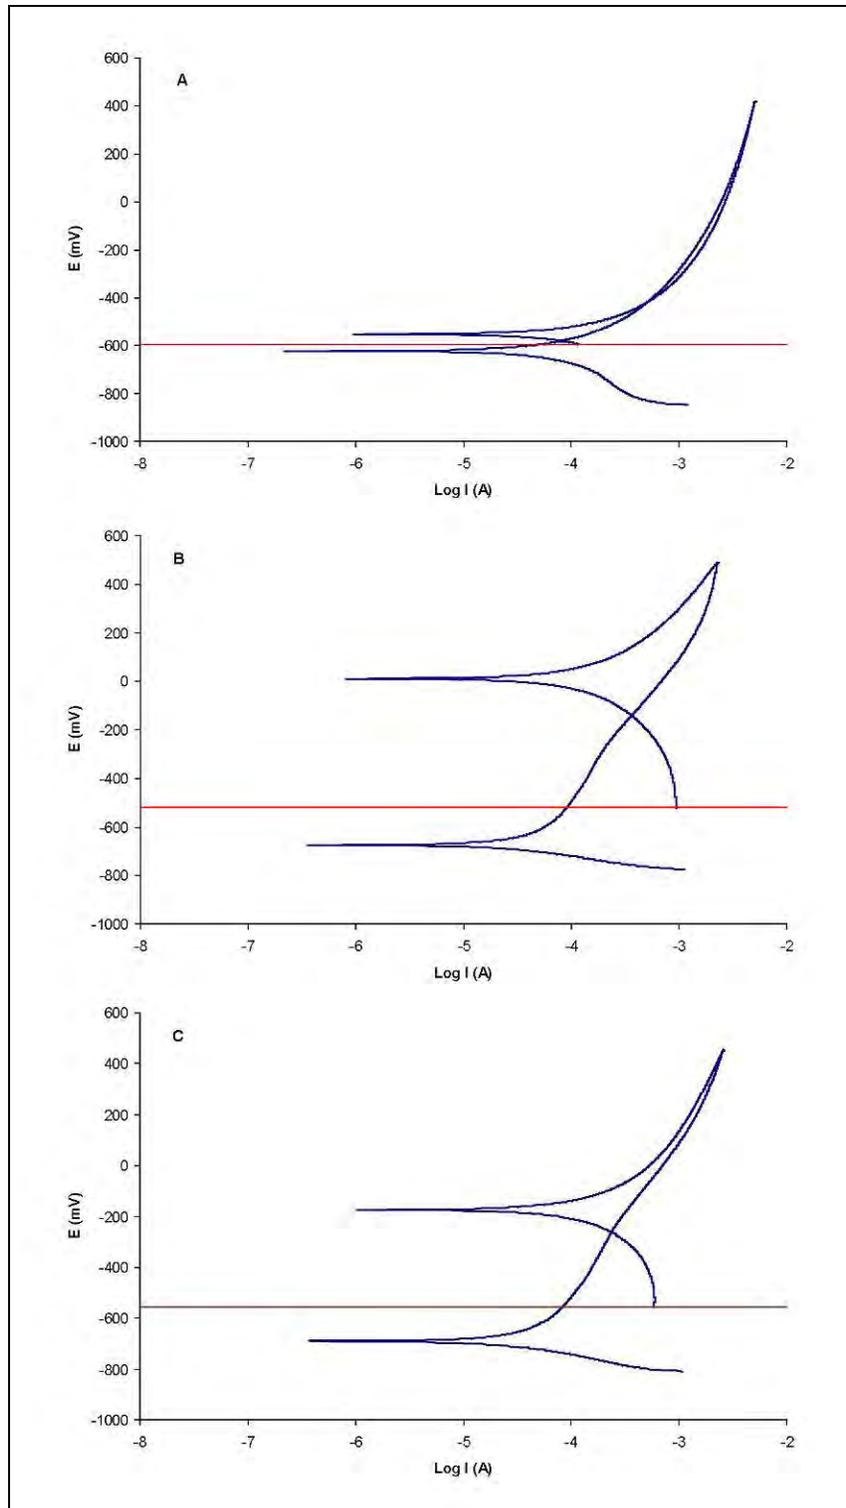
Figure 7.5. Cyclic polarization scans of inoculated cells after 0 (A), 1 (B), and 3 (C) weeks. The open circuit potential is indicated by the horizontal line.

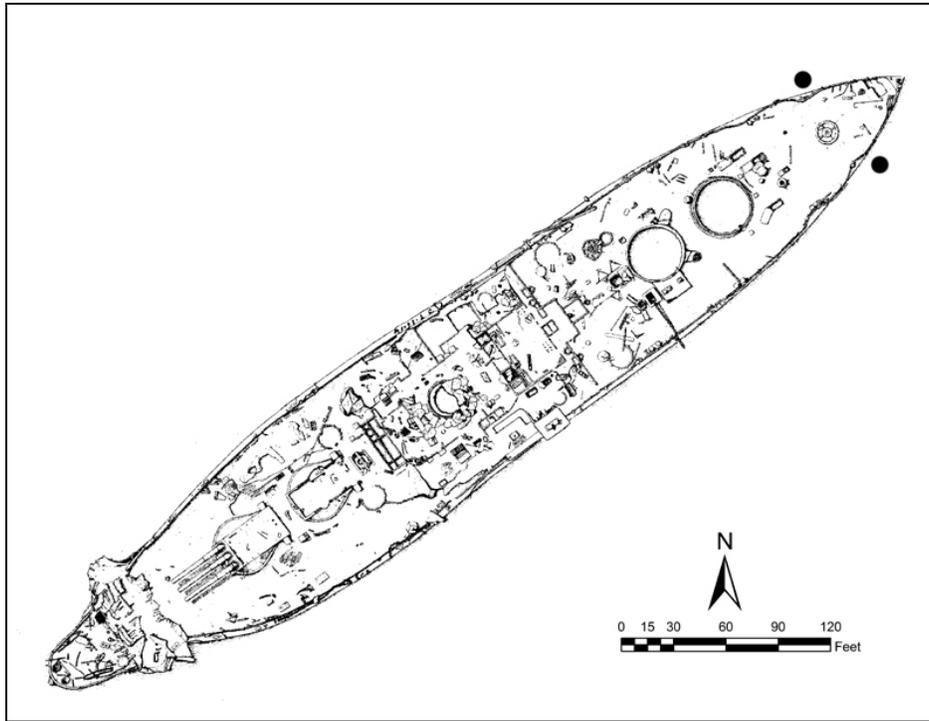
Figure 7.6. Points at the stern indicate sample locations on the exterior hull of USS *Arizona*. Sample 14 was collected on the port side of the ship and sample 15 on the starboard side (Drawing by NPS-SRC).

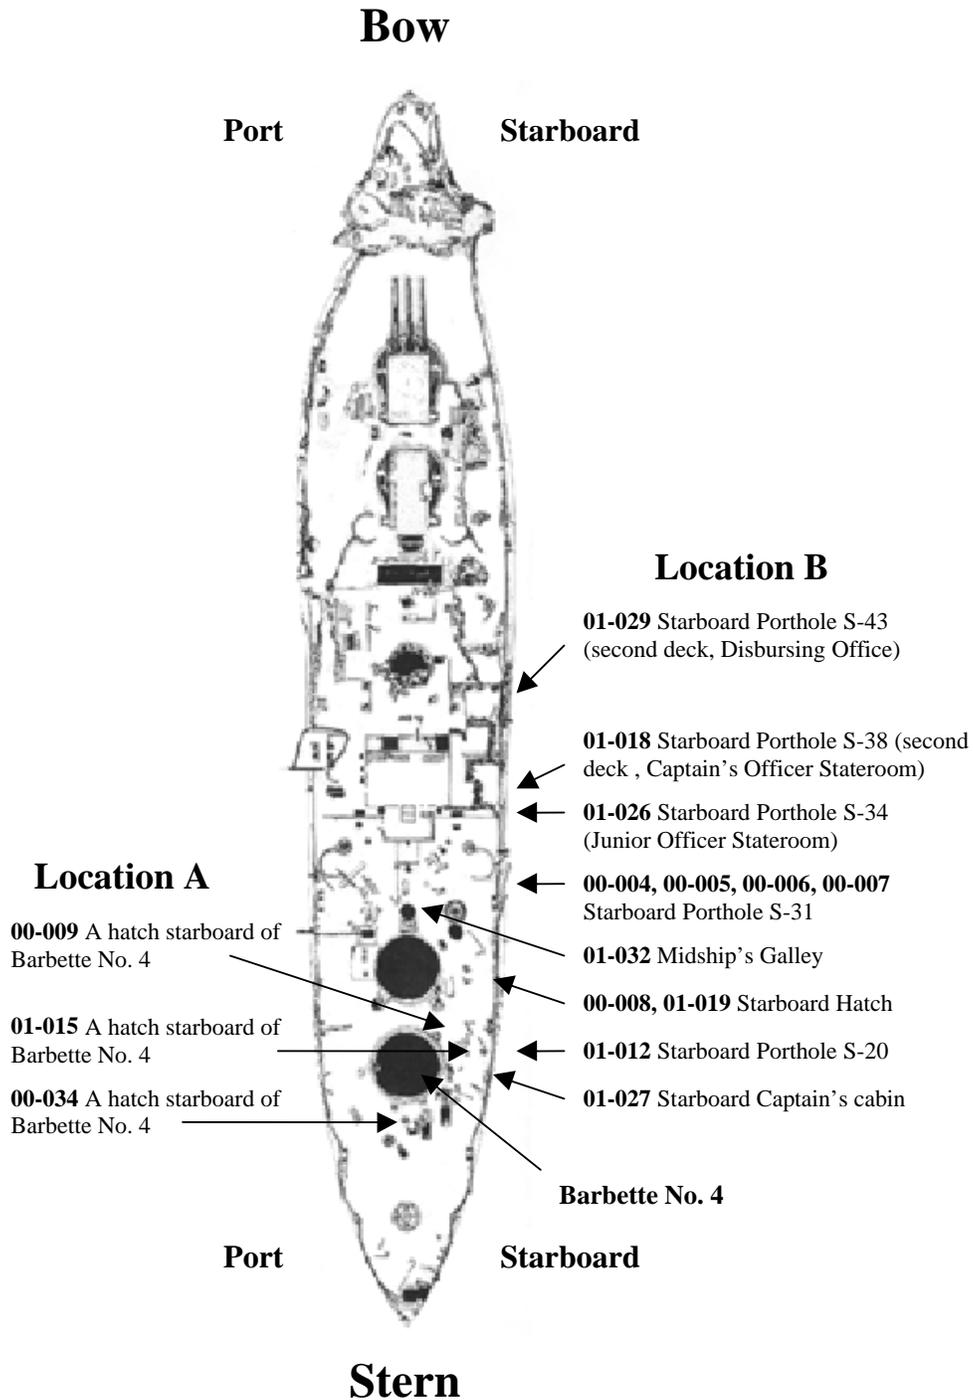
Figure 8.4. USS *Arizona* sample locations for oil leaking from the ship. Location A (stern starboard hatches) and B (stern starboard portholes) represent two different general areas of the ship.

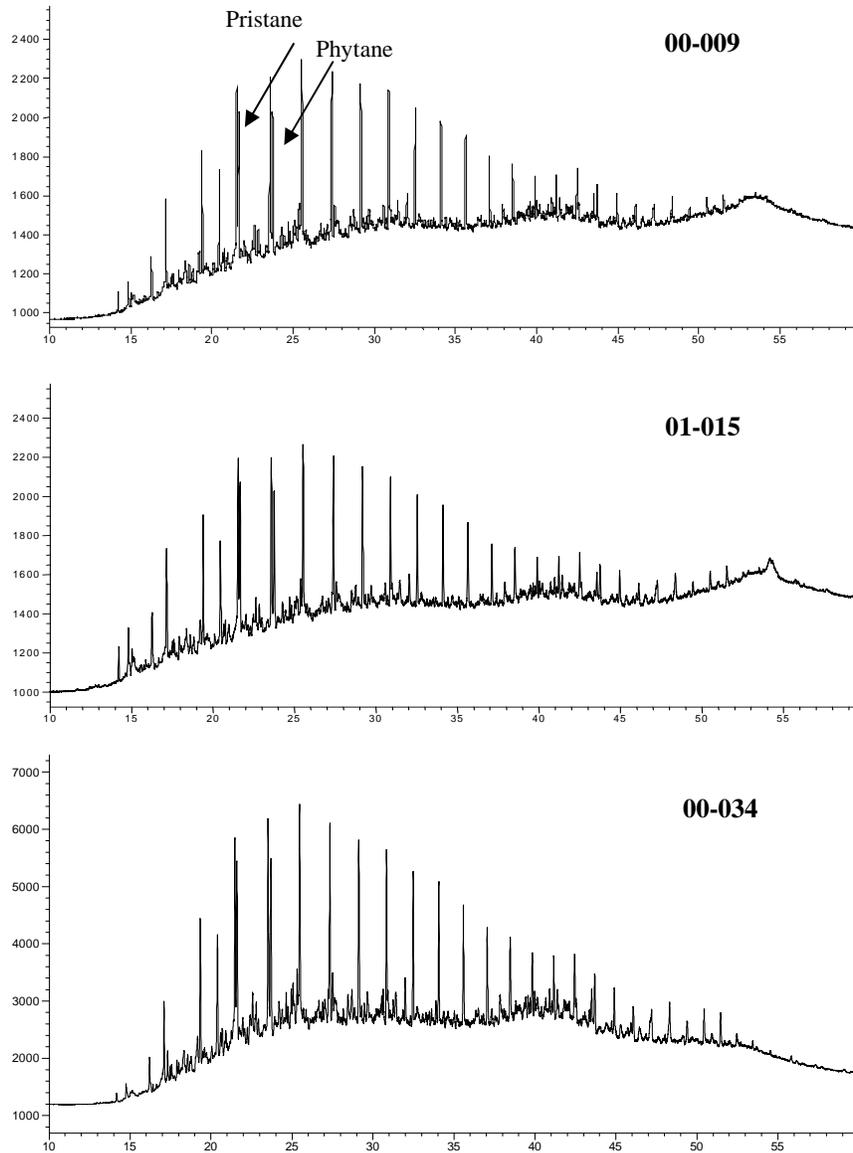
Figure 8.6 GC-FID traces of *USS Arizona* oil samples representative for oil leaking from location A. Oil leaking from location A still contains *n*-alkanes and the branched alkanes, pristane and phytane. In the above chromatograms, the y-axis is the detector response and the x-axis is the retention time in minutes. Detector response for the y-axis is not the same scale for each chromatogram.

leaking from location B (Figures 8.7 and 8.8). Gas chromatographic traces for 00-009, 01-015 and 00-034 are from location A and contain *n*-alkanes, along with pristane and phytane (Figure 8.6). In comparison, traces for 01-029, 01-018, 01-026, 00-004, 00-005, 00-006, 00-007, 01-032, 00-008, 01-019, 01-012 and 01-027 (Figures 8.7 and 8.8) are from location B and show a depletion of *n*-alkanes but still contain pristane and phytane. Overall, this suggests that oil leaking from location B has undergone more weathering (either biotic or abiotic) than oil leaking from location A.

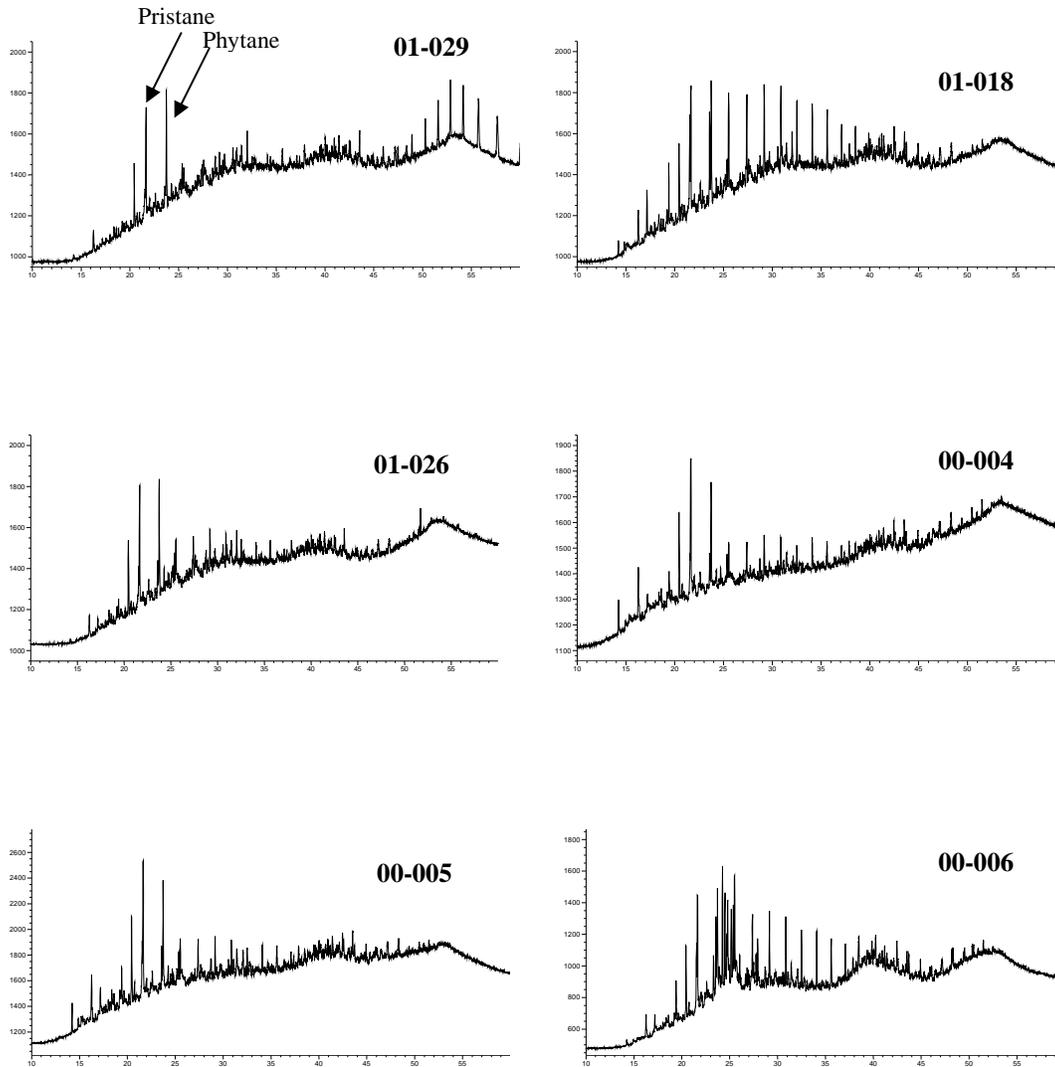
Figure 8.7 GC-FID traces of USS Arizona oil samples representative of location B. Oils leaking from location B show significant weathering, most noticeably depletion of *n*-alkanes in comparison to oil leaking from location A. The branched alkanes, pristane and phytane, are still present. In the above chromatograms, the y-axis is the detector response and the x-axis is the retention time in minutes. Detector response for the y-axis is not the same scale for each chromatogram.

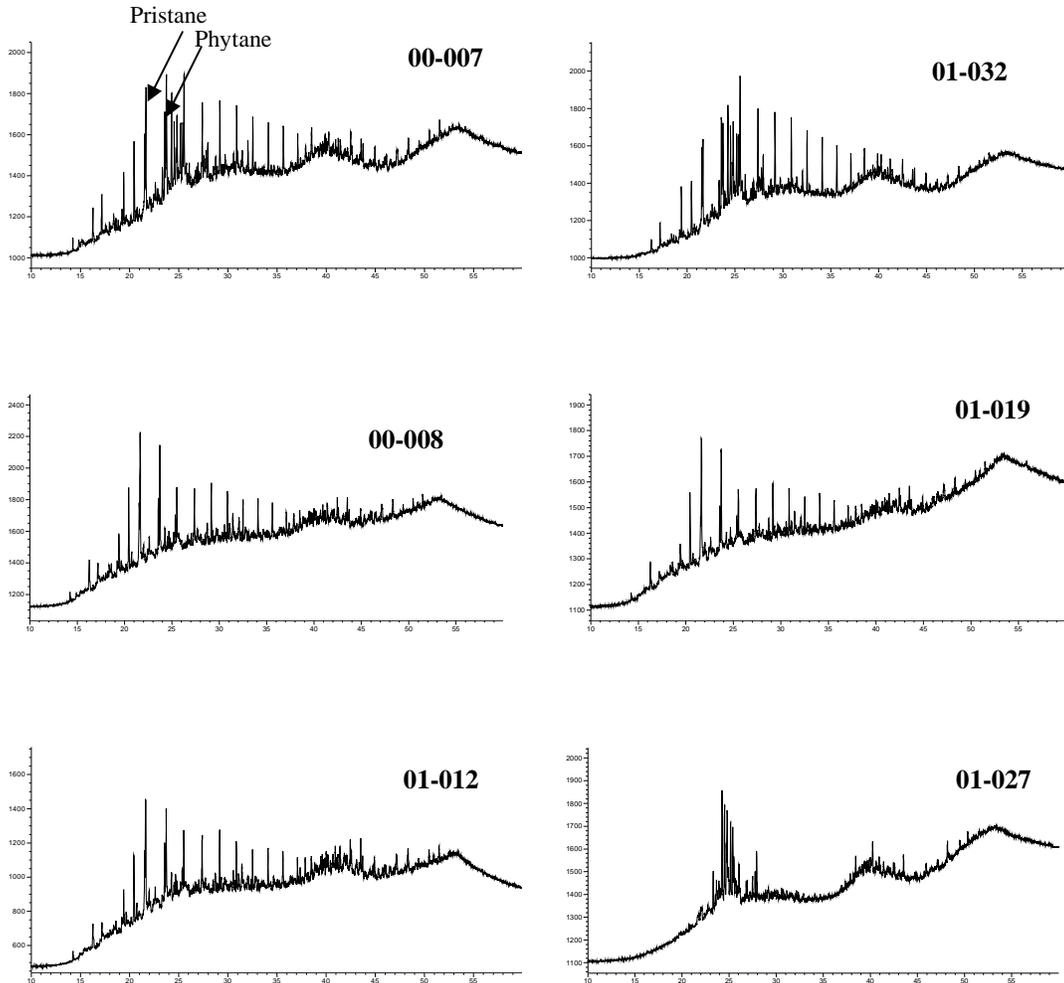
Figure 8.8 GC-FID traces of *USS Arizona* oil samples representative of location B. Oils leaking from location B show significant weathering of the oil, most noticeably depletion of *n*-alkanes in comparison to oil leaking from location A. In the above chromatograms, the y-axis is the detector response and the x-axis is the retention time in minutes. Detector response for the y-axis is not the same scale for each chromatogram.

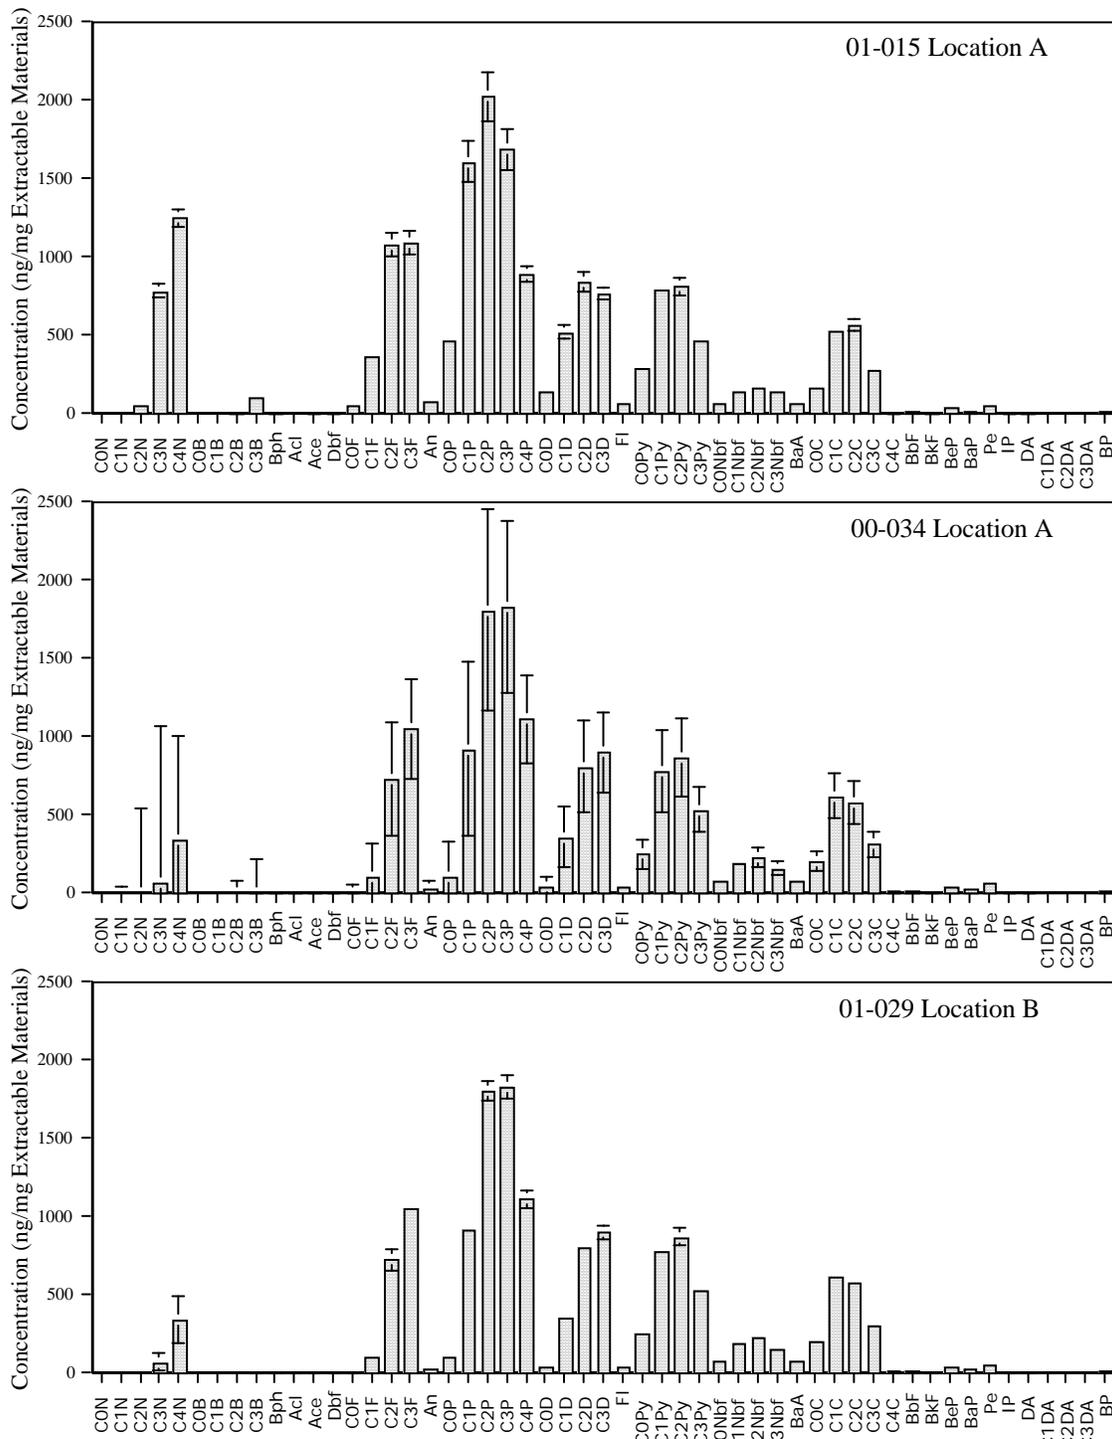
Mass spectrometry was utilized to monitor the concentration of 53 target PAHs (including heterocycles) (Table 8.1) in samples of oil leaking from different locations of USS *Arizona*. Triplicates of three oil samples, 01-015 and 00-034 (from location A) and 01-029 (from location B), were chosen for PAH analysis because they showed the least weathering (01-015 and 00-034) or the most weathering (01-029). Overall, mass spectrometry analysis indicated PAHs were still present in all three analyzed samples of oil (Figure 8.9). For oil sample 00-034, one of the three triplicates exhibited a different PAH pattern, causing large standard error bars. Mass spectrometry indicated oil samples 01-029 (location B) and oil sample 00-034 (location A) had fewer low molecular weight PAHs than sample 01-015 (location A) (Figure 8.9). For example, sample 01-029 and 00-034 contained less 2-ring naphthalene, and C₁-C₄ naphthalenes than sample 01-015 leaking from location A. Differences in high molecular weight hydrocarbons from locations A and B were not observed (Figure 8.10).

Figure 8.9 Individual PAH analysis for oil leaking from USS *Arizona*. Oil leaking from 00-034 and 01-029 shows a depletion of lower molecular weight PAHs in comparison to oil leaking from 01-015. Abbreviations are defined in Table 8.1 and locations of leaking oil are defined in Figure 8.4.

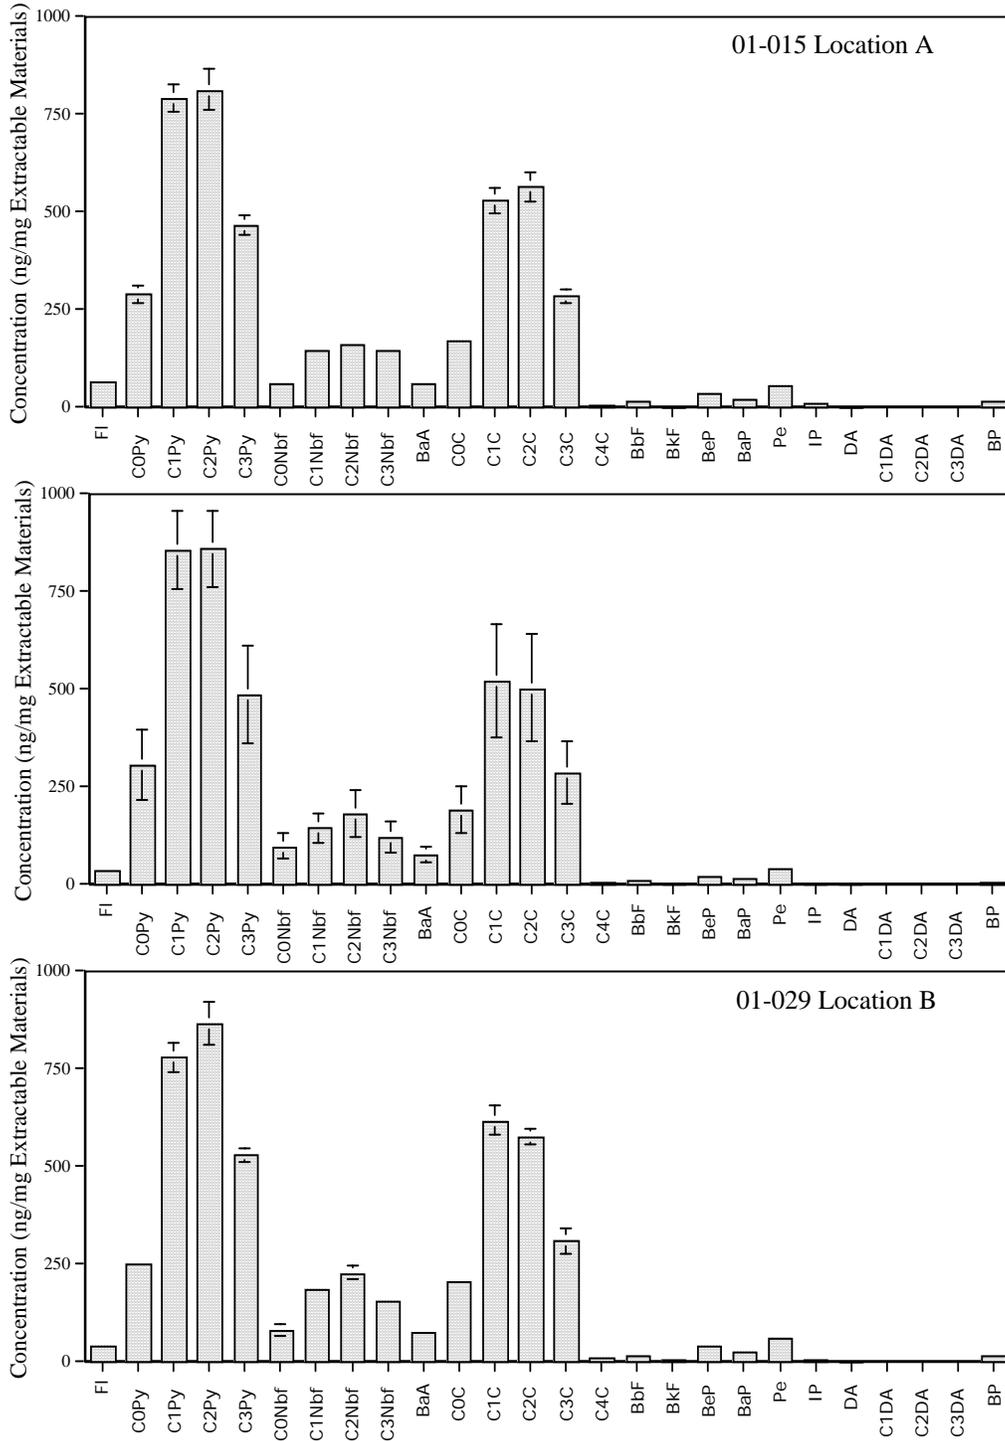
Figure 8.10. Individual PAH analysis of high molecular weight PAHs for oil leaking from USS Arizona. Abbreviations are defined in Table 8.1 and locations of leaking oil are defined on Figure 8.4.

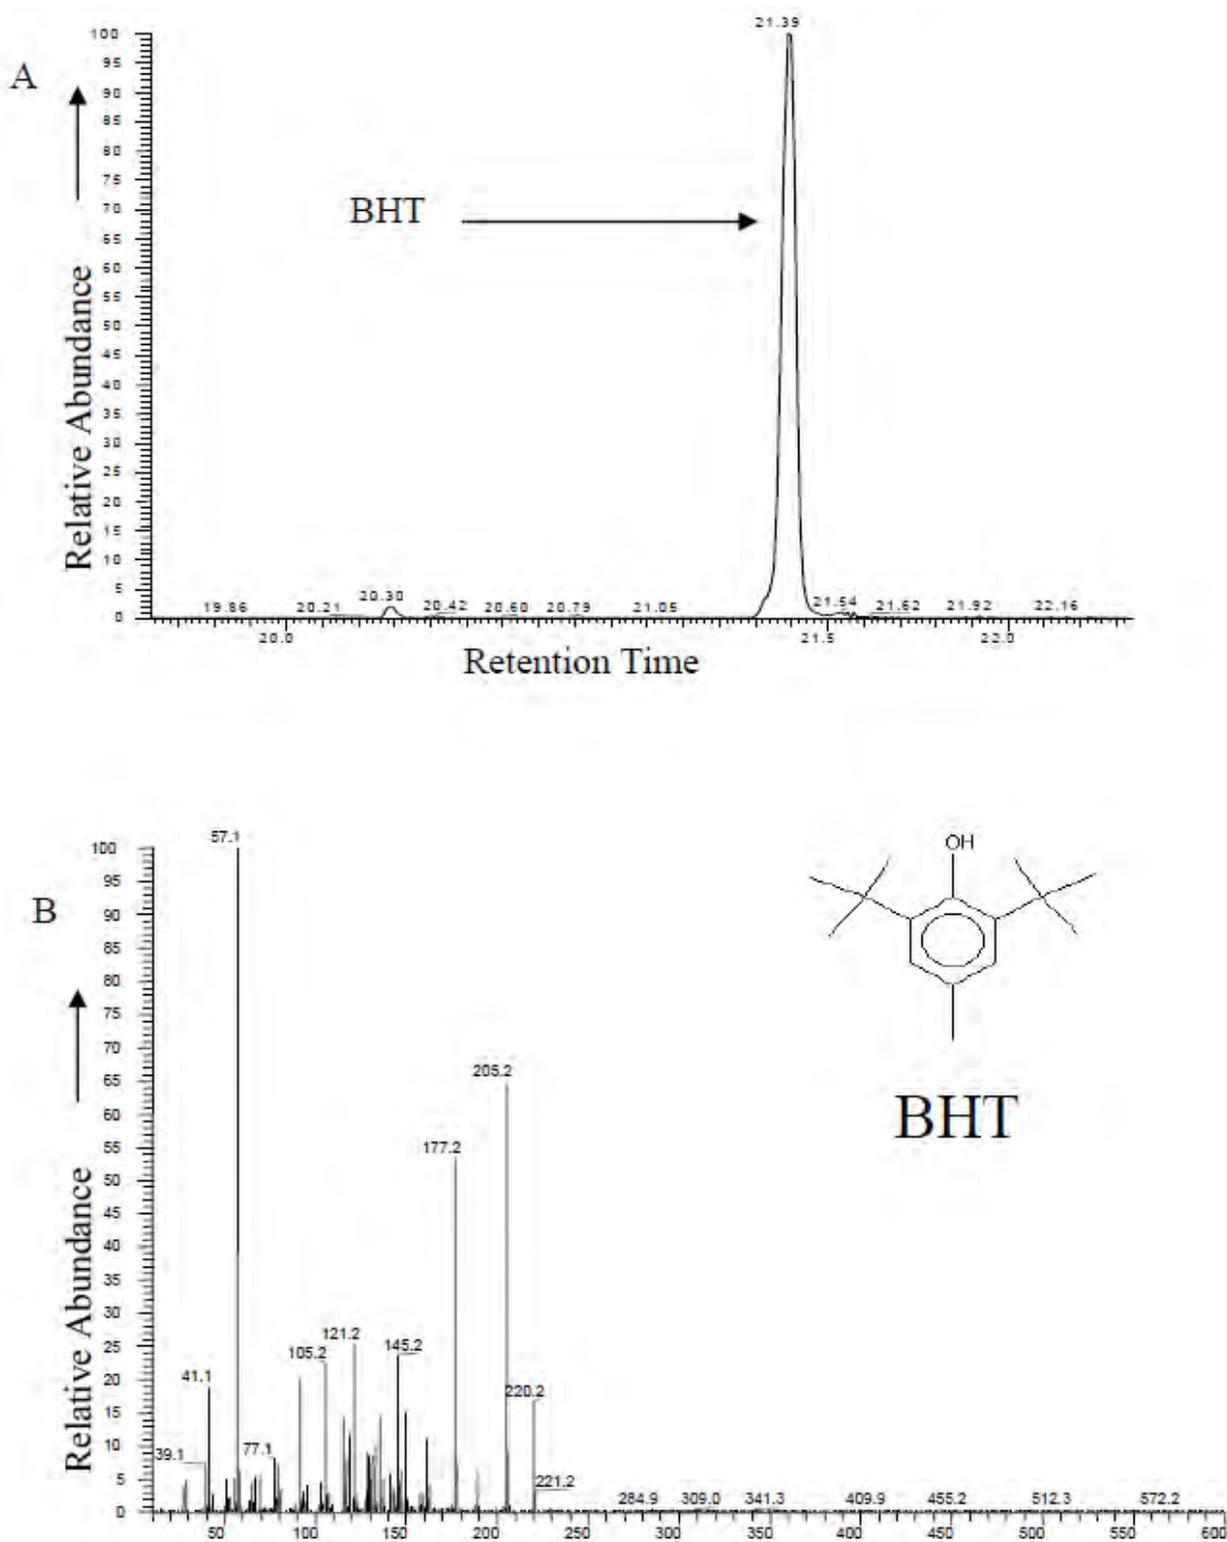
The large ubiquitous peak (observed at a retention time of 26.821) found in all solvent-extractable materials was identified as butylated hydroxytoluene (BHT) ($m/z=205$) by GC-MS (Figure 8.17). In order to elucidate the source of the BHT, soxhlet extraction was conducted without sediments, containing only solvent, boiling chips, and a cotton thimble. BHT was detected in these extracts by GC-MS (Figure 8.18). However, BHT was also detected by GC-MS in oil sample 00-034 of oil leaking from USS *Arizona* that was not extracted using a soxhlet apparatus (Figure 8.19). A soxhlet extraction control with just solvents was not conducted.

Figure 8.17. Total ion chromatogram (TIC) trace of the ubiquitous peak found in all sediment extracts (A). The mass spectra monitored at $m/z=205$ was identified as butylated hydroxytoluene (BHT) (B)

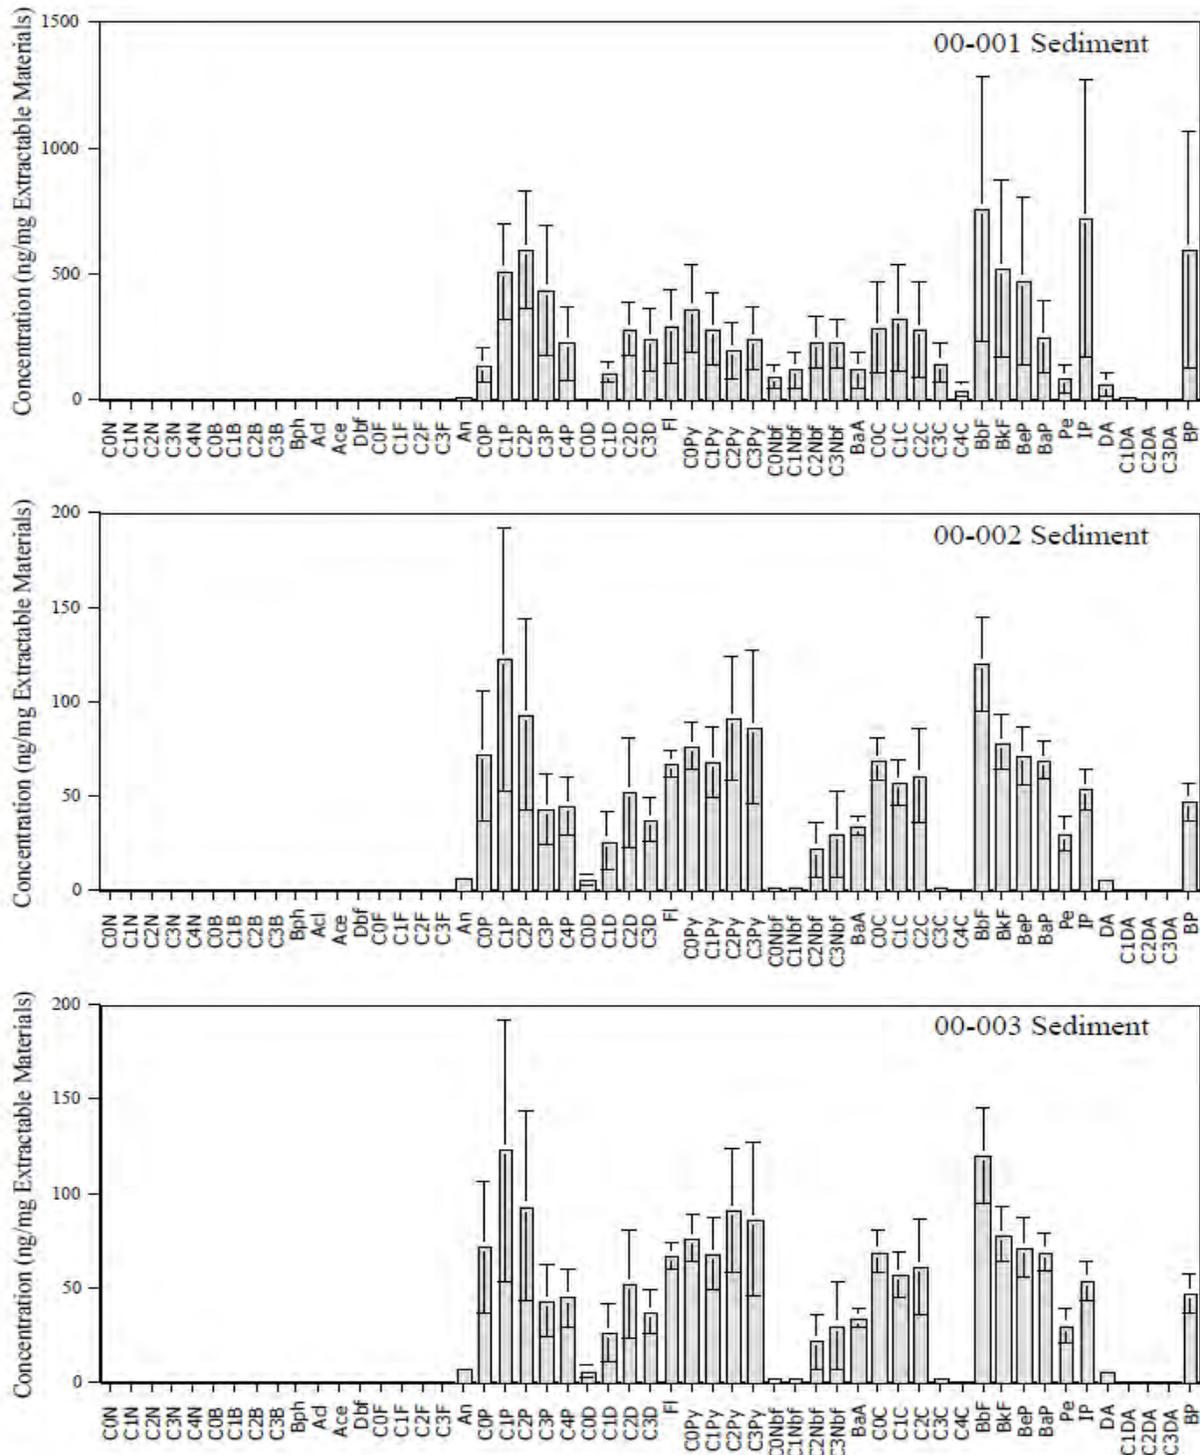
Further analysis of sediment solvent-extractable material by GC-MS for 53 PAHs and their alkylated homologues (and heterocycles) was conducted. The higher standard error for PAHs detected in sediment extracts (as compared to GC-MS analysis of PAHs in oil leaking from the ship) may be due to inherent variability in the sediments sampled. Using mass spectrometry, low molecular weight PAHs, naphthalene and fluorene or their alkylated homologues, were not detected. However, a number of high molecular weight PAHs (i.e., pyrene, chrysene) were detected (Figures 8.20–8.22).

Figure 8.20. Individual PAH analysis for solvent-extractable materials from sediments collected 12 ft. off the stern starboard side of USS *Arizona*. There are no detectable amounts of low molecular weight PAHs (i.e., naphthalene), but high molecular weight PAHs (i.e., pyrene) were detected. Concentration (y-axis) is not the same scale for each histogram. Abbreviations are defined in Table 8.1 and locations of sediments are defined in Figure 8.5.

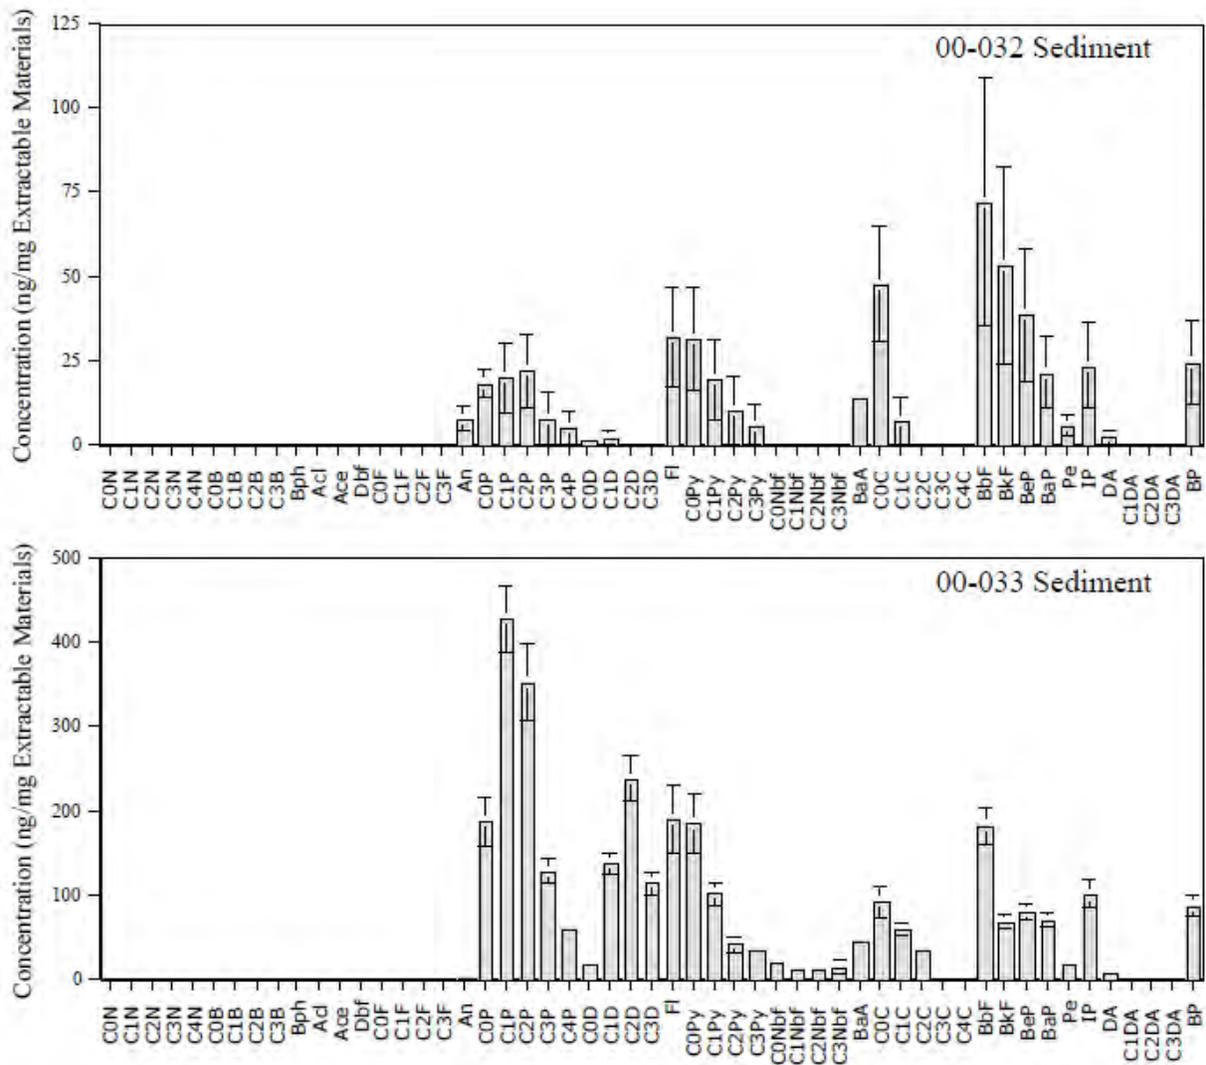
Figure 8.21. Individual PAH analysis for solvent-extractable materials from sediments collected 10 ft. off the port side of USS *Arizona*. There are no detectable amounts of low molecular weight PAHs (i.e., naphthalene), but high molecular weight PAHs (i.e., pyrene) were detected. Concentration for the y-axis is not the same scale for each histogram. Abbreviations are defined in Table 8.1 and locations of sediments are defined in Figure 8.5.
