PROJECT NUMBER (05-170)

Long-Term Management Strategies for USS ARIZONA, A Submerged Cultural Resource in Pearl Harbor

NATIONAL PARK SERVICE
SUBMERGED RESOURCES CENTER

SEPTEMBER 2008
THIS REPORT IS APPROVED FOR PUBLIC RELEASE

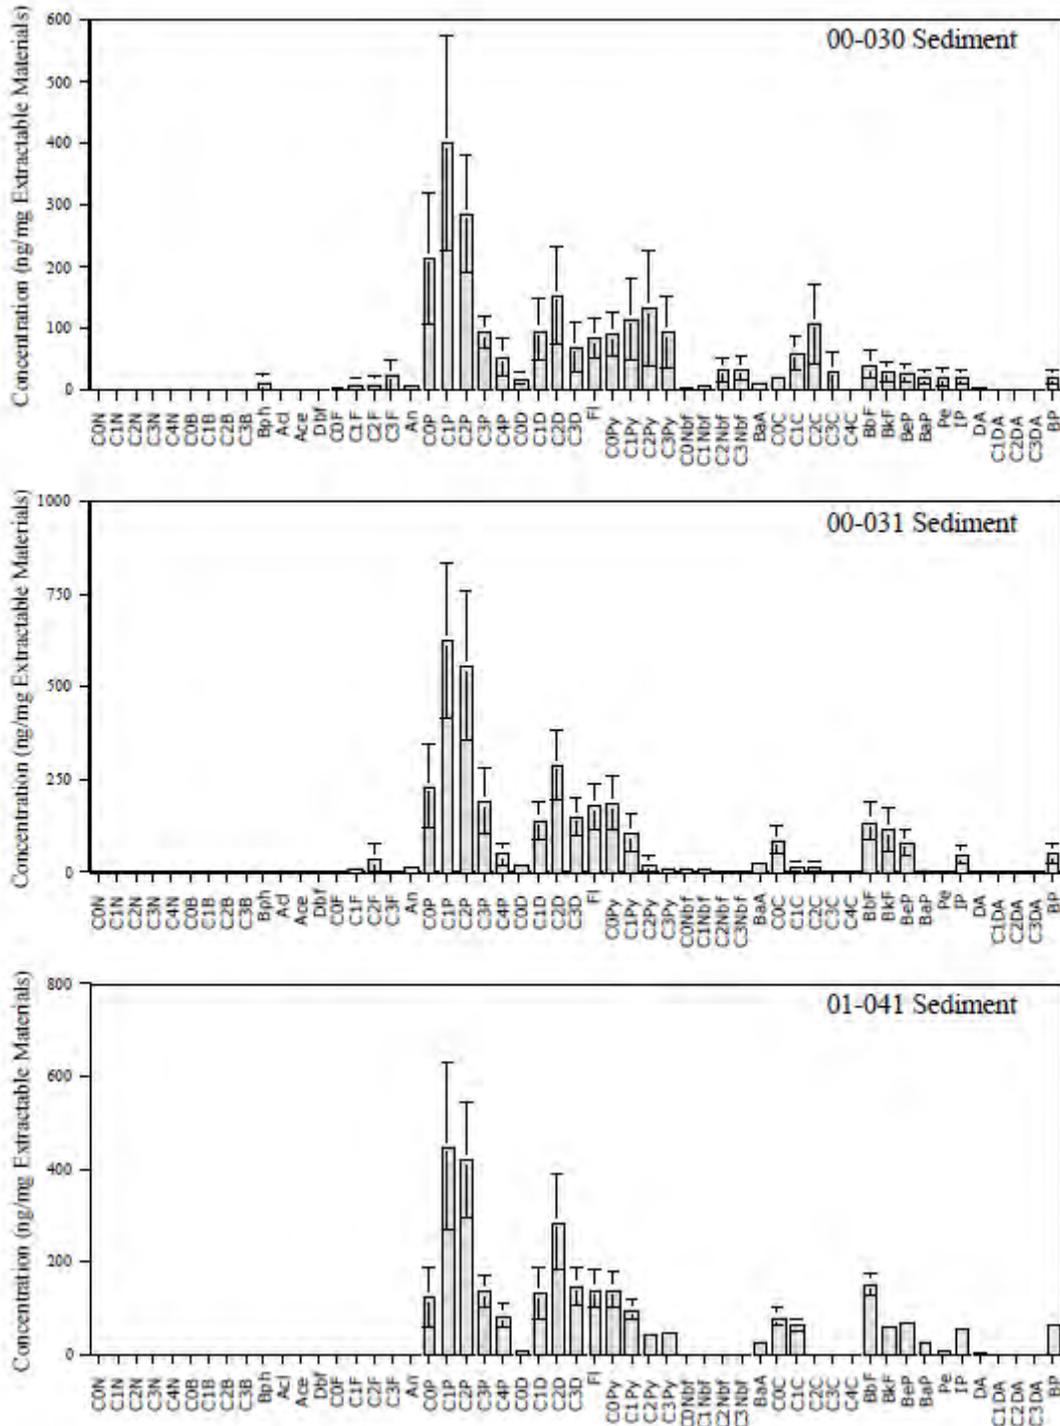
Figure 8.22. Individual PAH analysis for solvent-extractable materials from sediments collected on top of USS Arizona. There are no detectable amounts of low molecular weight PAHs (i.e., naphthalene), but high molecular weight PAHs (i.e., phenanthrene) were detected. Concentration for the y-axis is not the same scale for each histogram. Abbreviations are defined in Table 8.1 and locations of sediments are defined in Figure 8.5.

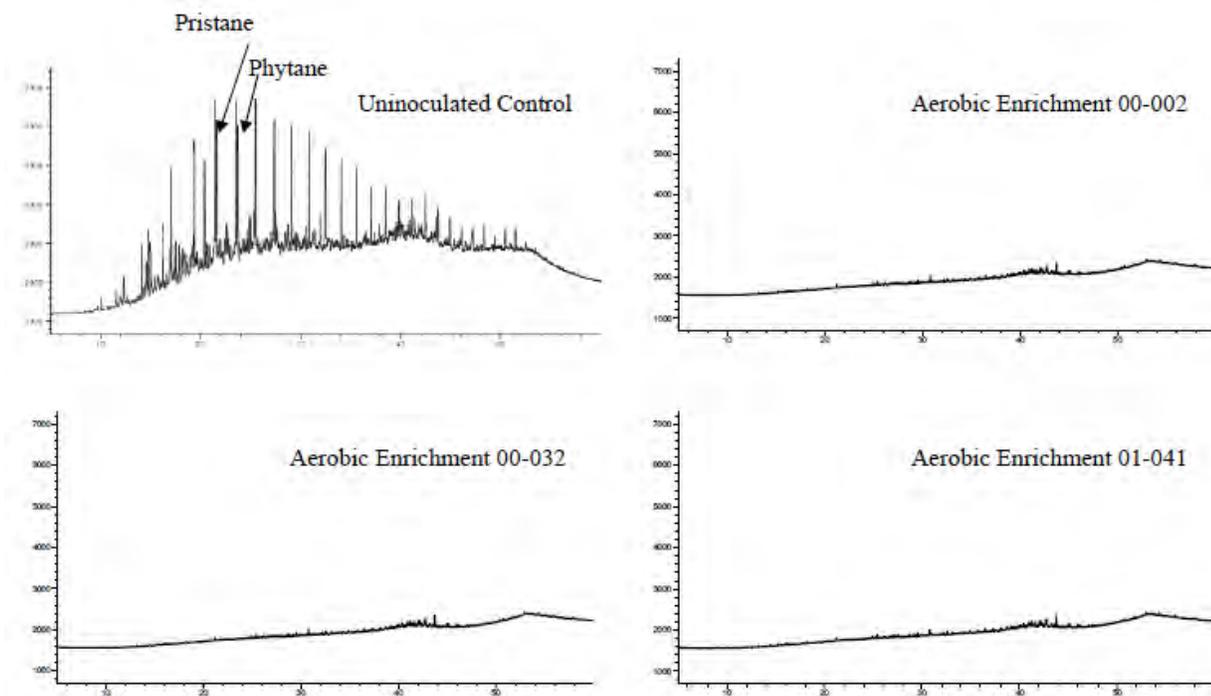
Figure 8.29. Gas chromatographic traces of oil extracted from USS *Arizona* aerobic enrichment cultures. The uninoculated control after 30 days still contains *n*-alkanes and branched alkanes. In comparison, following 30 days of microbial growth with Bunker C fuel oil as the only carbon source, loss of *n*-alkanes and the branched alkanes, pristane, and phytane, were observed. The y-axis is the detector response and x-axis is the retention time in minutes.

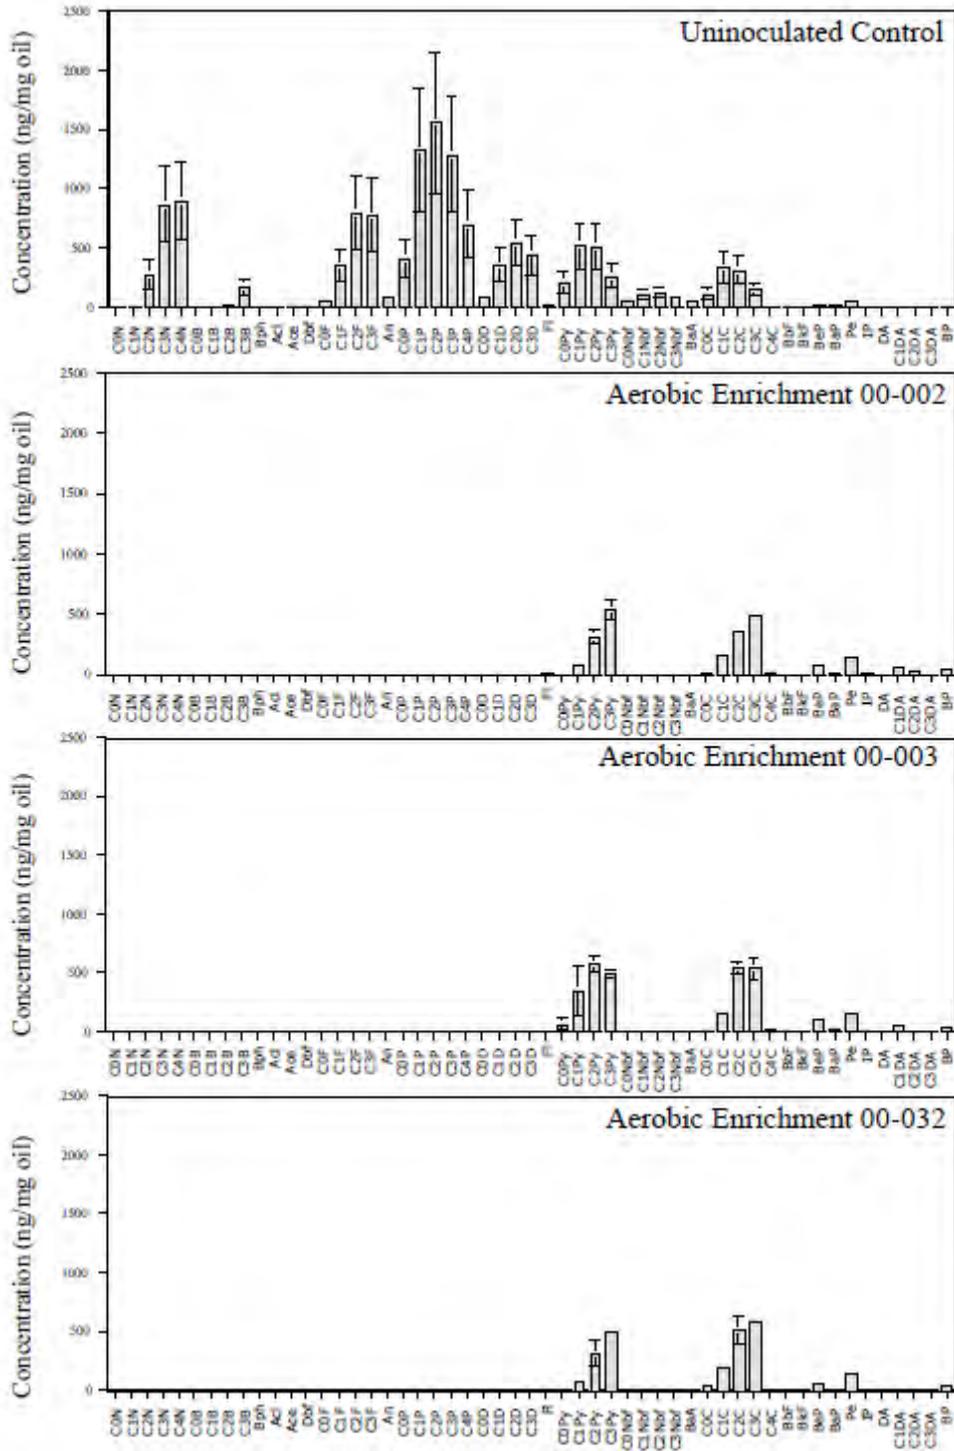
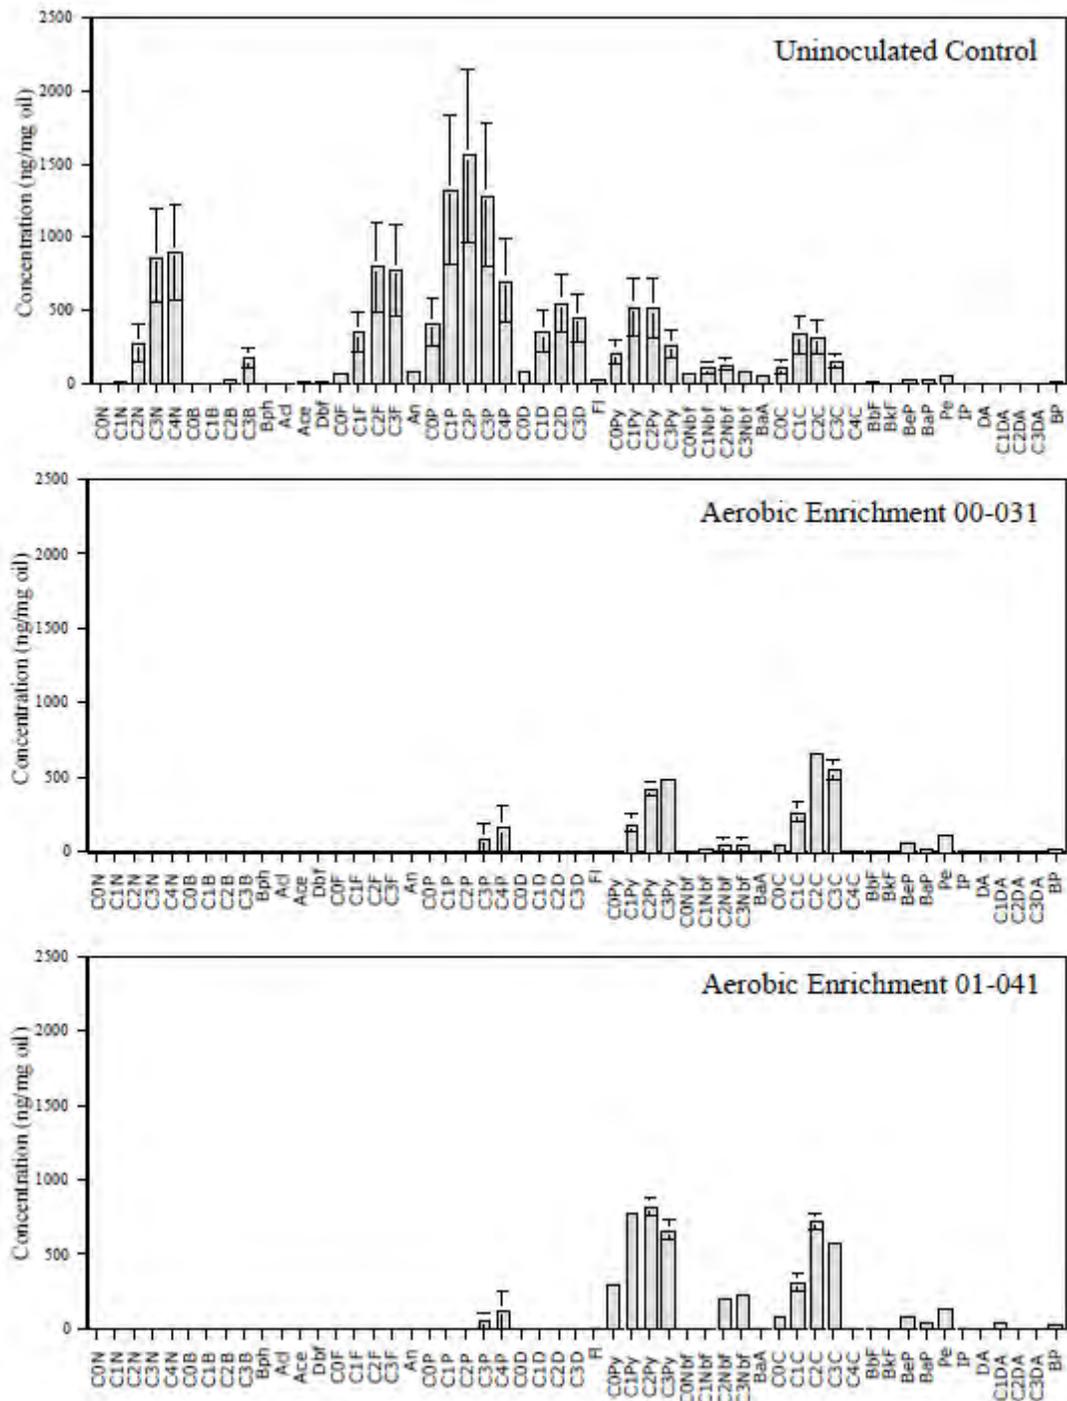
to the uninoculated controls (Figures 8.30 and 8.31). The concentration of higher molecular weight PAHs (i.e., perylene) were persistent relative to other PAHs when compared to the uninoculated control (Figures 8.32 and 8.33). It is important to note that during oil degradation, compounds that are not degraded will increase in concentration relative to the total amount of remaining oil. This occurrence does not indicate an increase in the absolute quantity of these compounds.

Figure 8.30. Individual PAH analysis for oil extracted from USS Arizona aerobic enrichments initiated from sediments surrounding the ship following 30 days growth indicates a substantial loss of PAHs in comparison to the uninoculated control. Abbreviations for PAH compounds are defined in Table 8.1 and locations for sediments used for aerobic enrichment inoculum are defined in Figure 8.5.

Figure 8.31. Individual PAH analysis for oil extracted from USS Arizona aerobic enrichments initiated from sediments on top of the ship following 30 days incubation indicates a substantial loss of PAHs in comparison to the uninoculated control. Abbreviations for PAH compounds are defined in Table 8.1 and locations for sediments used for aerobic enrichment inoculum are defined in Figure 8.5.

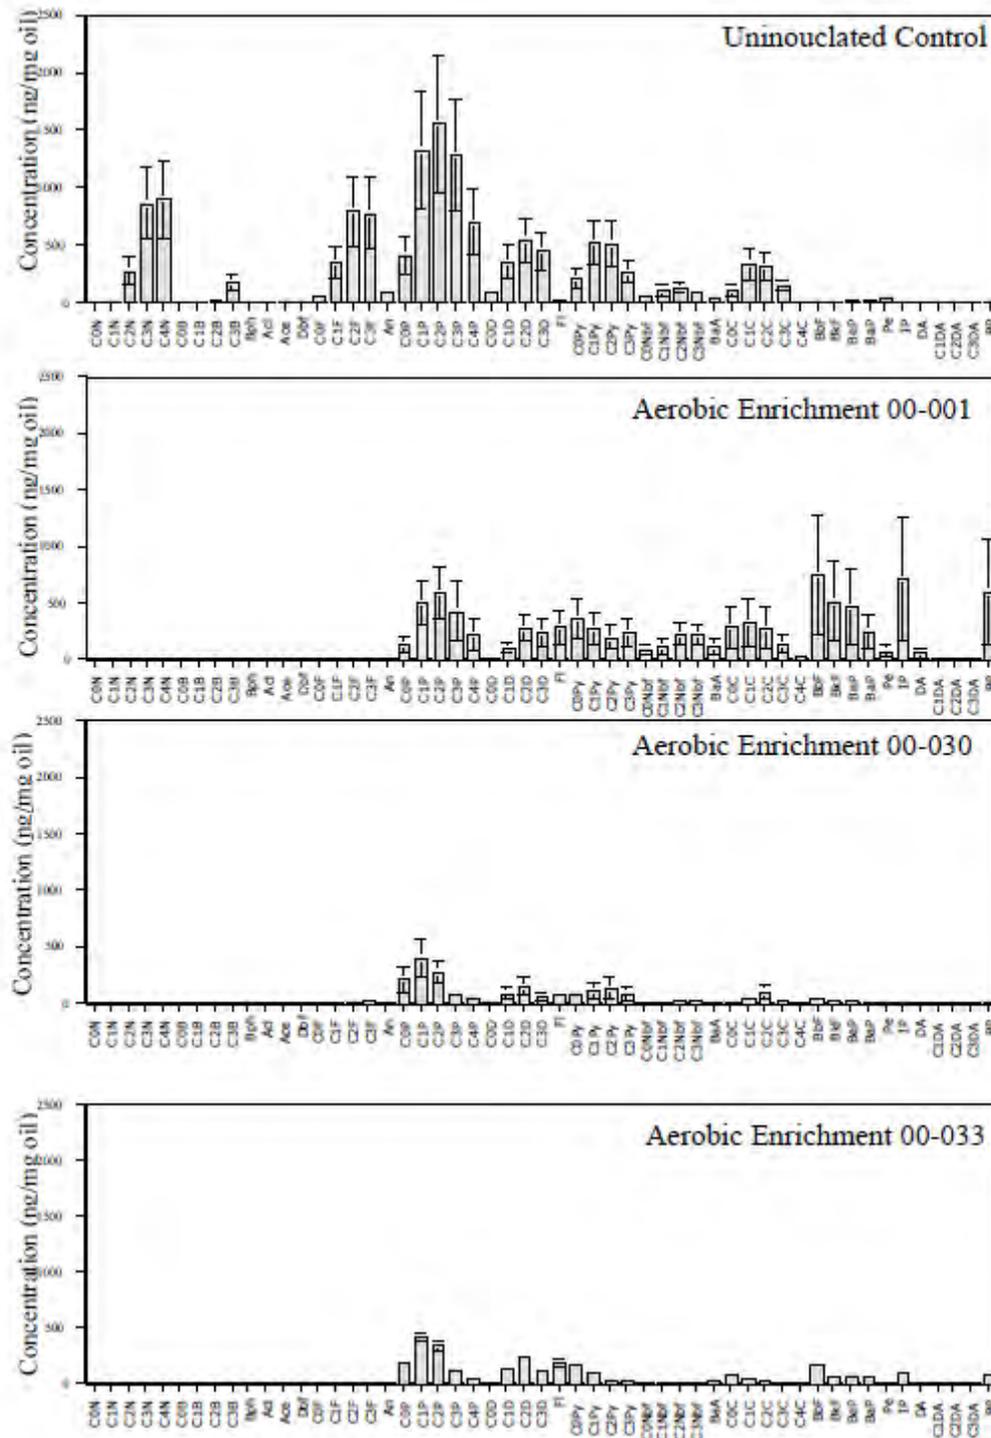
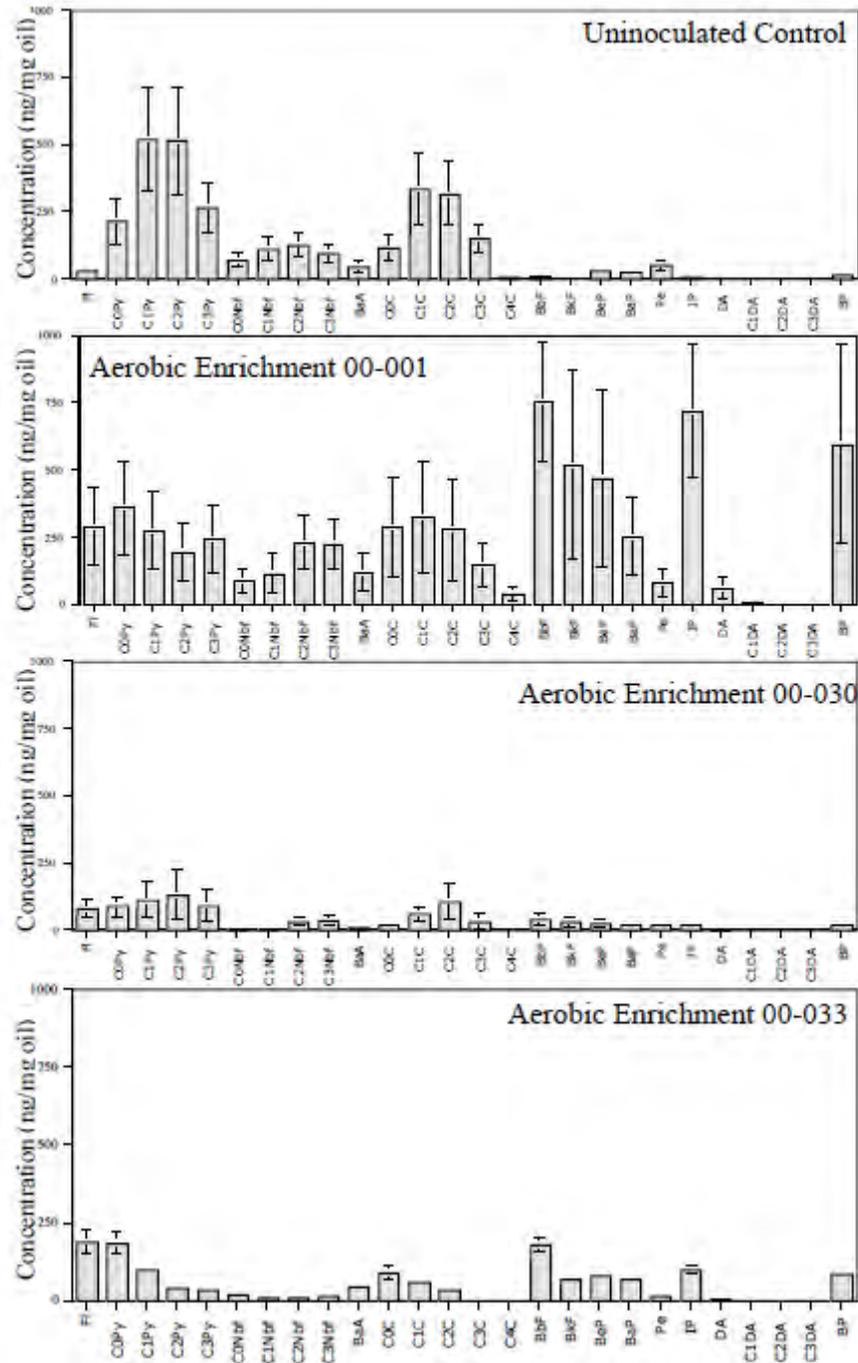
Enrichments 00-002, 00-003, and 01-041 had increased concentrations of C1-dibenzo(a,h)anthracene (C1DA) relative to other PAHs and the uninoculated control indicating no degradation of C1DA (Figures 8.34 and 8.35). Furthermore, enrichment 01-041 also did not demonstrate degradation of C2-phenanthrene/anthracene (C2Nbf) or C3-phenanthrene/anthracene (C3Nbf) relative to other USS *Arizona* aerobic enrichment cultures (Figures 8.34 and 8.35). Enrichment 01-041 also exhibited less pyrene degradation relative to other USS *Arizona* aerobic enrichment cultures (Figures 8.34 and 8.35).

Figure 8.34. Individual PAH analysis for oil extracted from USS *Arizona* aerobic enrichments following 30 days incubation. These enrichments had one of the three triplicates that did not show oil degradation. Abbreviations for PAH compounds are defined in Table 8.1 and locations for sediments used for aerobic enrichment inoculum are defined in Figure 8.5.

Figure 8.35. Individual PAH analysis of high molecular weight PAHs for oil extracted from USS *Arizona* aerobic enrichments following 30 days incubation. These enrichments had one of the three triplicates that did not show oil degradation. Abbreviations for PAH compounds are defined in Table 8.1 and locations for sediments used for aerobic enrichment inoculum are defined in Figure 8.5.

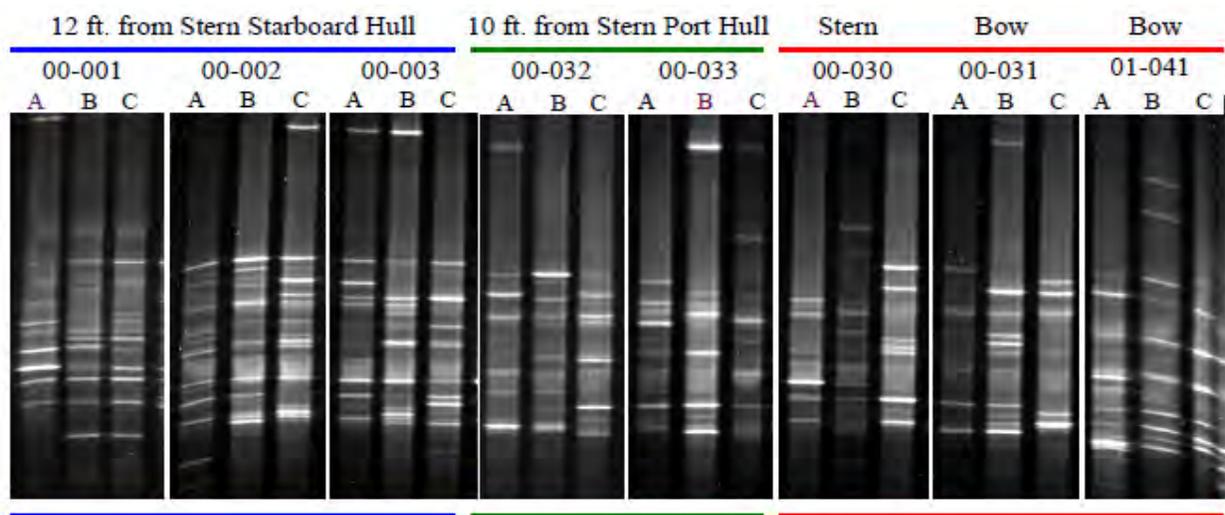
DGGE analysis was performed to determine differences in the microbial community structure of the aerobic enrichment cultures. For each aerobic enrichment culture initiated, triplicate Erlenmeyer flasks were inoculated with sediments from the different locations. Therefore, each of the triplicates (designated A, B, and C) is an independent (separate) culture. Following 30 days of incubation, the microbial community DNA was extracted from each of the triplicates for each enrichment culture, and then amplified using a 323 bp region of the V9 region of the 16s rDNA. This is a region conserved in the domain *Bacteria*. Following DNA amplification, DNA was run on DGGE. DGGE separates DNA based on the sequence, therefore, each band has the potential to represent a single microorganism. All DNA extracts were run on the same DGGE gel for band comparison. DGGE revealed multiple banding patterns with an average of 10 bands per enrichment lane (Figure 8.36). There was variability between banding patterns of enrichment culture triplicates and since each of the triplicates was incubated in a separate flask, some variability might be expected. Enrichments 00-001, 00-030, and 00-033, each had 1 of the 3 triplicate cultures that exhibited less degradation of oil, and these enrichments had fewer DGGE bands. For example, triplicate A in enrichment culture 00-001 contained 8 bands and less degradation of oil was observed than triplicates B and C (Figure 8.36). Triplicates B and C had 10 and 11 bands, respectively (Figure 8.36).

Figure 8.36. DGGE analysis of USS *Arizona* aerobic enrichment cultures. Triplicate cultures are designated by A, B and C. The blue bar denotes enrichment cultures that were inoculated with sediments collected from the stern section, starboard side, 12 ft. from the hull. The green bar denotes enrichment cultures that were inoculated with sediments collected from the stern section, port side, 10 ft. from the hull. The red bar denotes enrichment cultures that were inoculated with sediments collected from the top of the ship, and title above indicates the section they were collected from (bow or stern). The purple letters denotes enrichments that not did show degradation (00-001 A, 00-033 B and 00-030 A).

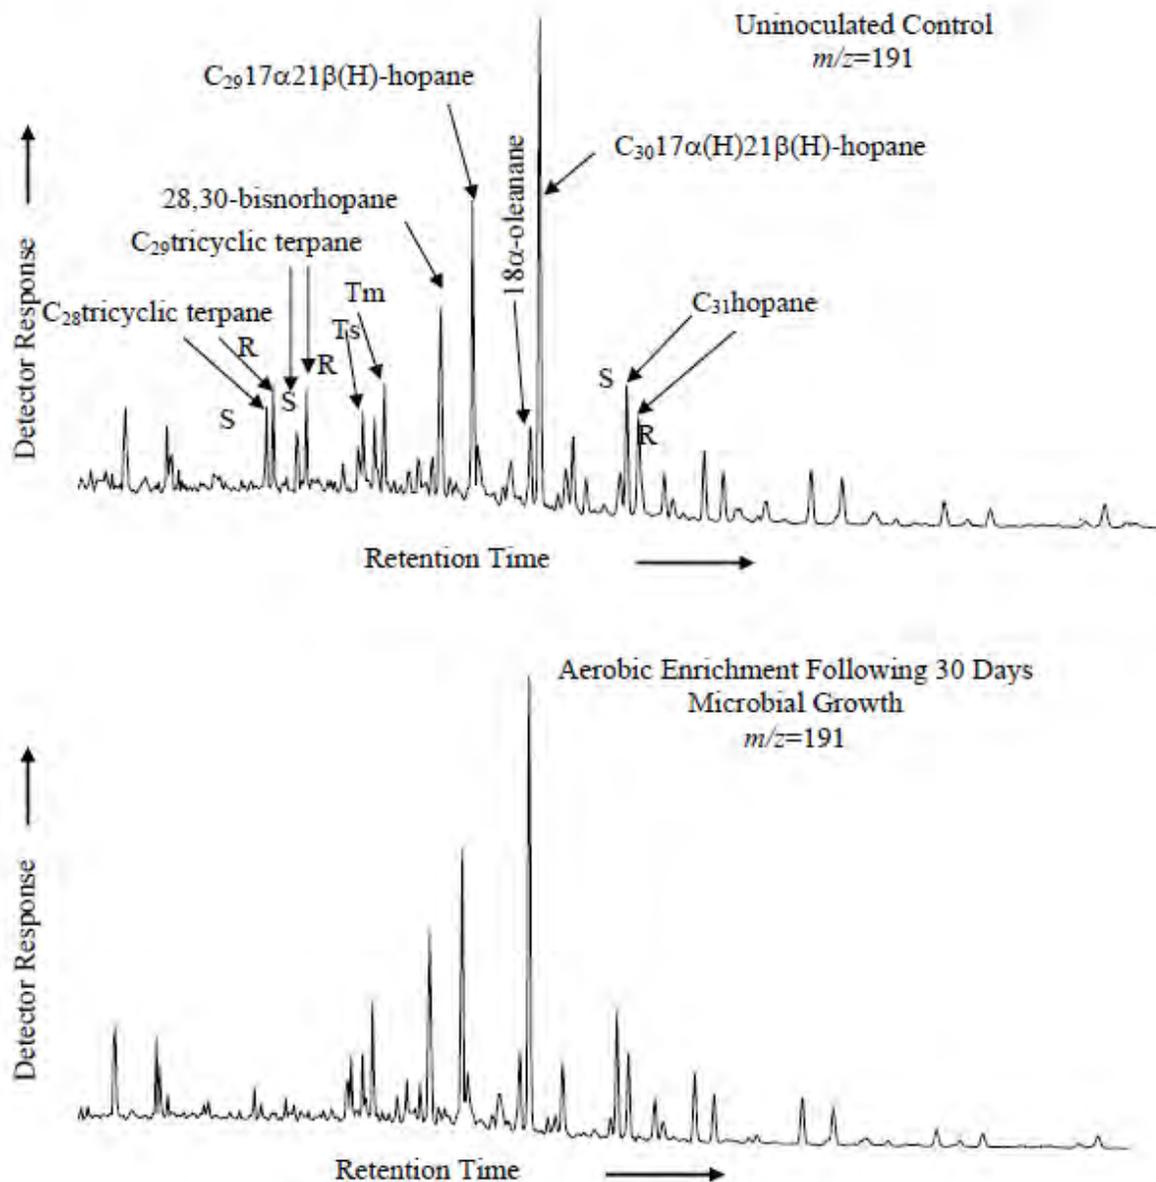
biomarkers (i.e., $C_{30}17\alpha(H),21\beta(H)$ -hopane) compared to the uninoculated control (Figure 8.37). However, there was a decrease in the $C_{28} - C_{29}13\beta,21\alpha(H)$ -tricyclic terpane 22R and 22S epimers in oil extracted from aerobic enrichment cultures in comparison to the uninoculated control (Figure 8.37).

Figure 8.37. GC-MS chromatograms ($m/z=191$) of hopanes extracted from USS *Arizona* aerobic enrichments and uninoculated controls following 30 days of microbial incubation. Chromatograms are representative of triplicate samples.

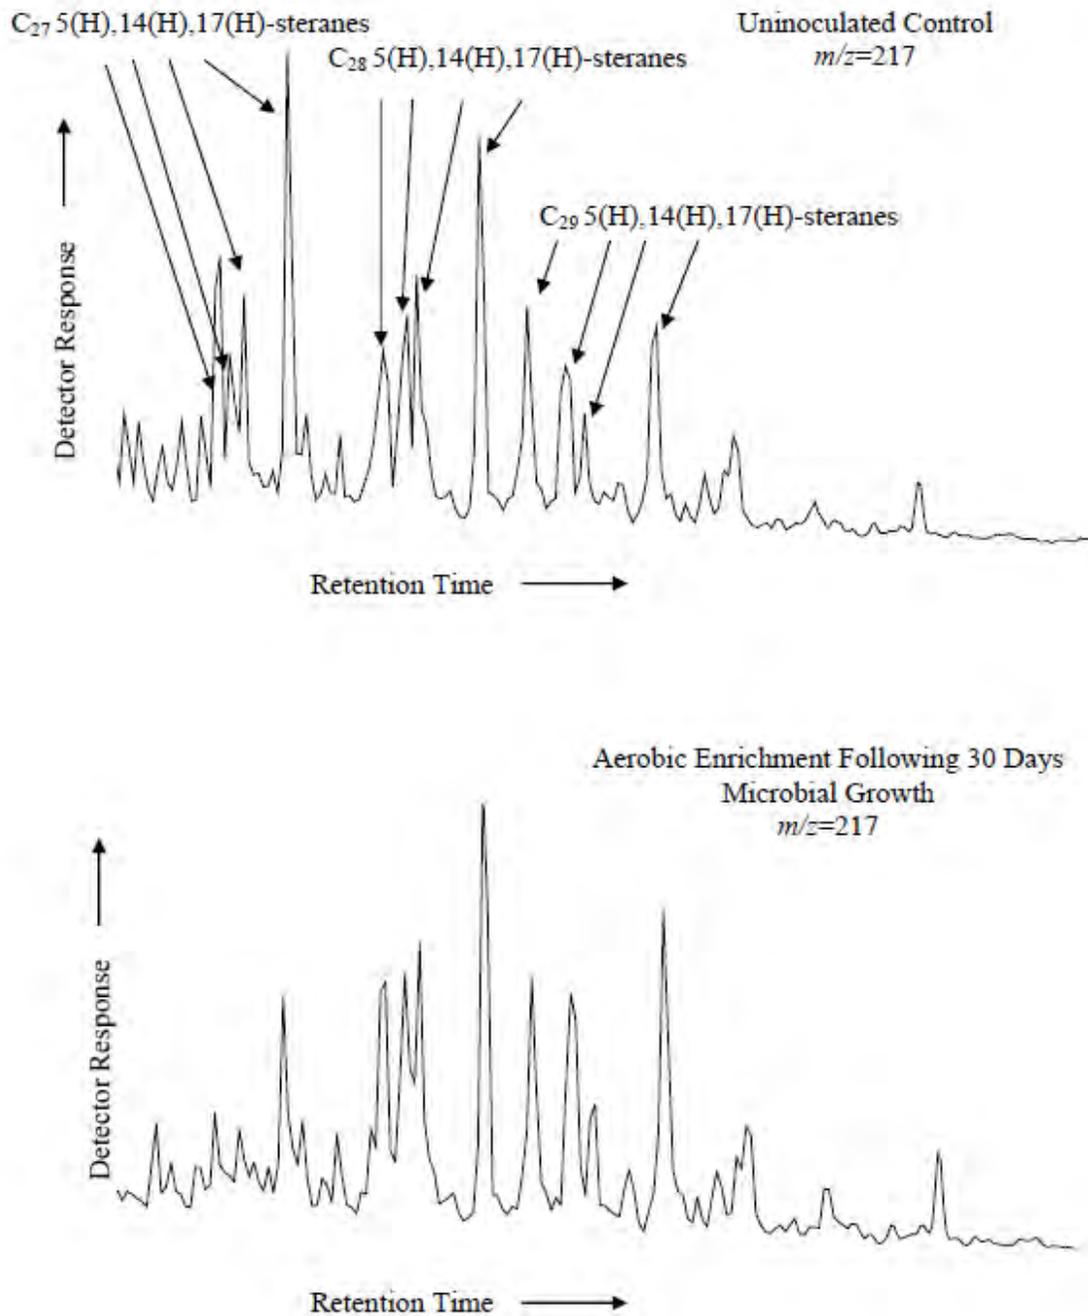
Mass chromatograms for ($m/z=217$) sterane trace showed a decrease in C_{27} steranes in oil extracted from aerobic enrichment cultures in comparison to the uninoculated control (Figure 8.38). There was no decrease in C_{28} steranes and C_{29} steranes in aerobic enrichment cultures (Figure 8.38).

Figure 8.38. GC-MS chromatograms ($m/z=217$) of steranes extracted from USS *Arizona* aerobic enrichments and uninoculated controls following 30 days of microbial incubation. Chromatograms are representative of triplicate samples.

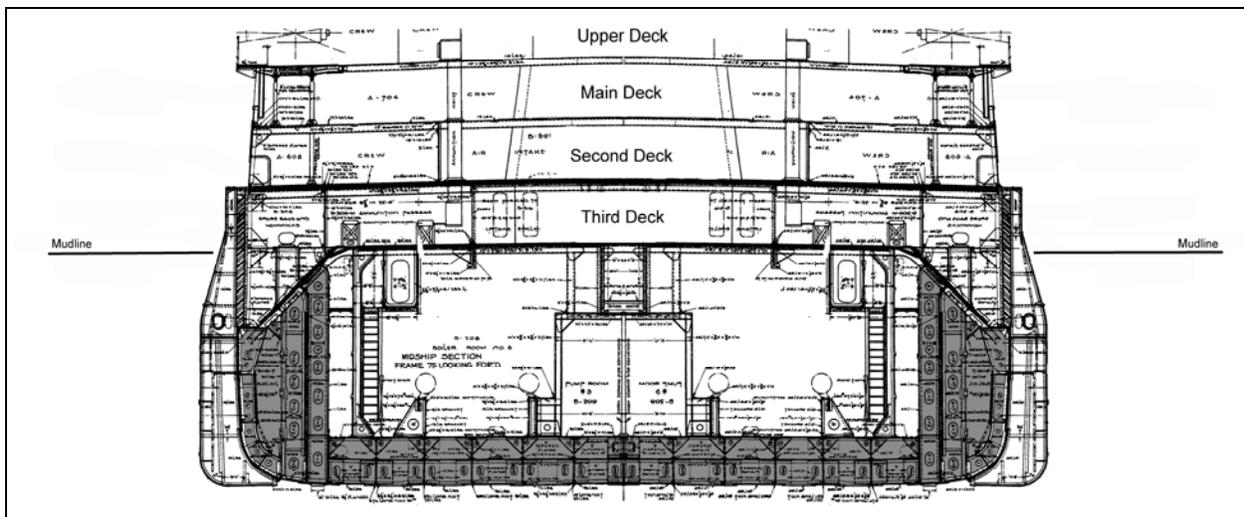
Currently, only a small portion of the third deck is accessible, and a smaller yet portion of the first platform, which is the deck level above the topmost oil bunker. There is no direct access to any oil bunker in the hull. Access would have to be gained by cutting through many structural elements. At the amidships section, most of the bunkers are near the hull sides, again not directly accessible because of armor and the torpedo blister. The hull is buried to the level above its normal waterline (Figure 9.2). There is no present estimate of the amount of sediment that may be within the hull at the second platform level and below. Direct ROV observations in the second and third deck levels, which are accessible and have been explored, reveal they contain significant sediment, which decreases the deeper into the hull one goes. In undamaged areas or areas with few penetrations, there may be little sediment due to lack of access to suspended sediment transport and few open doorways. Any access to oil bunkers would require excavation, certainly on the exterior, cutting bulkheads, deck and hull structures, including splinter deck and side armor plate, which would compromise the integrity of the hull and weaken the whole structure, even with significant shoring of passages.

Figure 9.2. *Arizona* hull cross-section at frame 75. Dark areas are oil bunkers and the line indicates the current seabed level relative to the hull (Graphic by NPS-SRC).

access to the single hull bottom greatly facilitating oil removal through a “hot tap process.” In *Arizona*, bunkers are of varying size and are found throughout the ship: on the first platform, there are 30 bunkers; on the second platform, 34 bunkers; in the hold, 28 bunkers; and in the double bottom, 36 bunkers. The rationale for the large number of separate oil bunkers is that it is part of the defensive strategy of battleships. With more separated bunkers, the less likely a vessel could be put out of commission by sustaining damage to its fuel supply. Half or so of these bunkers remain and must be assumed to still contain oil. Approximately 50 to 60% of the oil bunkers in the forward hull were destroyed by the explosion that sank the ship. Each oil bunker is independently piped, suggesting that any oil removal plan could likely require accessing each bunker individually.

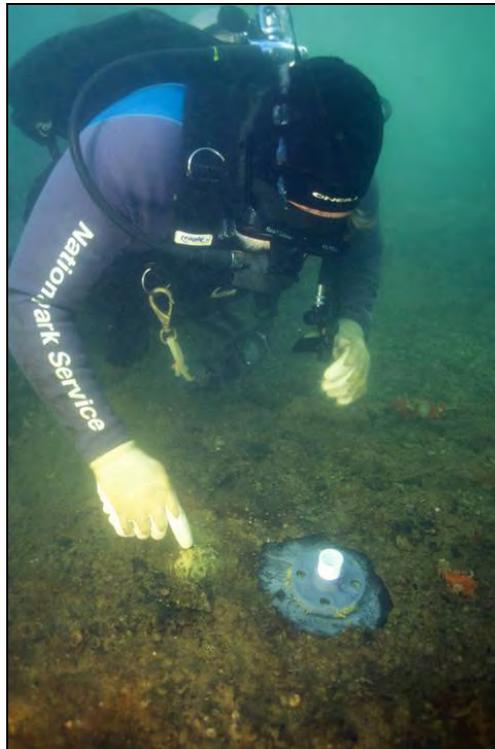
Figure 9.5. Comparison of the original, left, and current GPS monitoring points. Note: 2001 epoxy covered by pioneering organisms (NPS Photo by Brett Seymour).

During the 2003 reoccupation, the first problem encountered was that most of the epoxy encased stainless steel bolts had corroded away. The epoxy did not prevent electrolytic corrosion of the stainless steel embedded in the mild steel of the deck plates. Each point was reoccupied as best as possible, but new points not subject to corrosion had to be established. PVC was used, and each new point was established adjacent to the original point (see Figure 9.5). The diameter of the PVC datum point was selected to accommodate the point of the underwater tripod to both provide a solid support and facilitate deployment (see Figure 9.6). Each of these new points was then surveyed and became the permanent monitoring points or “superpoints” (see Table 9.1).

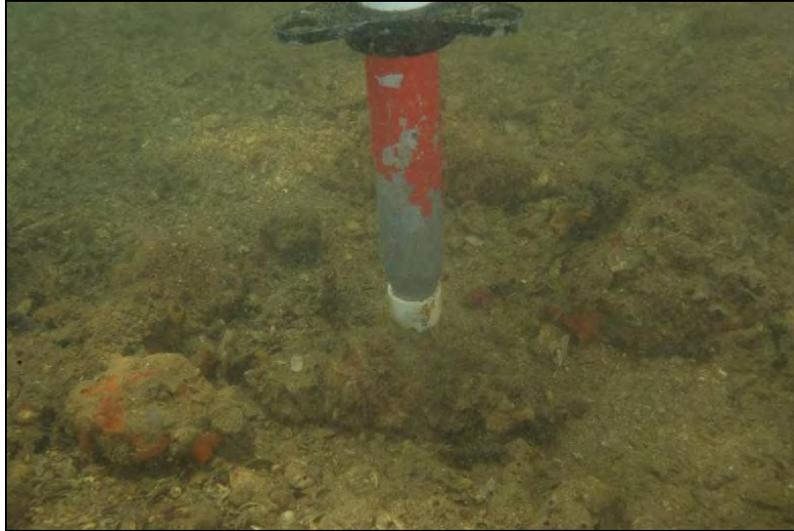
Figure 9.6. Surveying GPS monitoring points on *Arizona*, here using replacement PVC epoxyed to metal. This accommodates the point and facilitates set up. Note epoxy has been covered with pioneering organisms (NPS Photo by Brett Seymour).

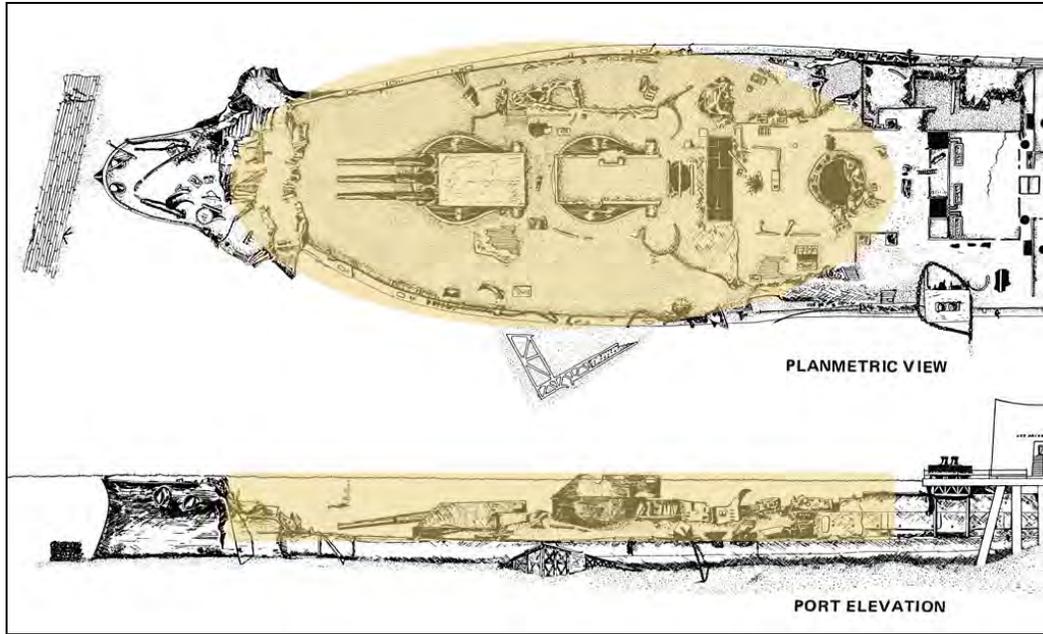
The galley-area on the second deck and those decks below have been damaged by the enormous explosion that sank the vessel, and they constitute the aft edge of the blast crater (Figures 9.10–9.12). The forward magazine blast force undercut the lower hull structure and the decks forward sufficiently for turret nos. 1 and 2 to have dropped more than 20 ft. The deck forward of the stack slopes down into the lower hull. The main deck and portions of the upper deck now are nearly even with the top of the 13-in. armor belt on the starboard side, and lower than it on the port side. Other deck areas were blown upward, and hull sides above the armor belt were blown outward nearly horizontal with the hull. The shell plate blown outward above the armor belt was removed during salvage of the superstructure in the 1940s. An indication of the extent and location of damage in this area can be derived from salvage reports (see Chapter 3). These salvage reports indicate divers were able to move forward within the hull during damage assessment dives to frame 76 on the main and second decks and not forward of frame 78 below the third deck. However, on the third deck in ammunition passageways A-504-M and A-505-M, access was possible as far forward as frame 66 (Paine 1943:5). This midships-area is the most damaged of the aft portion of the vessel, and it is here that most oil leaking occurs (see below). In addition to GPS, from 2001 to 2006 structural changes in the upper deck crew's galley (frames 80–88) were monitored using a series of plastic crack monitors normally used to measure crack movement in historic buildings (Figure 9.13). In June 2001, six plastic monitors were affixed over cracks in the upper deck galley where *Arizona*'s deck collapse had been qualitatively observed. These crack monitors were checked periodically to see if the cracks widened or shifted. After several years of monitoring, most of the gauges showed little movement, although at least one (#4) had fallen into an expanding hole on the starboard side of the galley floor as part of a limited upper deck collapse. The research team decided that the limited data they provided did not justify replacing the gauges as they broke or became dislodged, which happened frequently. Active monitoring of crack gauges ended in 2006, but they will be periodically checked as part of the ongoing monitoring project.

Figure 9.10. *Arizona* bow showing blast crater (highlighted) and weakened upper deck area from frame 10 to 78, or about 270 ft. of hull (Drawing by NPS-SRC).

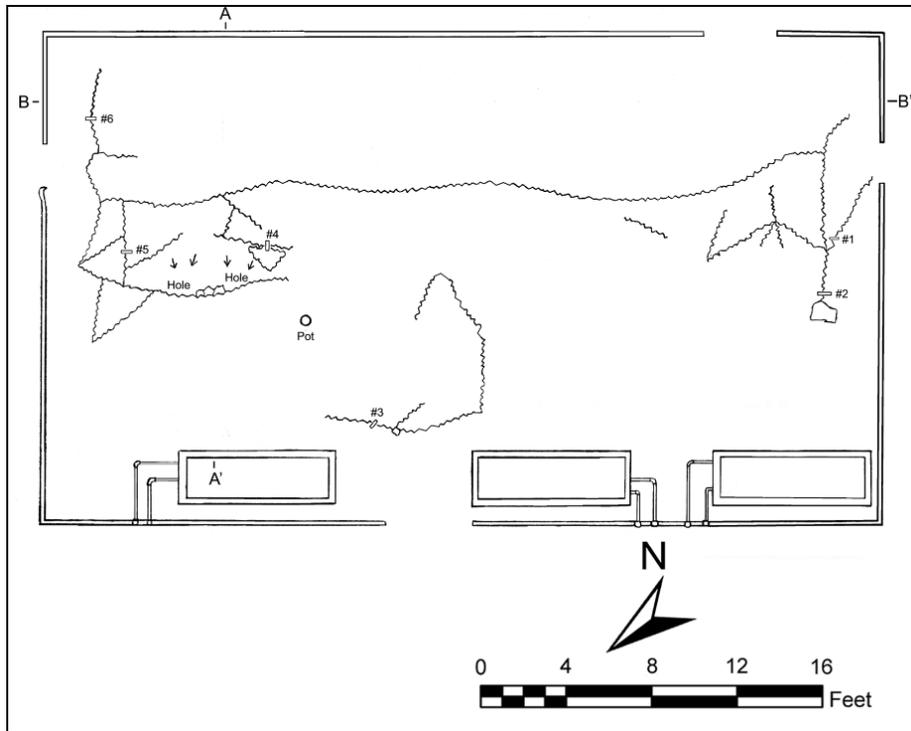
Researchers in the 1980s observed the deck sagging forward of the galley area while mapping the hull. At the start of the USS *Arizona* Preservation Project, this midships-area was sagging and beginning to collapse. It represents the aft-most damage from the forward magazine detonation, and does not contribute to the battleship's overall structural integrity, especially oil-containing spaces. These upper deck areas were expected to be the first to show signs of weakening because they are most affected by the blast.

Figure 9.12. Plan view of *Arizona* galley area showing cracks and collapsed areas. *Arizona*'s bow is to the bottom of the drawing, port side to the right. Crack monitors are identified by numbers (Drawing by NPS-SRC).

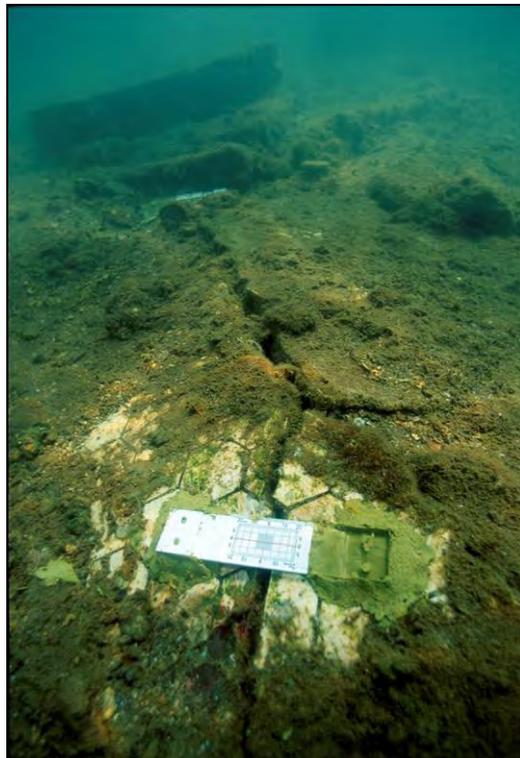
Figure 9.13. Crack monitor in *Arizona* galley-area (NPS Photo by Brett Seymour).

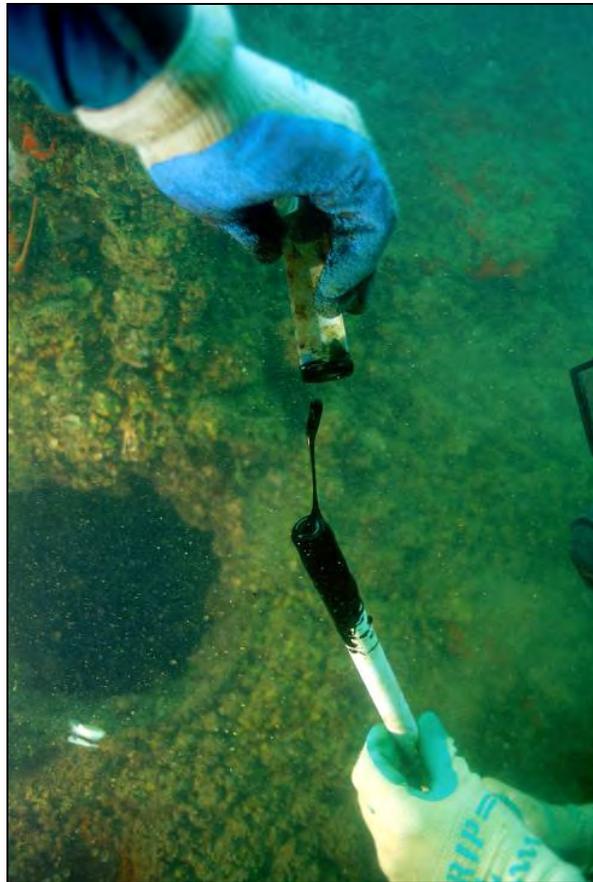
Internal oil observations and samples were collected with the VideoRay ROV (Figure 9.17), although most internal oil samples were collected from cabin overheads by reaching through an open second deck port hole on *Arizona*'s starboard side with a PVC pipe. No oil was observed in the port overhead spaces, likely due to the ship's 2–3° port list, which funnels the buoyant oil to the higher, starboard side. Oil has collected in most observable, starboard-side second deck cabin overheads, and the depth of oil in each cabin overhead was measured to give an idea of where internal oil releases are concentrated. A PVC pipe was pushed vertically up to the cabin overhead to obtain a depth (thickness) measurement of the oil layer, and samples were collected when the pipe was extracted (Figure 9.18). The results of oil depth measurements in overhead compartments on the second deck (Figure 9.19) indicate that oil concentrations increase moving forward from the stern, with the highest concentrations between frames 88–98. This is consistent with increased oil release observations in the upper deck, midships area (forward of frame 92). However, it also reinforces the observation that oil release in the midships and galley area is primarily “degraded” oil coming from secondary oil concentrations in second and main deck cabin overheads, not “undegraded” oil coming from primary oil containment spaces. The main deck (aft of frame 92) above oil-containing cabin overheads is apparently sound; there is no oil leakage above these second deck spaces. The closest oil leaks to this area are two open hatches on the main deck that continually release oil drops (see Figure 9.19). The oil coming from the aft-most hatch is different than the oil in cabin overheads, in that

Figure 9.18. Internal oil measurement and oil sample collected by reaching PVC pipe in porthole and pushing vertically to the overhead. Overhead oil depth is indicated by oil on pipe (NPS Photo by Brett Seymour).

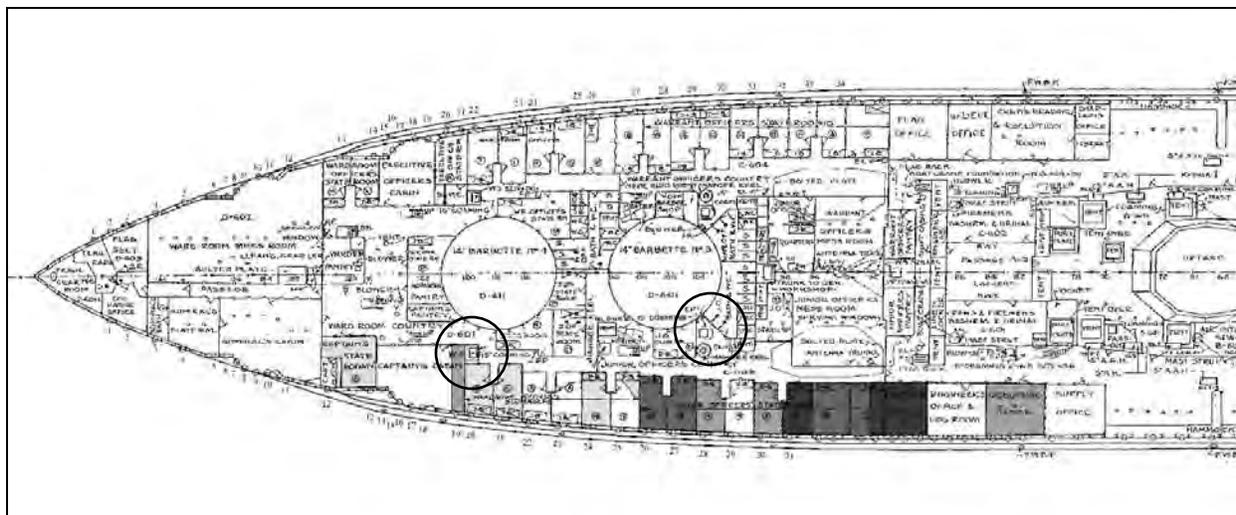
Figure 9.19. Illustration of thickness of overhead oil on *Arizona*'s starboard second deck (stern to the left). Relative darkness represents thickness of oil in each cabin overhead, and hatches releasing oil are circled (Graphic by NPS-SRC).

it is the only location producing undegraded oil. In addition, ROV observations have indicated the source of undegraded oil from the aft-most main deck hatch is below the third deck. All the other released oil tested has reduced *n*-alkanes (and other constituents), matching oil from the cabin overheads, which indicates microbial degradation has occurred through the oil's exposure to seawater (and microbial communities) of more than 30 days (see Chapter 8 and below). Most likely, oil leaking from the forward-most main deck hatch, and all other oil release points, is coming from reservoirs pooled beneath the main and upper decks where it is degraded for some time before being released.

Since 1998, the SRC and USS *Arizona* Memorial (USAR) have monitored oil release rates from *Arizona*'s hull. Oil release observed during the 1980s *Arizona* documentation project originated from a hatch on the starboard side of barbette no. 3, at frame 103, and later from a hatch on the starboard side of barbette no. 4, near frame 119 (see Figure 9.19).

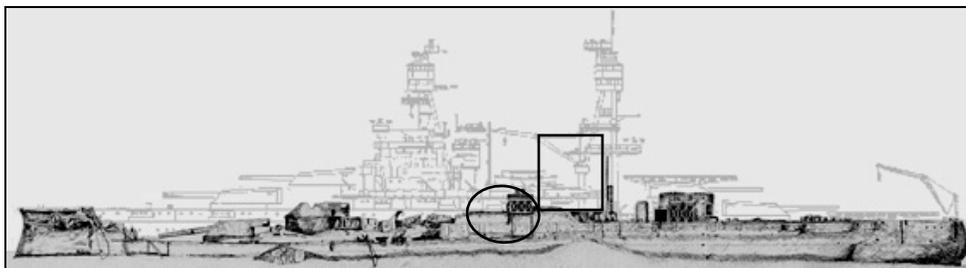
As discussed previously, the upper deck, midships galley-area (frames 80–88), just forward of the Memorial, is presently the principal oil release area on *Arizona*'s hull. This area is heavily damaged from the forward magazine blast that sank the vessel, representing the stern reach of the blast crater (see Figure 9.10 and Chapter 3). The decks are sagging, and there has been limited collapse observed, which is why this area was chosen for deploying the crack monitors (see Figures 9.11 and 9.12). During 1941 salvage investigations, divers noted that there was only access forward to frames 76 and 78. Forward of this location, the main, second, third, first platform, second platform and hold decks collapsed on top of one another to the level of the top of the 13-in. armor belt, as the blast undercut deck support structures. Turret nos. 1 and 2

both collapsed downward more than 20 ft. (Figure 9.24). The lower decks area beneath the galley area were certainly damaged as evidenced by both the forward multiple deck collapse, but also by the original film of *Arizona*'s explosion, which shows the magazine explosion clearly vented upward through the stack area, which is just forward of the galley area (Lott 1978:40). This indicates the blast most certainly affected adjacent spaces aft, including the galley.

Figure 9.24. USS *Arizona* wreck overlay on intact vessel plans. Oval indicates galley area oil release area and rectangle is Memorial location (Graphic by NPS-SRC).

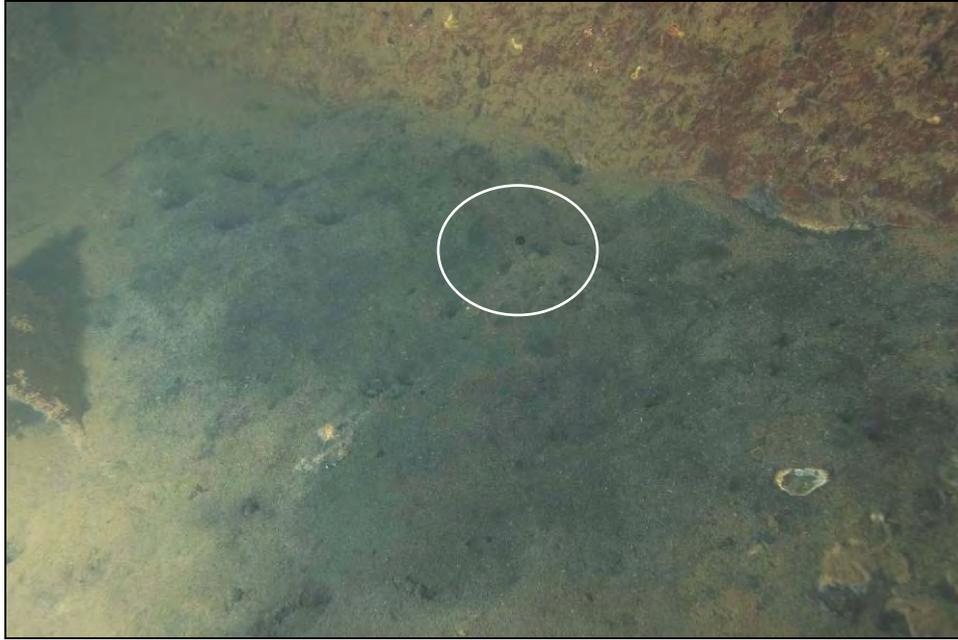
The oil escaping from the hull in the galley area comes through the sediments, which appear to be fully saturated with oil in several locations. Oil release has increased in this area based on comparisons with the 1980s fieldwork. Additional oil leaking from lower decks floats to the area beneath these sediments, and dislodges trapped oil that rises to the surface (Figure 9.25). It is a reasonable question to ask "where does the oil leaking through the galley area sediments likely originate?" A partial answer is revealed by an examination of the ship's blueprints on this area, specifically focusing on ship's plans in the area between frames 70–90. The crew's galley was on the upper deck. Directly beneath this area, below the third deck were engine, boiler, distribution and pump spaces (Figures 9.26–9.32). Oil bunkers are on the first platform and below. There is no record of damage to these spaces, only the main and third decks are mentioned as being accessed by divers during the salvage work, but it is very likely there is damage to the engine and boiler spaces in this area. Oil could be coming from associated piping, machinery, cracked or damaged bunkers, and trapped in overhead spaces. Episodic releases may be caused by further collapse of lower decks, much like that observed on the upper deck area. More likely, the oil in the galley area is resulting from original battle damage, and weakened decks collapsing and releasing trapped oil that rises up from engine, boiler and pump spaces, than from deteriorating oil bunkers. The rising oil is directed by collapsed decks to cracked areas surrounding the upper deck galley that contain sediment, where the oil saturates the sediment and is released.

Figure 9.25. Sediments in crew’s galley area forward of Memorial. Dark areas are oil saturated sediments. White oval circles a drop of released oil moving toward the surface (NPS Photo by Brett Seymour).

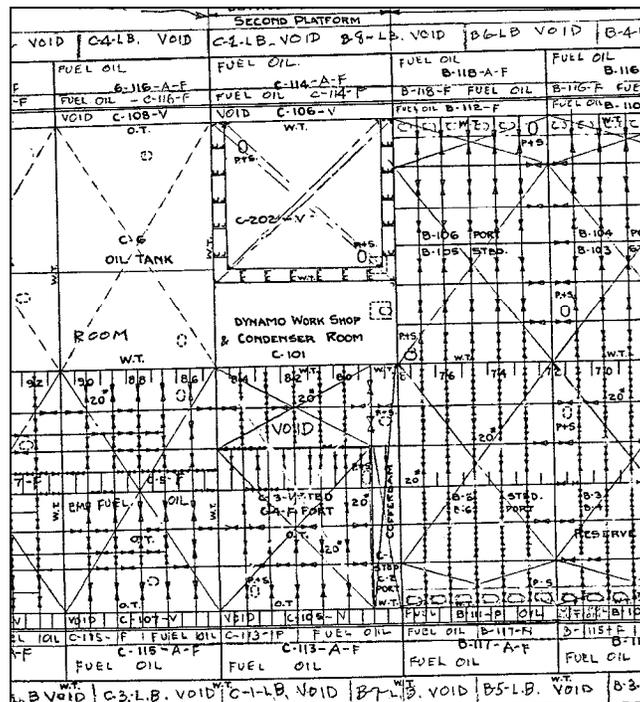
Figure 9.32. Double bottom, frames 70-90. It is unlikely that this area suffered significant damage from the magazine blast (USS Arizona Memorial Archives).
