PROJECT NUMBER (05-170)

Long-Term Management Strategies for USS ARIZONA, A Submerged Cultural Resource in Pearl Harbor

NATIONAL PARK SERVICE
SUBMERGED RESOURCES CENTER

SEPTEMBER 2008
THIS REPORT IS APPROVED FOR PUBLIC RELEASE

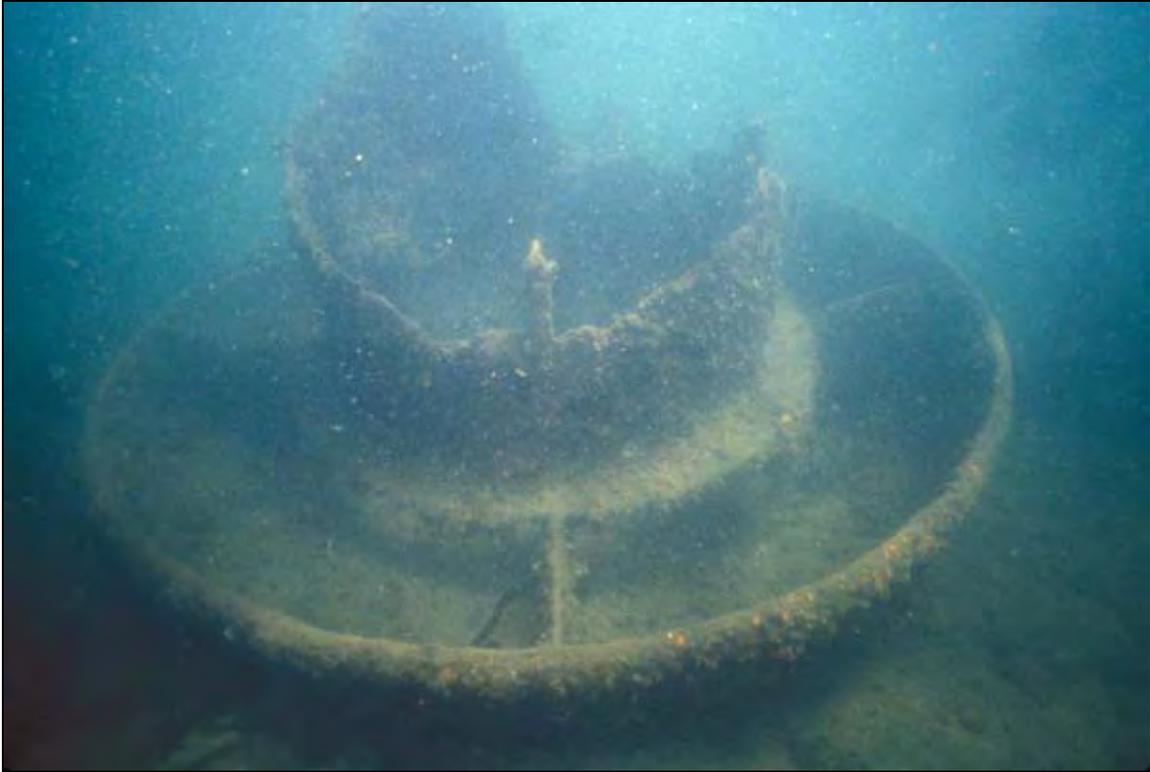
Figure 9.38. Inverted ventilator, on *Arizona*'s aft deck in 1983 (NPS photo by Larry E. Murphy).

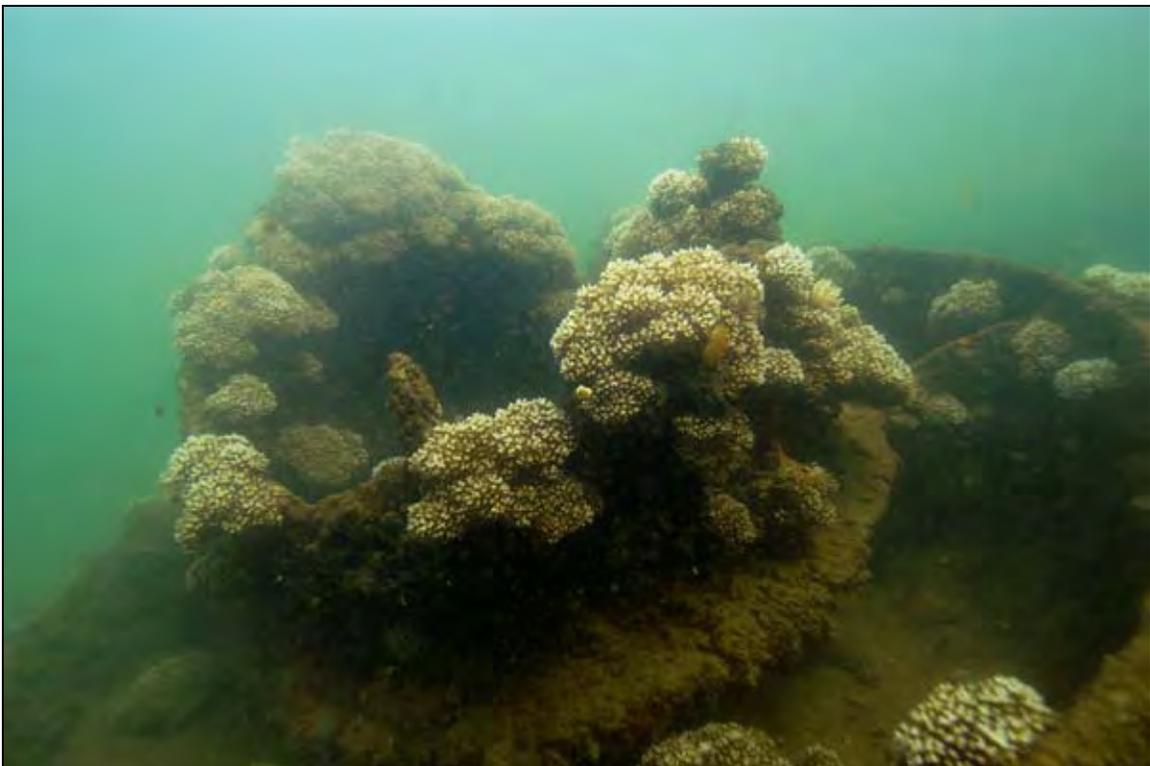
Figure 9.39. Inverted ventilator, on *Arizona*'s aft deck in 2005 (NPS photo by Brett Seymour).

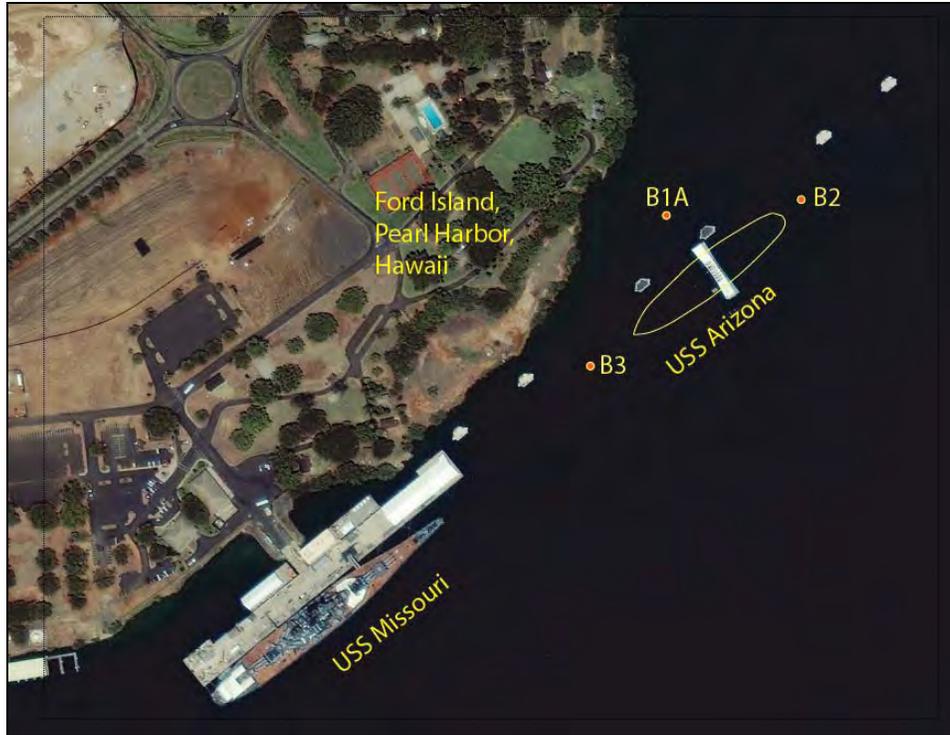
The three boreholes are located as follows: B1A is located midship between the USS *Arizona* and Ford Island (E608813, N2362945) in 8.5 m of water at the time of drilling; B2 is located directly northeast of the vessel (E608943, N23662957) in 11.9 m of water at the time of drilling; B3 is located directly southwest of the vessel (E608749, N23662811) in 11.3 m of water at the time of drilling (Figure 10.1). The boreholes B1A, B2, and B3 have sub-bottom drill depths of 15.2, 21.3, and 15.2 m. USS *Arizona* is currently resting on the floor of Pearl Harbor, submerged and tilting away from Ford Island. Immediately following the attack, on December 7, 1941, portions of the deck and railing were sub-aerially exposed, along with the superstructure and guns removed during salvage operations (Figure 10.2). The superstructure and guns were removed in 1942. Photos taken in the winter and spring of 1942 clearly show much of the vessel

Figure 10.1. Boreholes B1a, B2 and B3 located around the hull of USS Arizona, west of Ford Island.

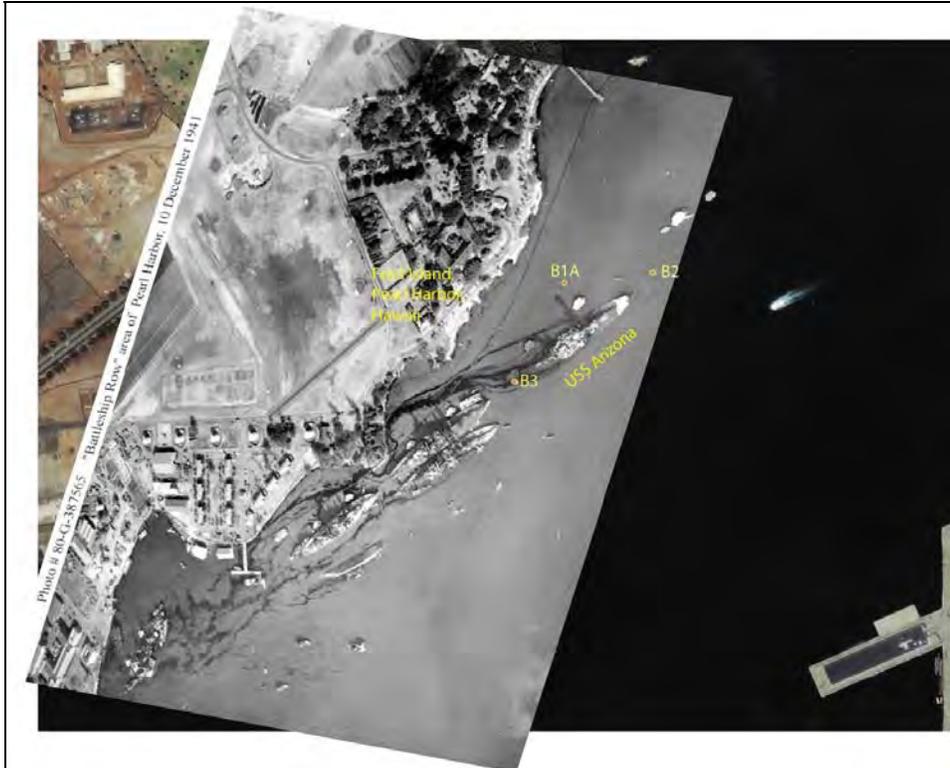
Figure 10.2. An overlay of DOD photo 80-G-387565, taken December 10, 1941, on Figure 10.1, showing the location of the vessel and boreholes. Most of the vessel was still sub-aerially exposed after the attack.

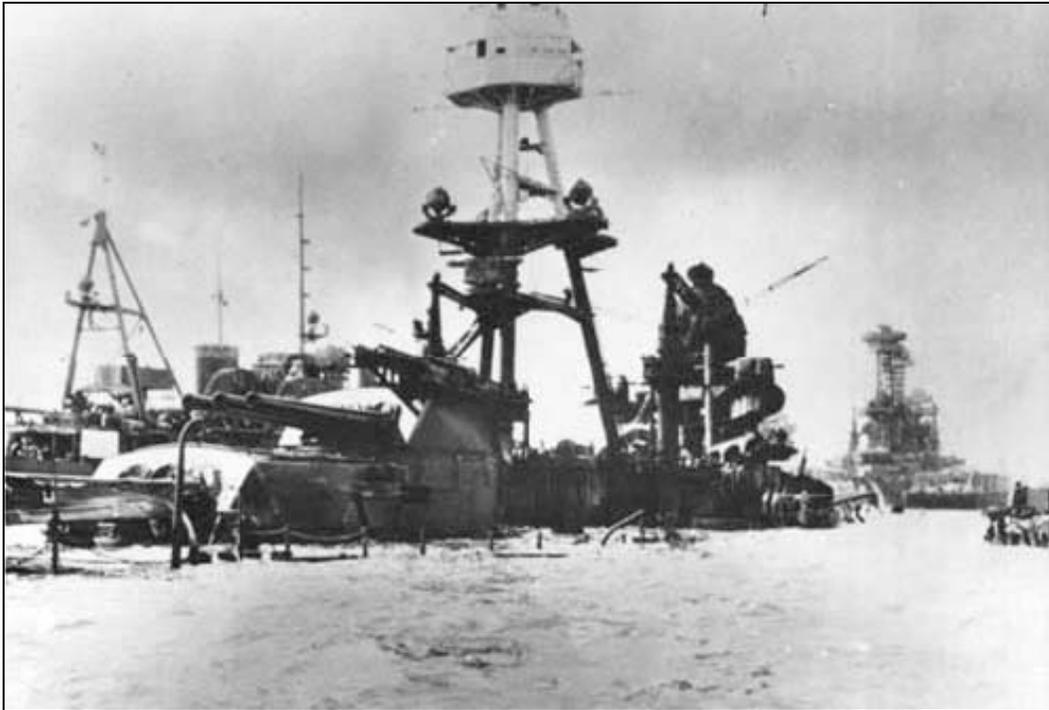
Figure 10.3. Gunnery deck and deck railings visible above the harbor water in 1942 (USS Arizona Memorial Photo Archive).

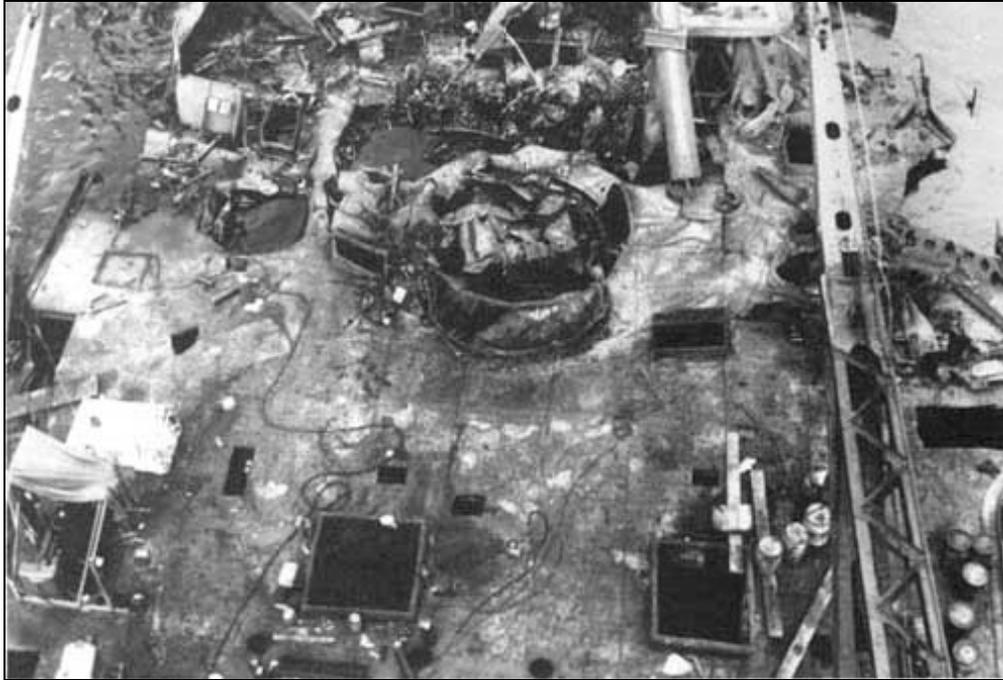
Figure 10.5. Salvage crews in 1942 were able to work on the deck above water and cut entry-ways into the vessel for recovery operations (USS Arizona Memorial Photo Archive).

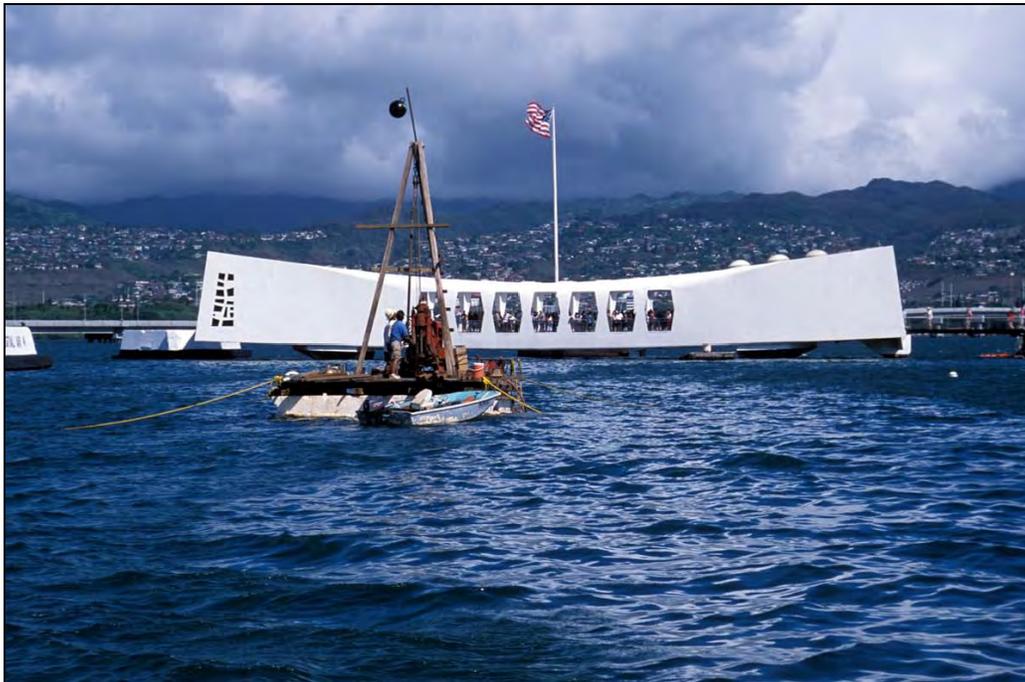
Figure 10.6. A small anchored barge was used to advance the borehole. The deck and railings of USS *Arizona* are completely submerged in 2003, with the vessel tilting several degrees to the southeast (USGS Photo).

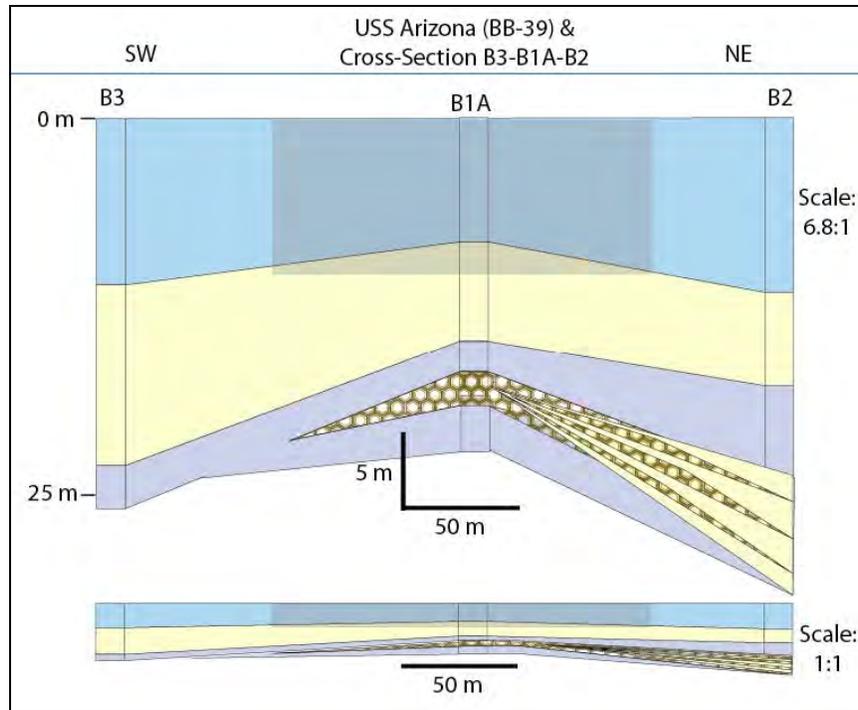
The lithology of the samples and drill cuttings are presented in the appendix. The uppermost unit in all three boreholes is a silty sand/sandy silt (SM/ML) with shell fragments (upper yellow unit Figures 10.7, 10.8, and 10.9). Beneath this is a silty sand unit (gray) that thickens toward the north stern area. Borehole B1A is shoreward of the vessel and the silty clay there is interbedded with a coralline rubble and sand. Likewise, the silty sand near the stern is interbedded with silt and sandy silt that coarsens down core. What is most noteworthy regarding the cross-sections in Figures 10.7, 10.8, and 10.9, is the heterogeneity of the sediment beneath the vessel. A relatively stiff profile of silty sands and sandy silts is found near the bow section at B3, whereas, soft deformable fine-grained deposits thicken toward the stern (B2) with a corresponding thinning of stiffer silty sand and sandy silt deposits. Midship on the starboard, shoreward, side, a coralline rubble may provide some stiffening element to the sediment deposit that is not present at the stern, bow, or port side. A seaward thickening wedge of silty-sand is present in the bow (B3) area, whereas, a seaward thickening wedge of finer grained clay is found near the stern.

Figure 10.7. Cross-section from bow area (B3) to stern area (B2) through the shoreward midship boring (B1A). The upper blue unit is the water column. The seafloor is a silty sand and sandy silt underlain by a silty clay. The B1A clay unit is interbedded with a coralline rubble. B2 is a silty clay that transitions into a clayey silt with interbedded sandy silt. The gray shaded area is USS Arizona.

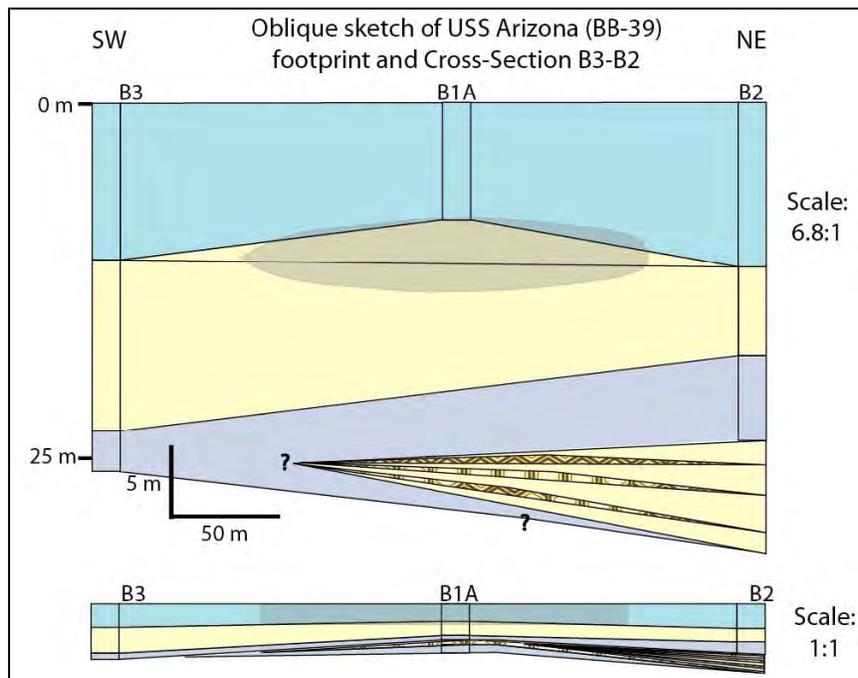
Figure 10.8. A proposed model of the lithology directly beneath Arizona between B3 and B2. The silty clay unit thickens toward the northeast (stern). Coralline rubble may be beneath the vessel midship, offshore B1A.

The study presented here, addresses the potential for normal settlement processes to affect the orientation and elevation of USS Arizona, with respect to the seafloor and the waterline. Three boreholes around the vessel indicate that the vessel rests upon highly variable sediment. The settlement potential of the vessel is greater toward the stern, and toward the port side (bay side). A coralline rubble layer observed at boring B1A midship on the shoreward side

may act to prevent settlement of the vessel there and may amplify tilting toward the bay. The presence of the stiffer rubble zone may also enhance differential settlement beneath the vessel that can result in hull stresses that deform the underbody of the vessel. In the area of maximum settlement potential, we compute a estimated settlement at full consolidation of approximately 1.6 m. Future measurement of the stiffness properties of the sediment, and monitoring of the settlement of the vessel is recommended. A 2-dimensional settlement analysis is needed to estimate the final degree of seaward tilting that is expected to occur.

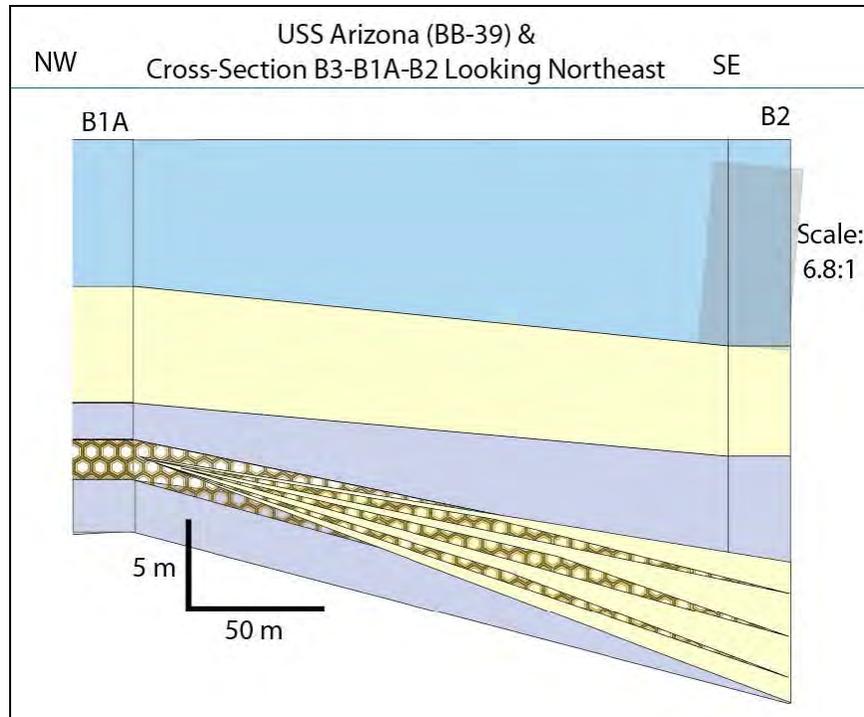
Figure 10.9. A proposed model of the downslope lithology between B1A and *Arizona* based on the B2 borehole to the northeast. The silty clay unit and the clay silt-to-sandy silt thickens toward the southeast (port side). Coralline rubble may be beneath the starboard side of the vessel midship, offshore B1A.

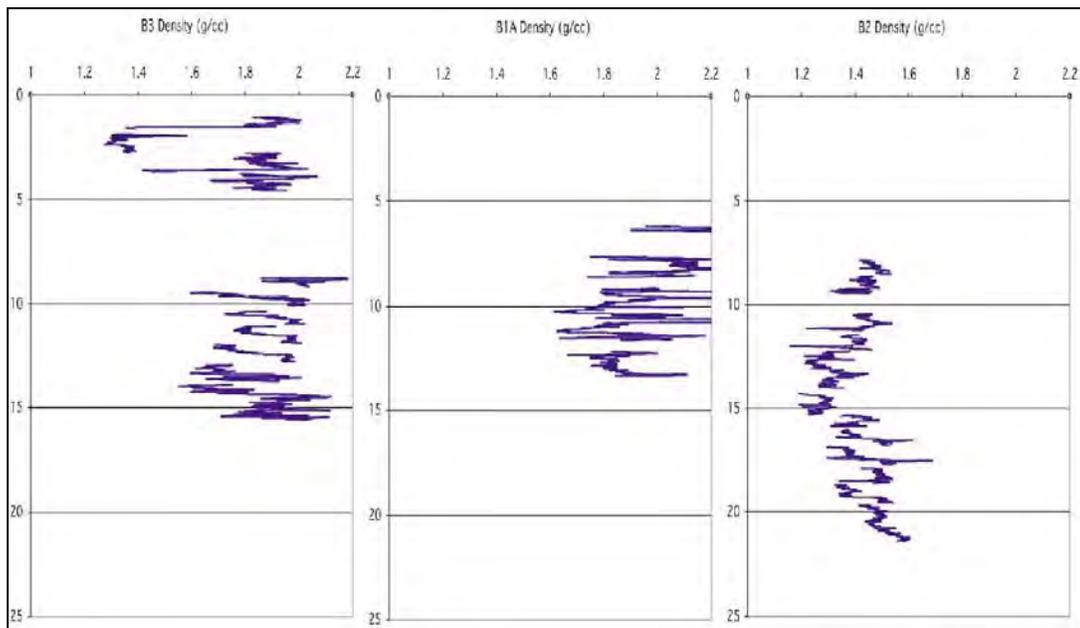
Consistent with the lithologies noted in the Hirata & Associates report (see Appendix), a higher density deposit, typical of coarse grained sediments is found toward the bow of the vessel (B3); a low density deposit, typical of finer grained sediment is found near the stern of the vessel (B2). At B1A, mid-ship and shoreward of the hull, a coarse higher density deposit fines downward through the sampled section. The density profile for B2 was used to compute the natural seafloor effective overburden stress above consolidation test samples.

Figure 10.11. Wet bulk density of samples taken at borings B1A, B2, and B3.
