Project Title: Squaw Mooring Installation

Project Summary:

In January 1977, the Chesapeake Division, Naval Facilities Engineering Command (CHESNAVFACENGCOM) was tasked by the Public Works Center (PWC), San Diego to reinstall the sonar target *SQUAW*. *The SQUAW* is a 134.6 foot long 409-ton model experimental submarine hull which has been used by the U. S. Navy since 1959 as a sonar target in various locations off San Diego, California. The Squaw submarine mooring had failed three times since it was first moored in 1959 never lasting longer than five years.

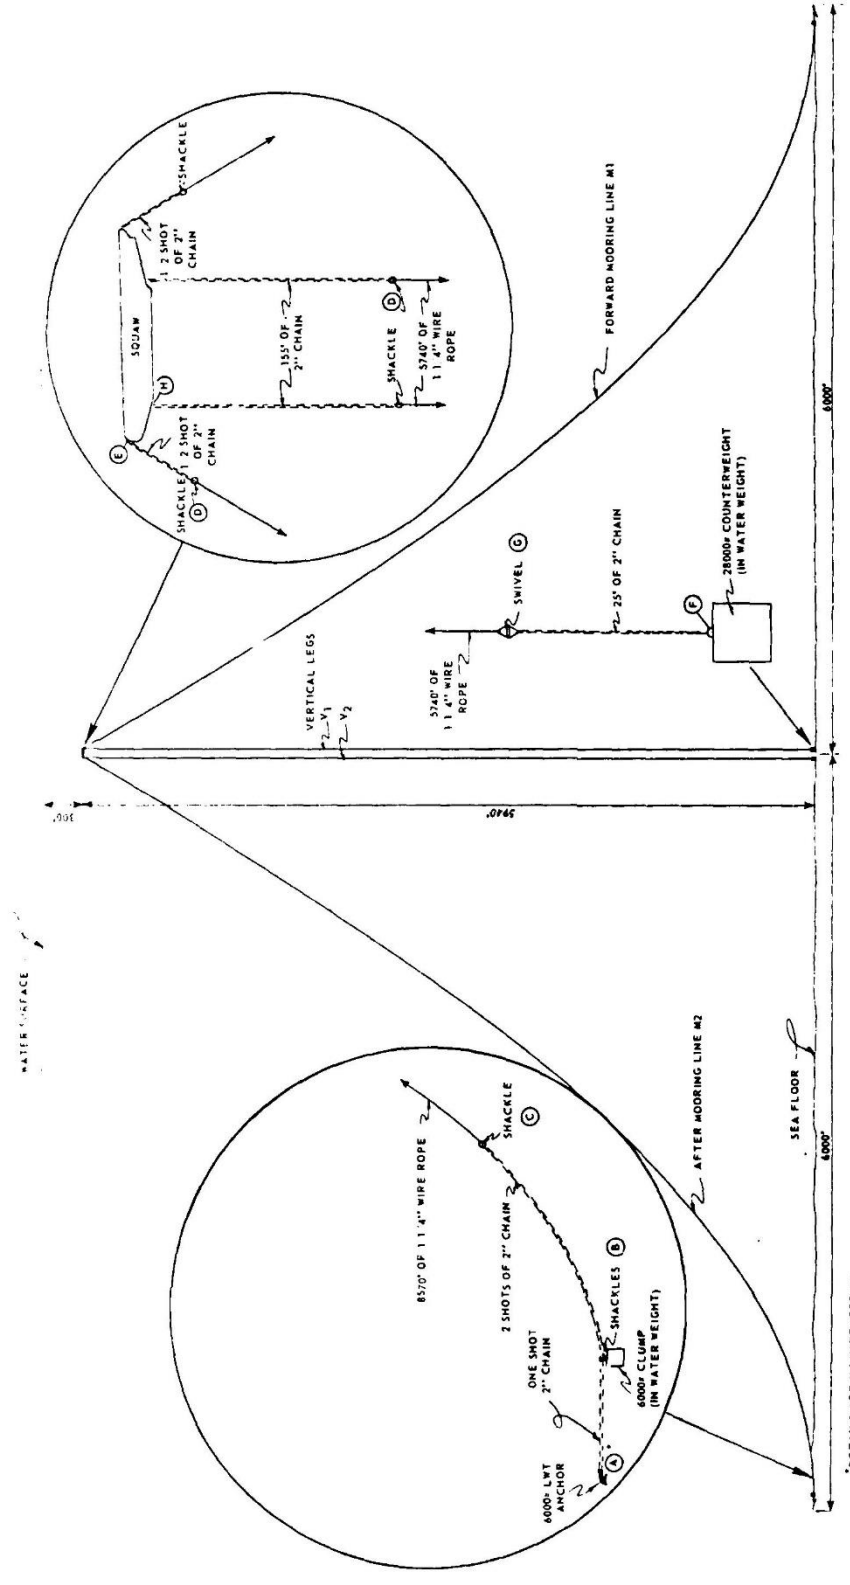
SQUAW MOOR COMPONENTS
FIGURE 3-2A

DETAILS ARE ILLUSTRATED IN FIGURES 3-2B AND 3-2C

The SQUAW mooring system consisted of four legs aligned in one plane. Two legs are suspended vertically from the hull, each to its own clump or counterweight. These counterweights resist the major part of the vessels reserve buoyancy and hold the *SQUAW* at a submerged depth of 300 feet. Two additional mooring legs are included to resist fore and aft excursions. These legs form catenaries and also add to the vertical force opposed by the vessel's reserve buoyancy. Anchor spread was on the order of two nautical miles. The mooring was designed with a projected life in excess of five years. A substantial effort in the design was made to optimize the installation to preclude overstressing components before the mooring is set. The environmental loadings on the system are highly predictable in that the *SQUAW* is submerged 300 feet. Significant safety factors over the submerged conditions were included. The highest stresses occur during the installation phase; hence the greatest effort was made to optimize this installation. The various legs were installed separately with no interdependence during installation. The mooring system life is dependent on proper distribution of loads which is a function of moor geometry. The installation included both underwater navigation and leg tension measurement to ensure that the moor was installed as close as practical to the planned geometry.
