Project Name: St. Croix Underwater Tracking Range Repair/Upgrade

Project Date: 1973-1976

Project Summary:

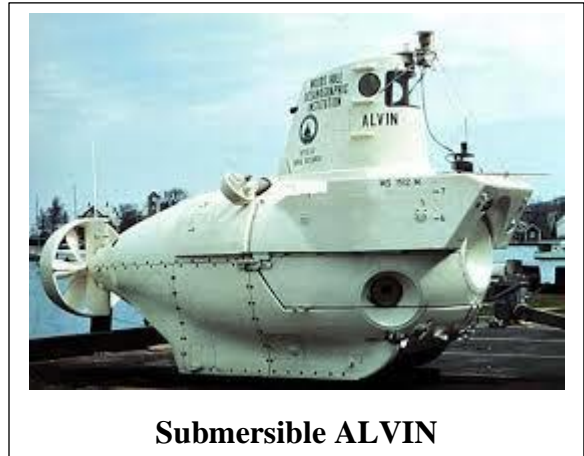
Submersible ALVIN

FPO-1 made seven dives with ALVIN on the five array sites and two other locations that needed to be checked out. On each dive, FPO-1 had two people on board to record observations of the array and cable track back to shore. Lcdr Don Wells and project engineers from FPO-1 were the observers on each dive.

The experience in diving in the ALVIN was quite different from anything FPO-1 had ever done before. The pressure hull is about 7 feet in diameter of which half of that volume is filled with electronics and operating systems. In the remaining space, there has to be room for the pilot who sits in the center to see all the instrumentation and the two observers of about six feet each who lay on a small mattress against the skin of the hull and observe from the small portholes. It is very cramped quarters to get use to. Plus, you're in the submersible for about 8 hours so your better not have drunk any coffee because there is no bathroom. When you start out at the surface, you only are wearing a t-shirt because it is hot in the submersible. When you get to the bottom it is cold so you bring along layers of clothing to keep you comfortable. To go down, the pilot opens the ballast tanks to take on water to make the submersible slightly negative and you begin your decent to the bottom. Near the bottom, water is pumped out of the tank to make the submersible neutrally buoyant and you cruise

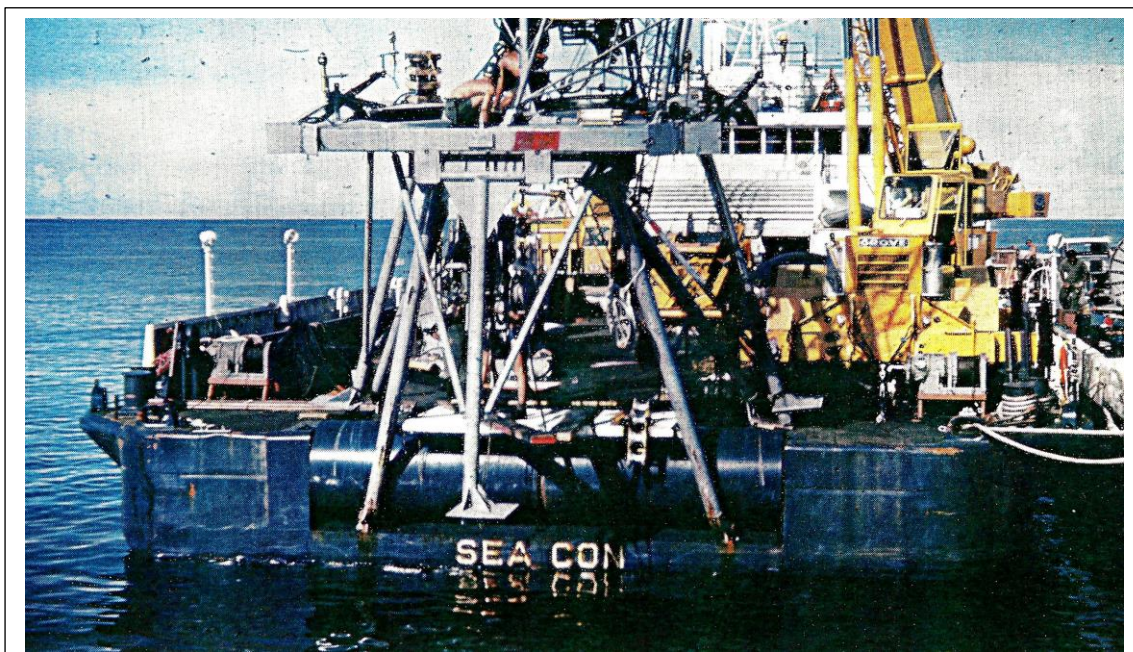
New Hydrophone Array Loaded on SEACON Ready to be Offloaded

Secondly, FPO-1 had to design a new foldable array structure that could be safely handled at sea and opened to its 30-foot cube dimension before lowering it to the bottom. The new array structure would also include newly designed electronics that were more reliable than the
