NAVAL AVIATION

CVE Air Department  
Jap Coastal Defenses

May 15, 1945

## JAP COASTAL GUNS

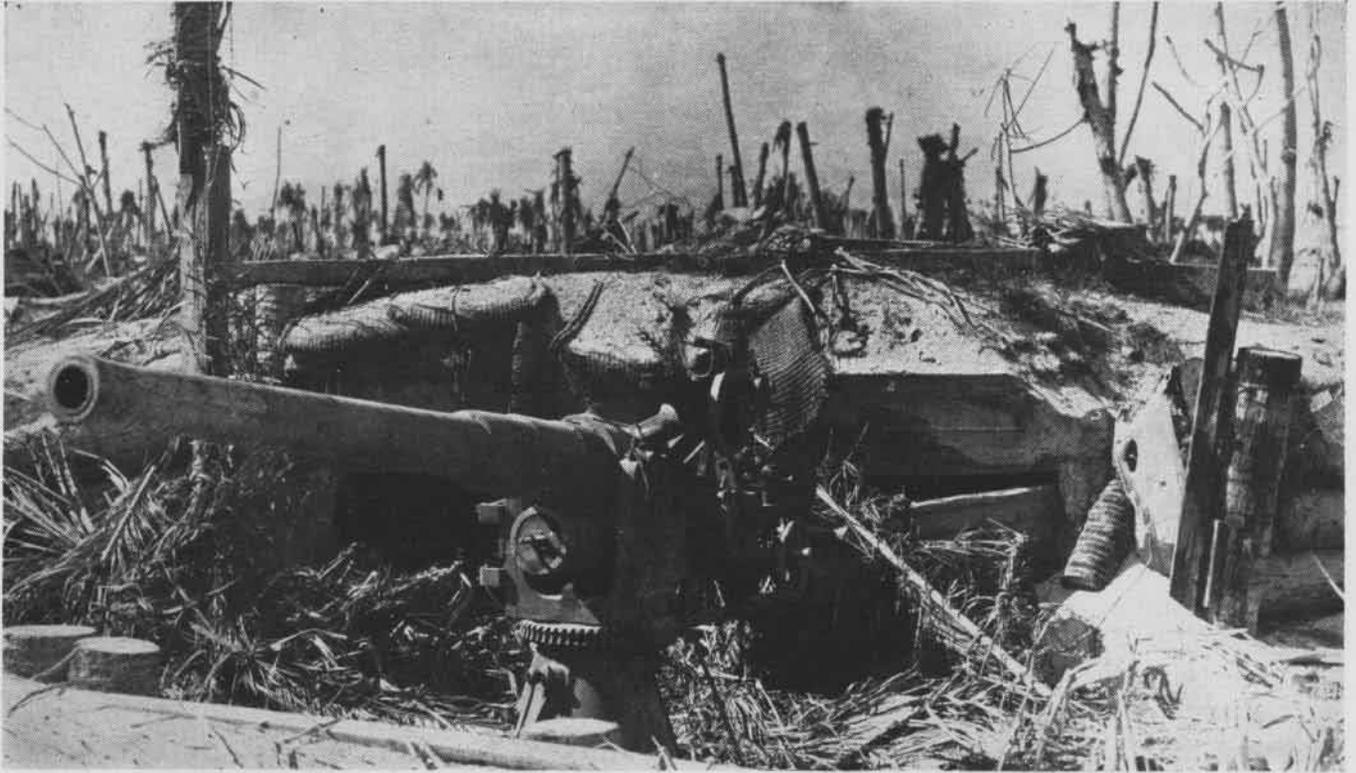
JAP 76.2 MM. COAST DEFENSE GUN WAS PURCHASED ORIGINALLY FROM BRITISH FACTORIES. THE GUN IS POINTED AND RAISED BY HAND

**76.2 mm.** THIS is a naval gun which was purchased originally from British manufacturers (Armstrong, Whitworth and Co., and Vickers). The Japanese also produced copies of it at Sasebo Naval Arsenal. It is used on Jap cargo ships and transports.

The 76.2 mm. is laid out in batteries of one, two and three guns situated to defend beaches or harbor entrances. Revetments usually are square covered emplacements, measuring approximately 16' x 16'. On one island, hexagonal revetments with an inner diameter of 16' were constructed by the enemy, and a palm leaf canopy extended over the emplacement. No external fire control equipment has been photographed in connection with the gun. Firing is done by direct laying with telescopic sights, combined with range scales. The 76.2 mm. is on a fixed pedestal mount and has no shield. Overall length, including breech is 11' 3".

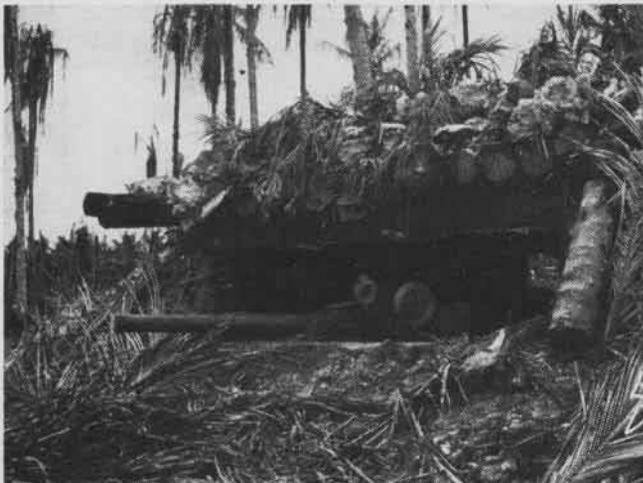
COCONUT LOGS AND ROCKS COVER THIS 76.2 MM. EMPLACEMENT

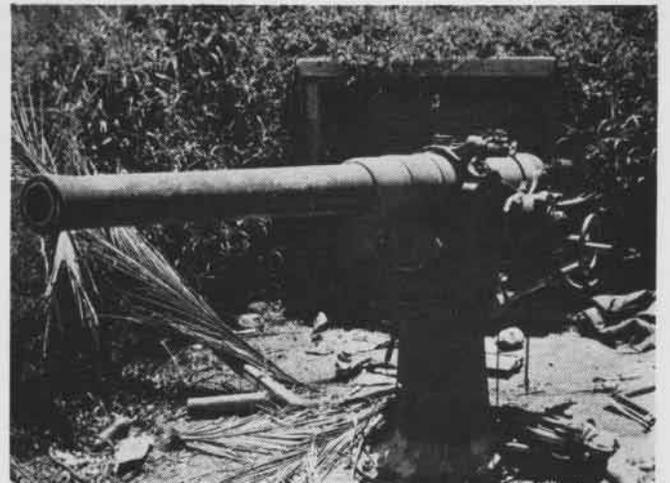
JAP COPY OF BRITISH GUN APPEARS SIMILAR TO THE ORIGINAL

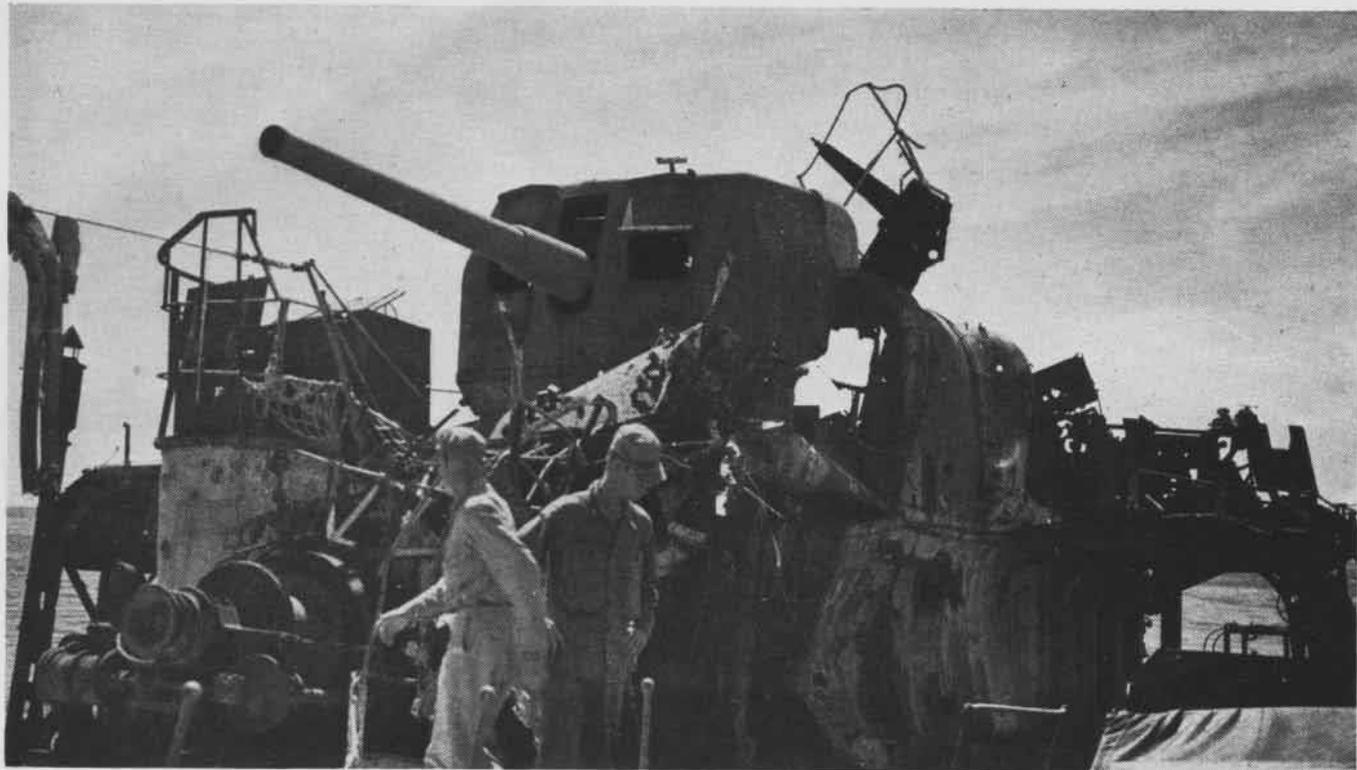
120 MM. NAVAL GUN, FOUND ON DD'S OF MINEKAZE, WAKATAKE AND MOMI CLASSES, OFTEN IS USED ASHORE FOR COAST DEFENSE WORK

THE JAP 120 mm. .45 caliber coast defense gun is a naval weapon found on destroyers of the *Minekaze*, *Wakatake* and *Momi* classes. It is emplaced ashore with or without a shield. Batteries of 120's on land usually consist of one, two, three or four guns laid out in a straight line along the coast. Open revetments measure from 20' to 25' in inner diameter, and covered positions are approximately 10' x 10'.

No external fire control has been used in captured batteries. Firing was conducted by direct sighting (telescopic) combined with range scales. The weapon has a pedestal mount. An 8' x 3' shield sometimes is found on the 120, but often the Japs remove it. Overall length of gun, including breech mechanism, is 18' 4".

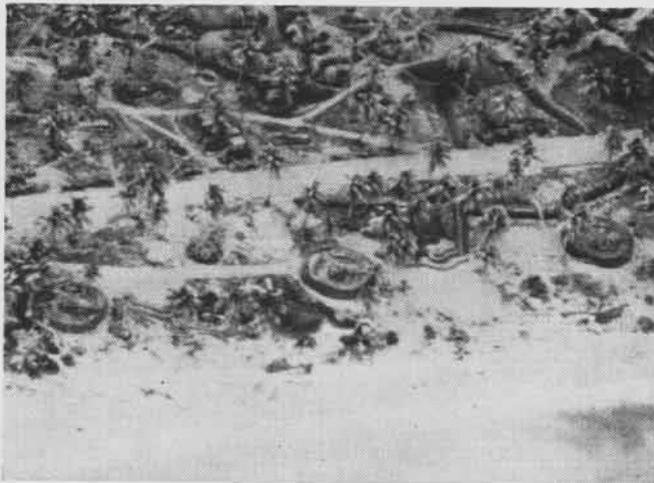
BATTERIES OF 120'S ARE IN STRAIGHT LINE ALONG THE SHORE

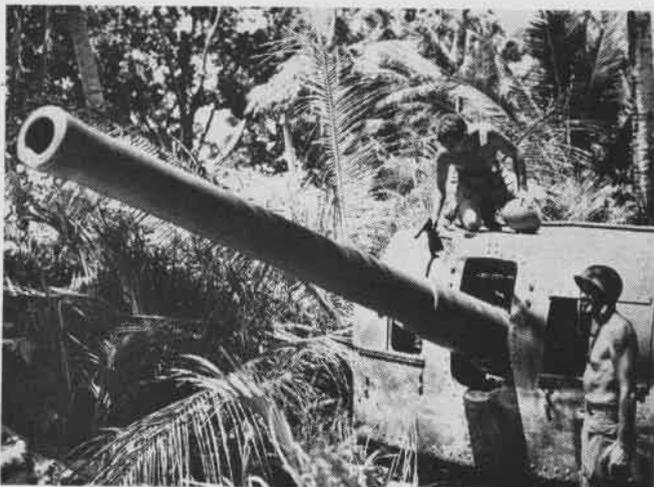
PRESENT HERE, THE SHIELD OFTEN IS REMOVED IN OTHER SITES

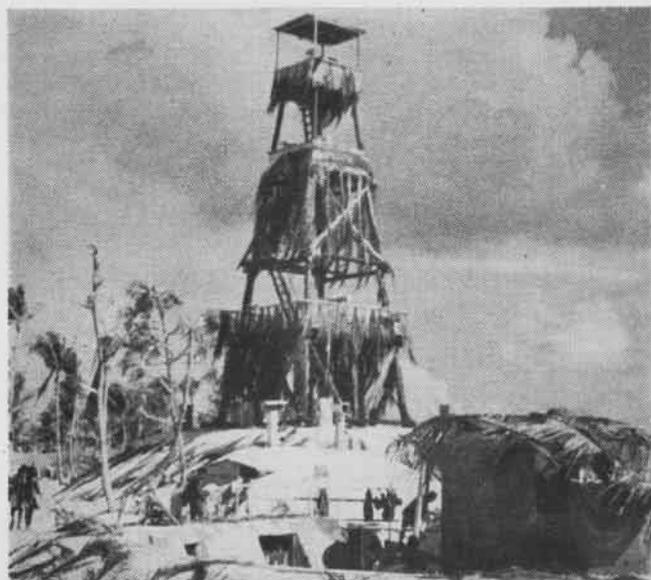
OBSERVATION TOWER OFTEN IS BUILT NEAR THE 140 MM. CO GUN

**140 mm.** THIS is a naval gun which is mounted on Jap battleships, carriers, light cruisers and submarines. It is used also on land and is the most frequently found Japanese coast defense gun to date. The shield often is removed when the 140 mm. is mounted ashore.

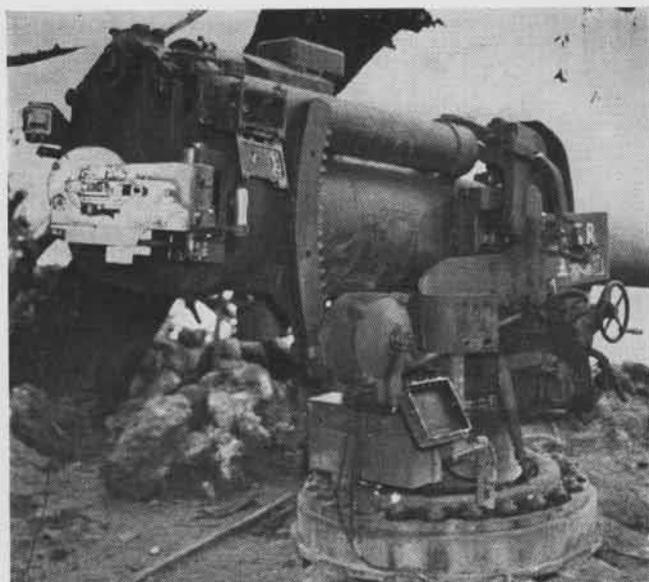
140 IS THE MOST FREQUENTLY USED ENEMY CO WEAPON TO DATE

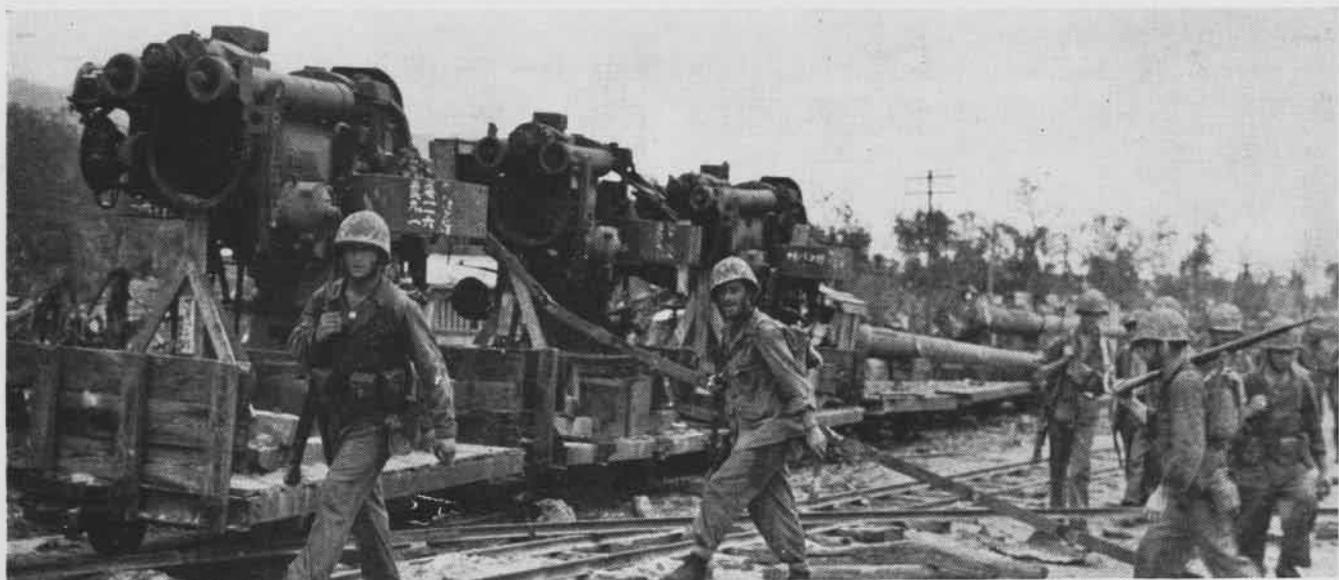
THESE 140'S, CAPTURED UNASSEMBLED ON FLAT CARS IN THE MARIANAS, NEVER HAD OPPORTUNITY TO FIRE ON AMERICANS

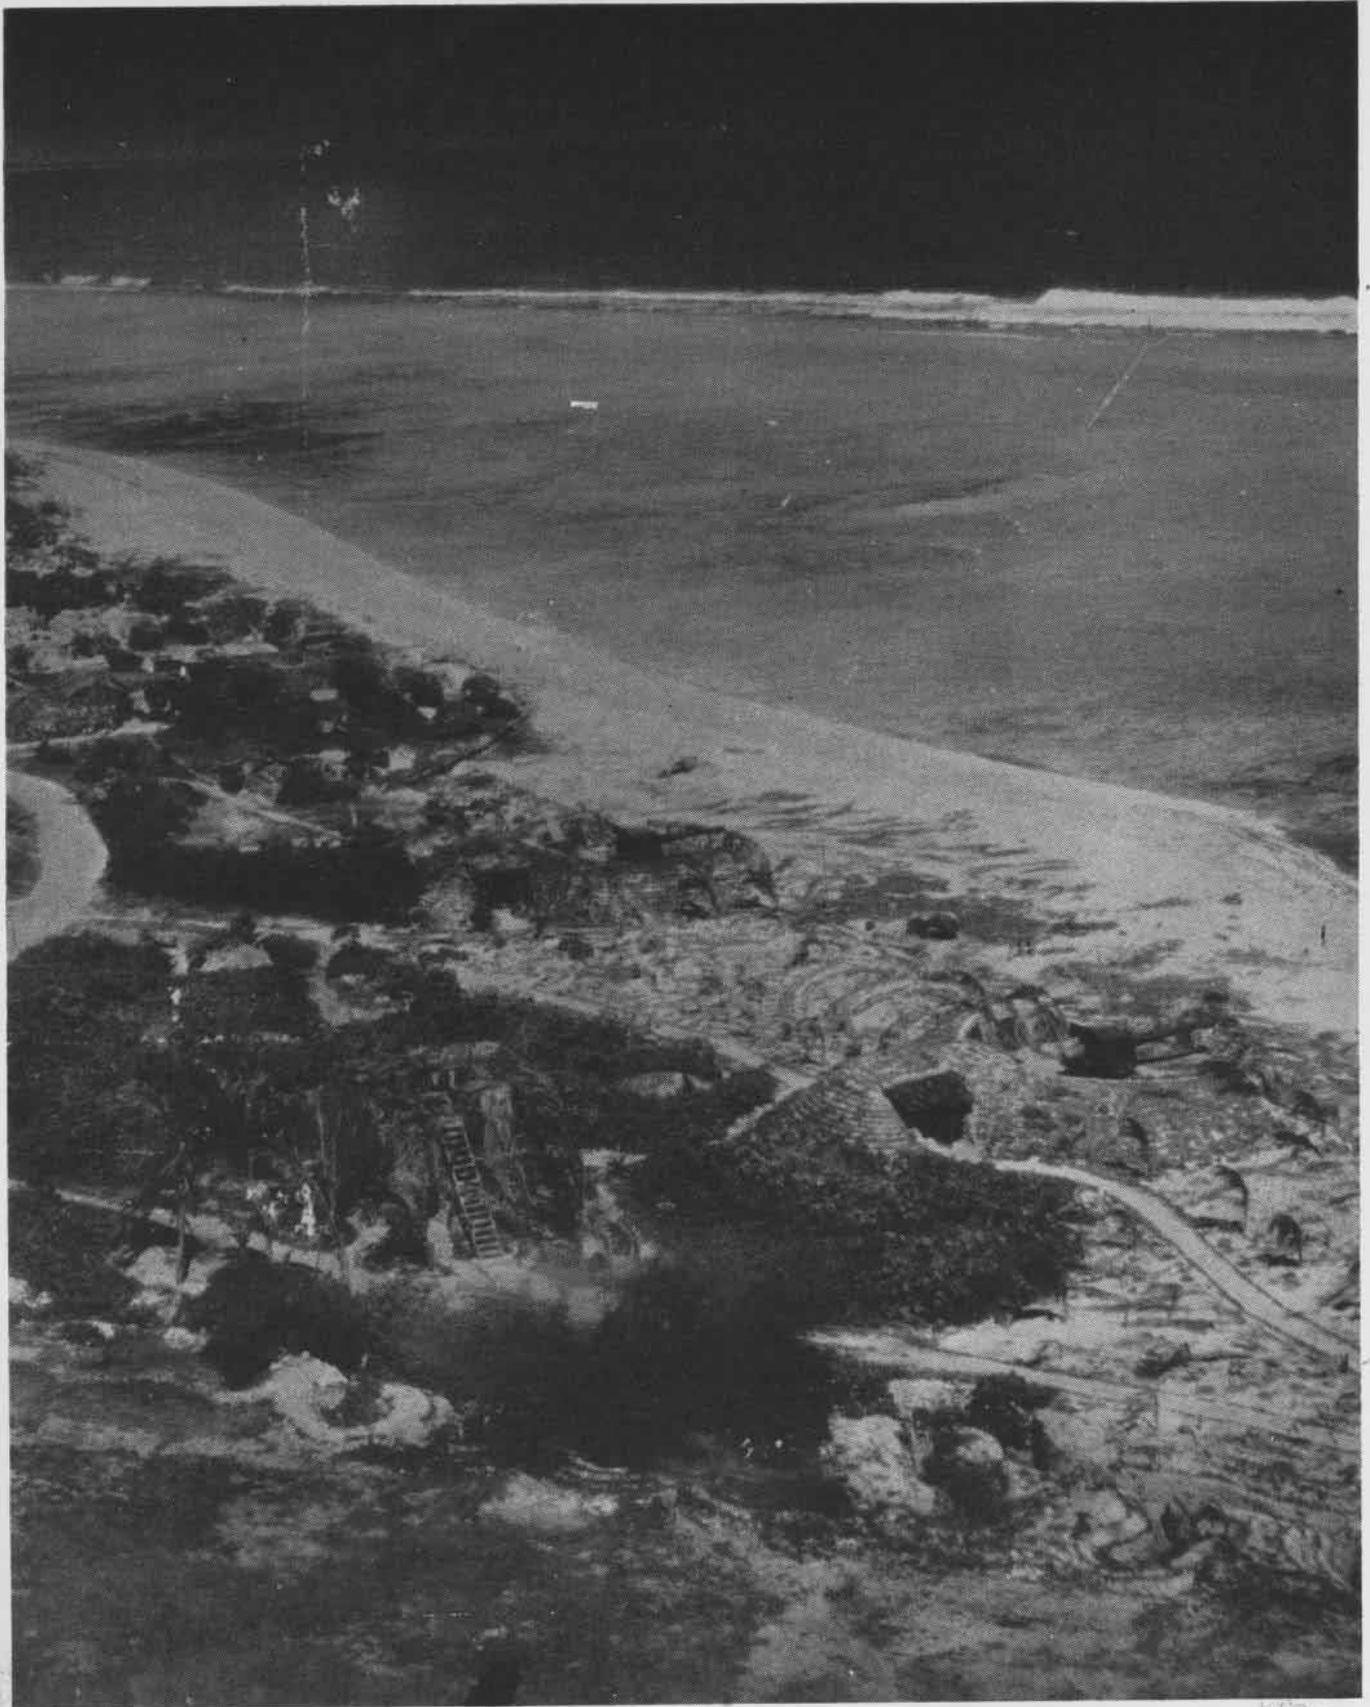
Japanese 150 mm. coast defense gun battery has three revetments in straight line along shore (third revetment is at extreme right and cannot be seen). Fire control building, which has camouflaged range finder on top, is located centrally at rear of revetments. A hit has been made on gun pits in foreground. Japs appear to have set palm fronds in sand and to have attempted camouflage on revetments and fire control building, but white

paths and large gun shields make this battery conspicuous from the air. Revetments have covered section in rear, which probably is for ammunition storage. This section can be entered by a visible outside door with a small shed roof over it. Breeches of guns project well beyond shields. There are landing obstacles and apparently some barbed wire on the beach. This type of low oblique photo, sometimes hard to get, reveals much about defenses.

**150 mm.** THE JAP 150 mm. CD was purchased originally from the British (Armstrong, Whitworth & Co.—Model 1900), and it has been copied by the Japs at Kure Naval Arsenal. It is used afloat and ashore. Land batteries consist of two, three or four guns, usually arranged in a straight line, with centrally located fire control building and range finder. The 150 has been captured in circular revetments, with an inner diameter of 26' to 30', and also in covered emplacements.

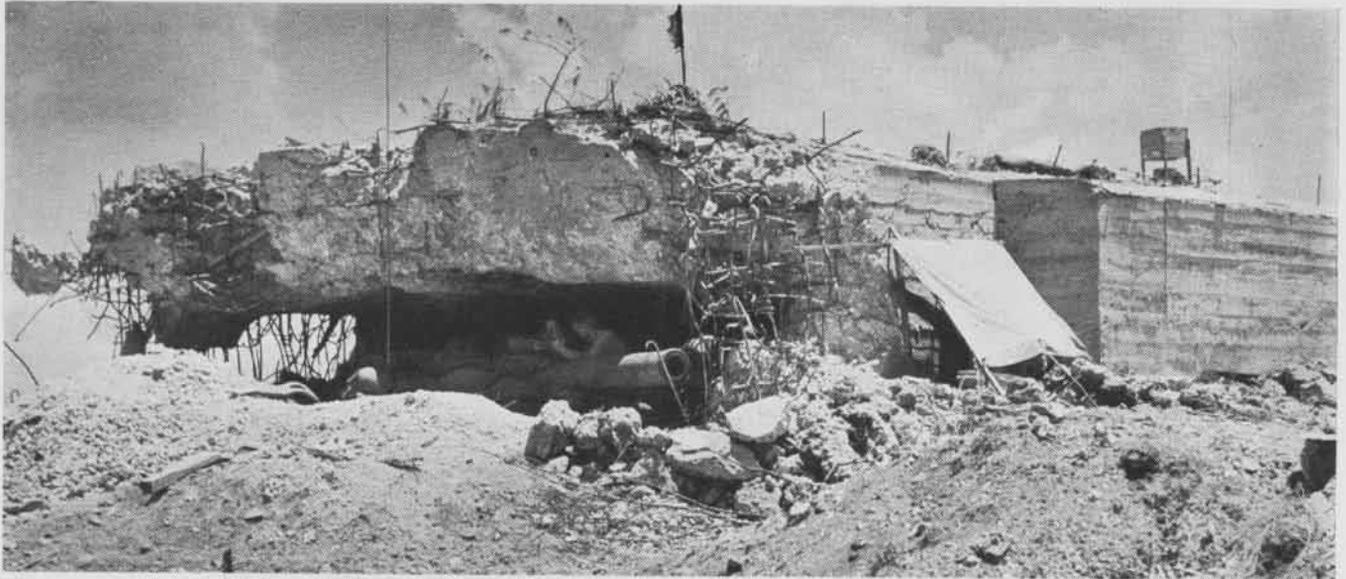
HEAVY REINFORCED CONCRETE EMPLACEMENT COVERS JAP 150 MM. COAST DEFENSE GUN ON SAIPAN, MAKING IT A DIFFICULT TARGET

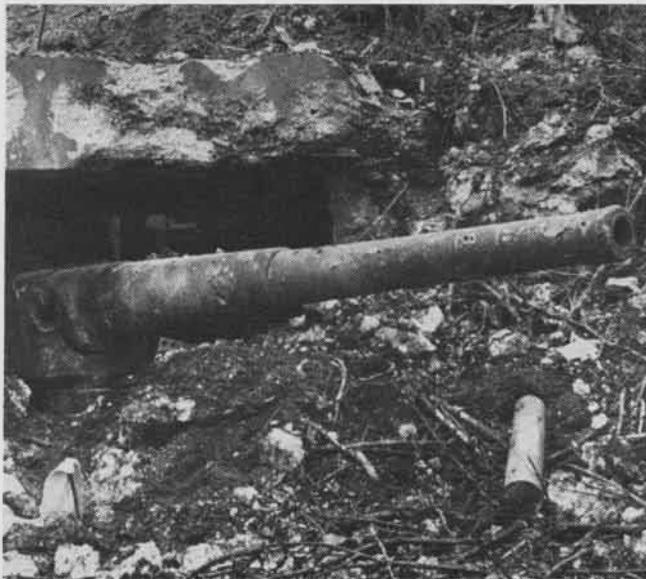
150 POKES OUT DANGEROUS NOSE FROM TINIAN EMPLACEMENT

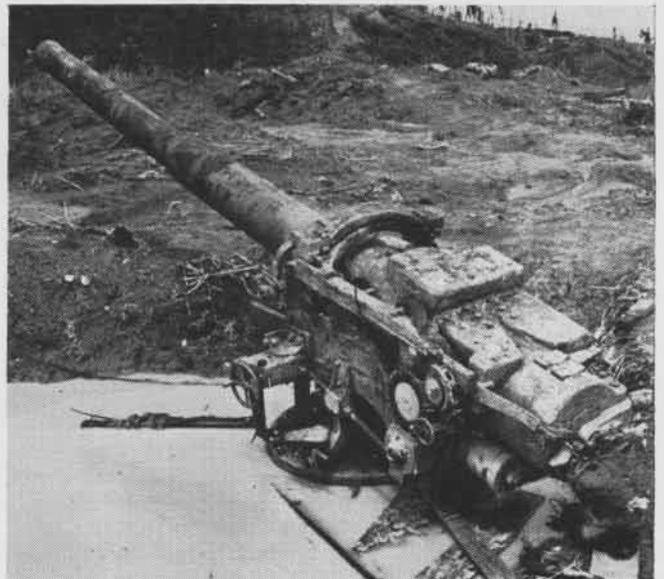
NEW, LONGER TYPE OF 150 MM. WAS TAKEN FROM JAPS ON GUAM

but less is known of it. It appears to be of British design. Three guns were in each of the captured batteries, and revetments were 31' in inner diameter. A 4.5-meter range finder was used. The weapon had a pedestal mount, no shield, and was considerably longer than the Jap 150 mm. CD guns that had been captured at other enemy strongholds.

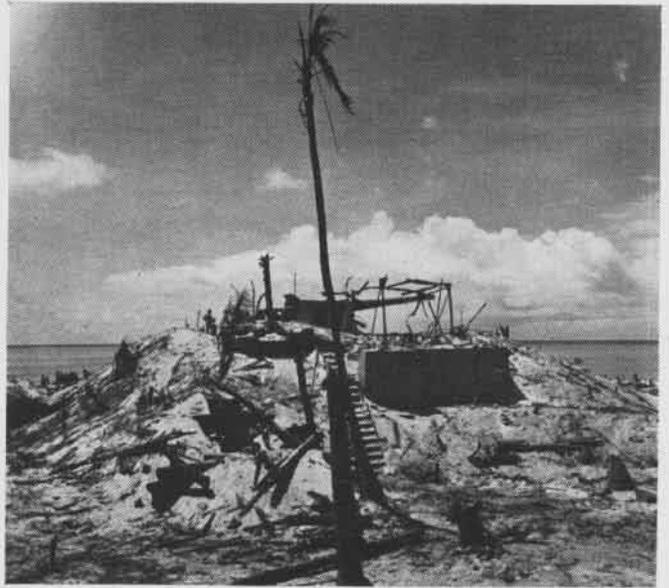
THIS 200 MM. PROBABLY WAS LOOTED BY JAPS FROM SINGAPORE

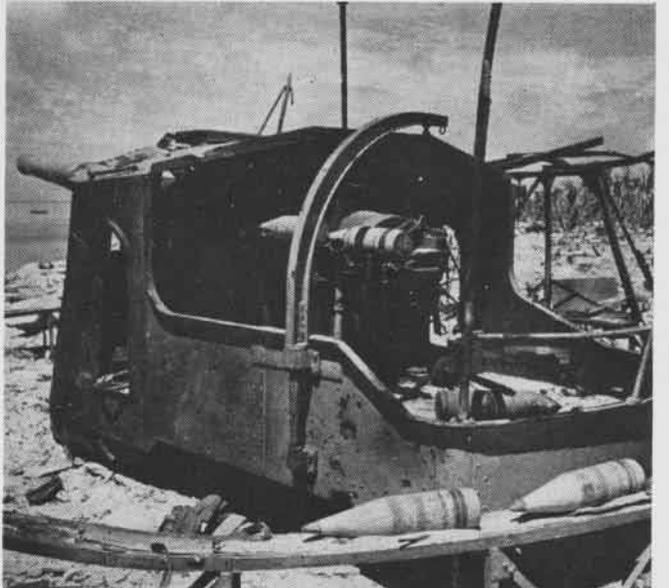
12-INCH STEEL AMMUNITION TROUGH ALMOST ENCIRCLES JAP GUN

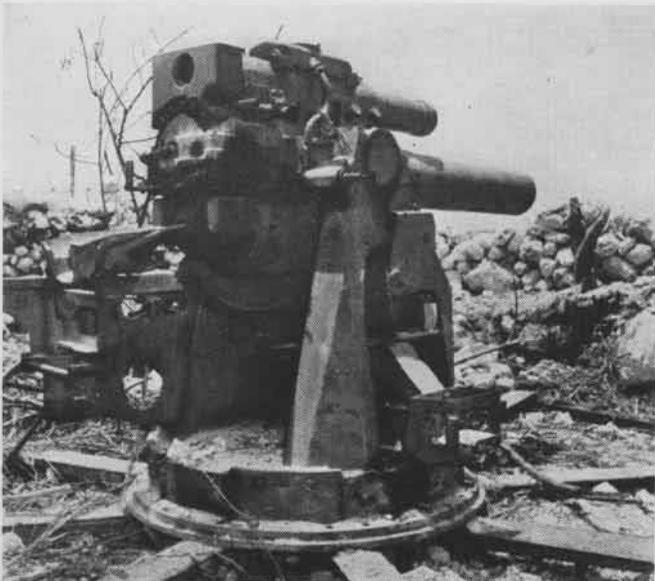
200 MM. HOWITZERS ARE USED BY ENEMY FOR COAST DEFENSE

Considerable use of howitzers for coastal defense has been made by the enemy. A 200 mm. heavy CD howitzer is the principal one encountered thus far. Batteries of these, usually consisting of two guns, are located at strategic beaches and used to fire on landing boats. Concrete covered emplacements normally are built, but some howitzers are found in open revetments. Other positions are built into hillsides and cliffs. No external fire control has been identified with this weapon. It has a pedestal mount, no shield and is short, overall length including breech mechanism amounting to only 6'8". A swinging-arm loading mechanism is located at the rear of the howitzer on the left side.

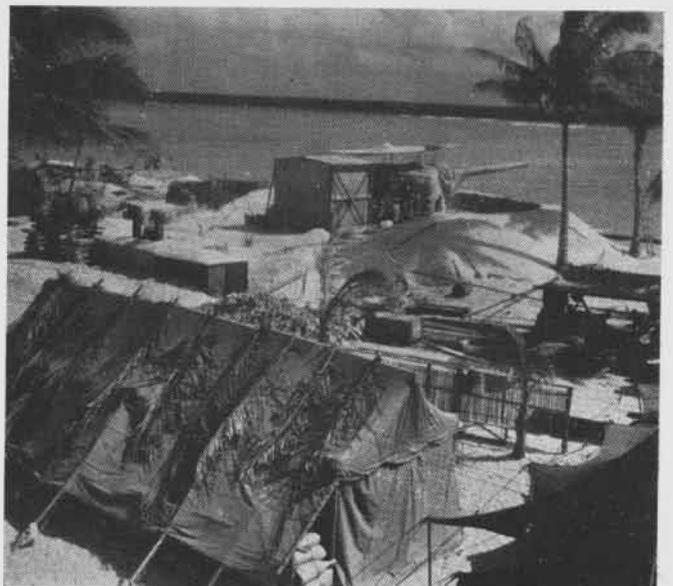
CAPTURED PHOTO SHOWS CANVAS AWNING OVER 200 MM. SHIELD

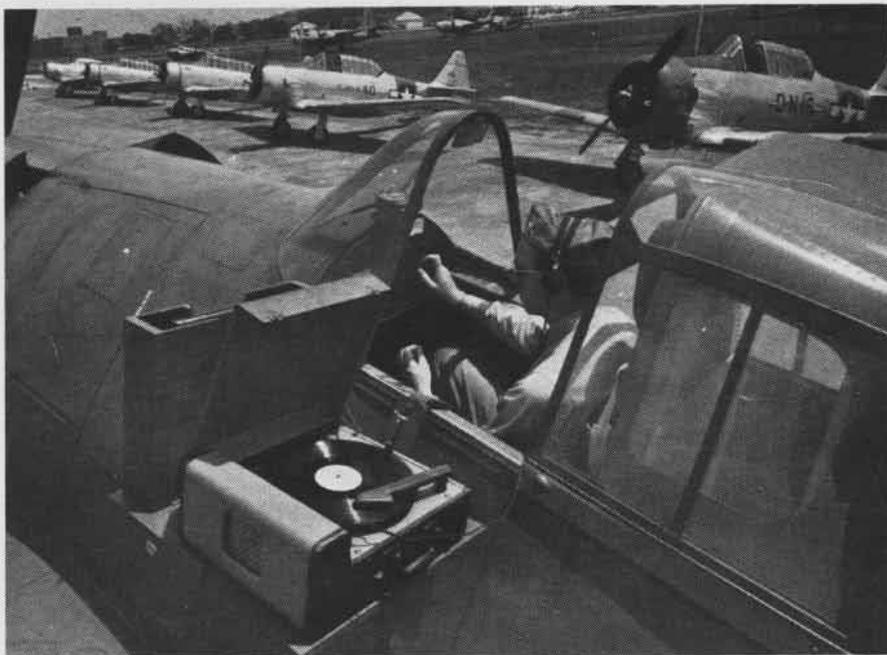
COCKPIT CHECKOUT recordings, developed by BuAer's Special Devices Division, assist flight personnel to check out in various types of aircraft in Cockpitainers or in the operational aircraft itself. A shelf is hung over side of cockpit to hold album and phonograph. A headset is provided for individual instruction. A loudspeaker may be used for large groups. Recordings have been prepared for almost all types of naval aircraft.

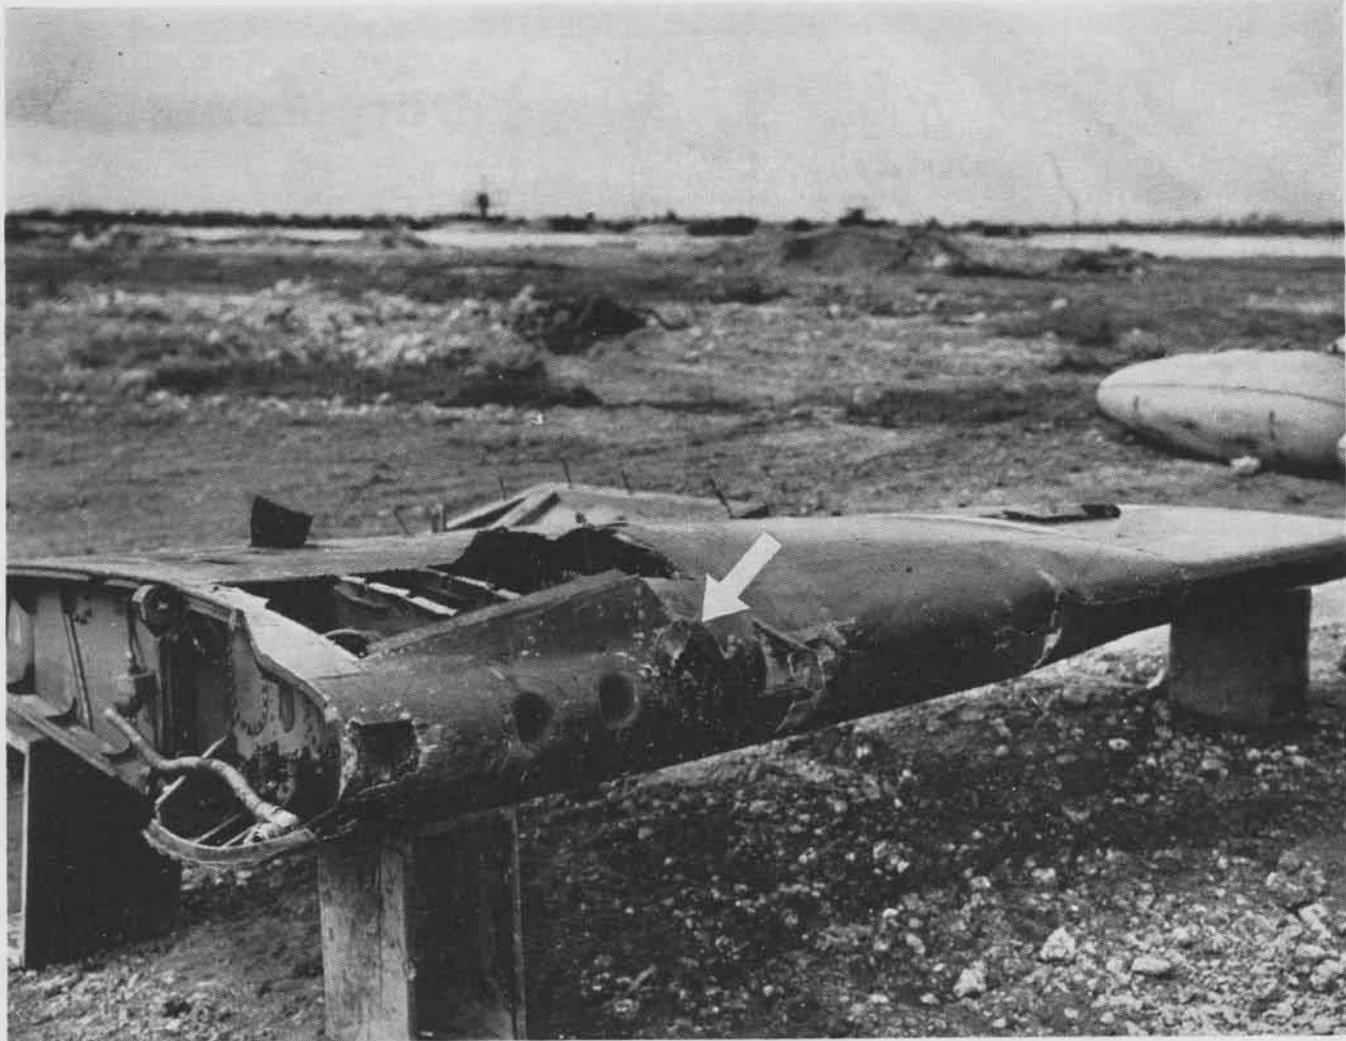
CORSAIR WING SHOWS DAMAGE DONE BY OVERHEATED GUNS WHICH THREW BULLETS OUT BLAST TUBE, CAUSING EXPLOSION IN WING

In a recent test the "critical barrel temperature" was exceeded and a projectile tumbled into and through the blast tube within 14 inches of the end of the barrel. It is felt that this is the cause of most of the blast tube trouble and wing explosions being reported, especially on airplanes being used extensively for strafing.

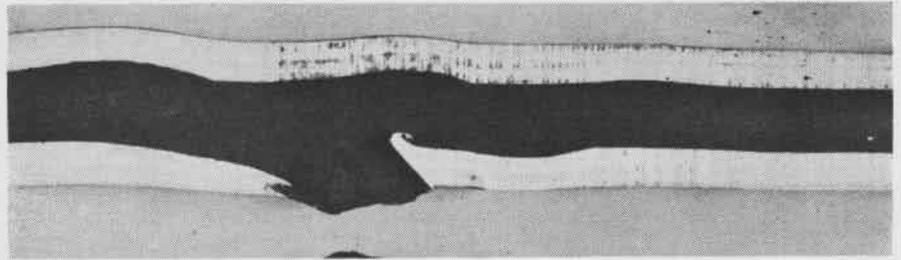
.50 CAL. GUN BARREL IS SO DEFORMED BY OVERHEATING THAT BULLETS GO OUT SIDE

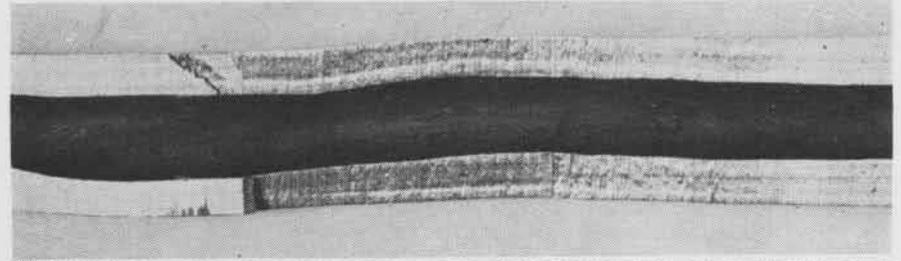
OVERHEATING OF BARREL CAUSES IT TO BULGE: FIRST 125 ROUNDS ARE MOST ACCURATE

The loss of good effective fire power and occurrence of actual tumbling which can be observed in tracers when firing, does not occur at the same instant. The barrel temperature has to rise to a higher degree to cause observable tumbling which accounts for certain test figures showing, for example, 150 rounds fired before tumbling occurred.

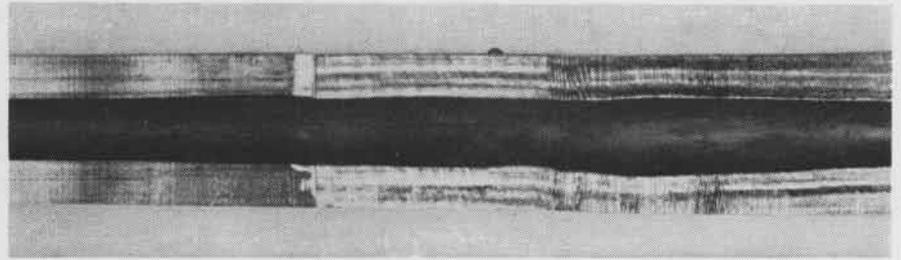
NEW BARRELS CAN BE FIRED MORE TIMES THAN WORN ONES; 900 DEGREES IS CRITICAL

The "critical barrel temperature" for a new barrel is approximately 900° F. and for barrels worn .020 inches it is only 600° F.

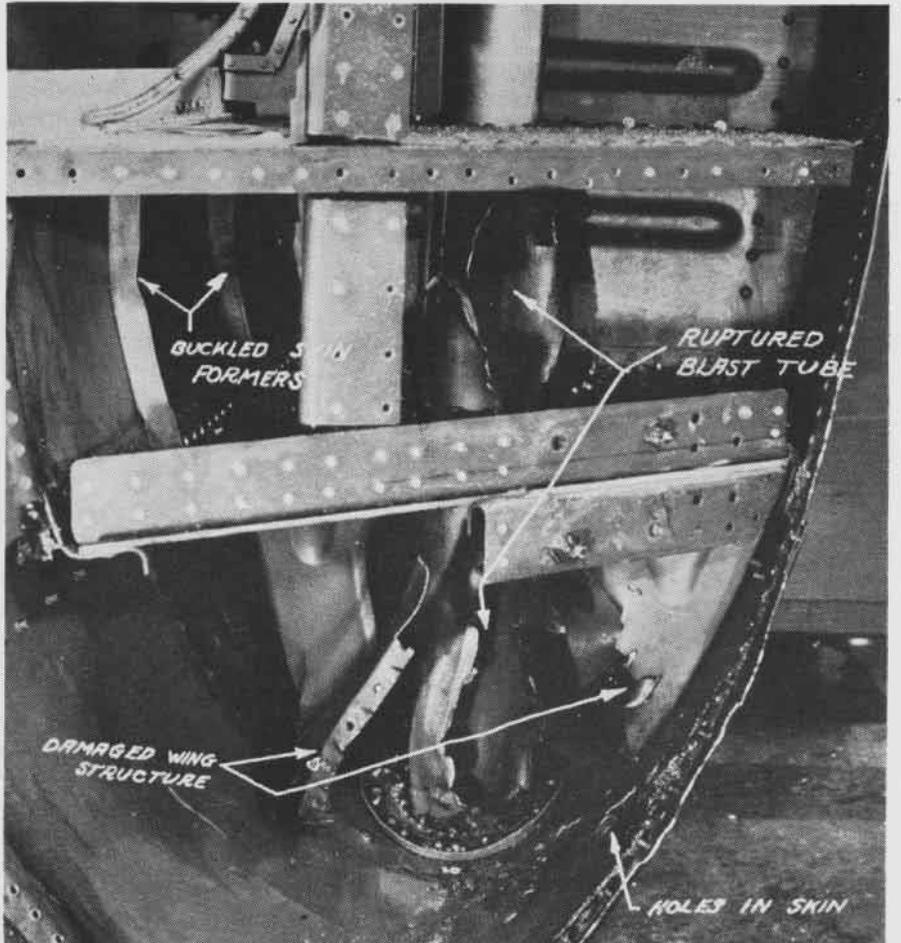
CROSS SECTION OF WING SHOWS RUPTURED BLAST TUBE CAUSED BY TUMBLING BULLETS

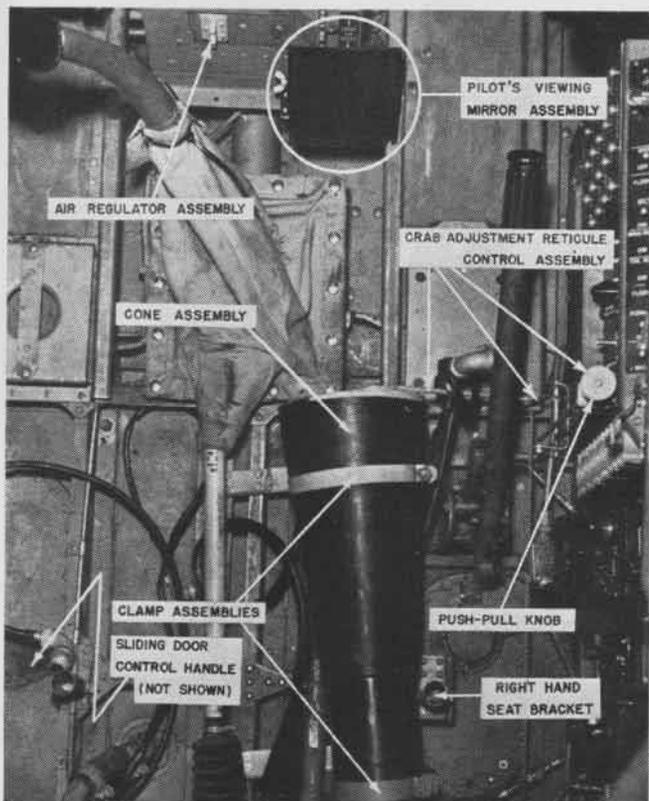
Vertical view of cockpit with pilot's seat removed shows location of pilot's viewing mirror and cone assembly next to stick

Pilots will be materially assisted in maintaining a flight line over a desired area when using this new installation. Since the real image of the area being photographed is formed in the retina of the pilot's eye, the necessity for a ground glass is eliminated, which provides for a much more brilliant image. The image viewed also moves in the same direction as the ground being photographed, which is less confusing than the standard viewfinder where it is reversed. The angle of view is 52 degrees and allows sufficient lead to see the approach of the target.

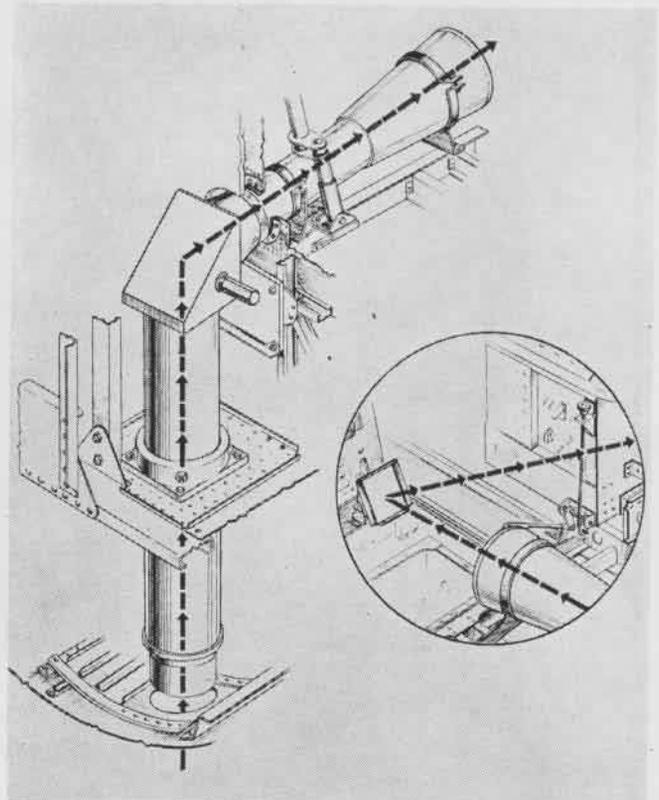
Three lens assemblies and two mirrors in this aerial view finder bring an image of the ground directly below to pilot's mirror

ter only through a silica gel dehydrating plug, although air is allowed to circulate within the finder by means of air vents. This acts as a preventative to condensation of moisture, due to changes in temperature and altitude, on the lens and mirror assemblies.

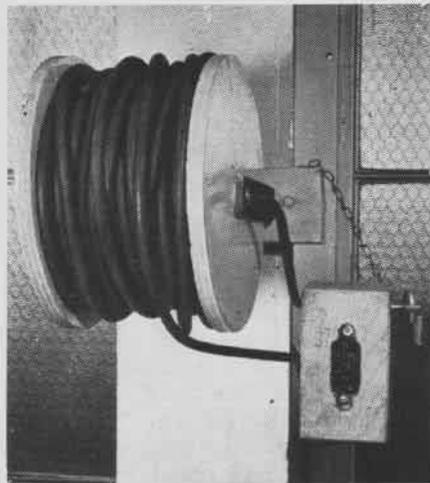
HEDRON 9-1—Electric extension cord reels, using a detachable reel, have been installed throughout this squadron's hangars. Nine reels with double outlets on 100 ft. extension cords cover

REEL HOLDS 100 FT. OF EXTENSION CORD

the working space and provide ample lighting wherever maintenance work is underway.

The extension cord reel system has saved materials, wire and electrical fittings. Prior to installation, cords and fittings frequently were damaged and mashed on hangar decks.

► **BuAer Comment**—Use of electric extension cord reels as developed by HEDRON 9-1 is a good suggestion. Electric reel is well suited for use by CASU's, HEDRON's and shore-based squadrons where a great variety of work takes place and airplanes are moved in and out of hangars at all times. The idea will be adaptable to certain divisions of A&R departments such as radio, radar, repair divisions, maintenance divisions, etc. Other departments of A&R's use cords constantly day and night and the reel would be of less value to them. Advisability of locking the box depends on local conditions. It is not considered advisable for ASO to stock the reel as a standard item since any joiner shop can manufacture it.

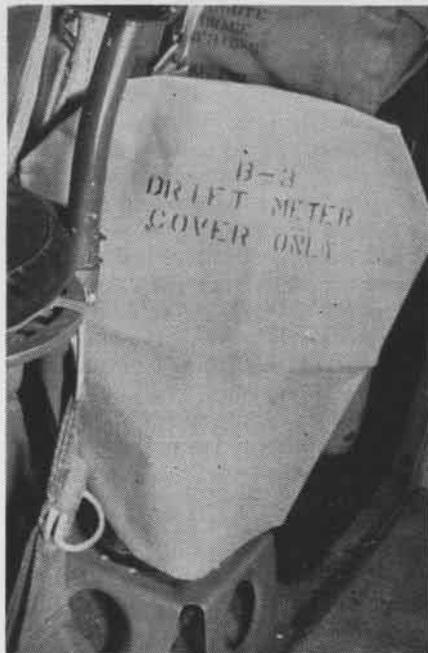
B-3 DRIFT METER COVER PROTECTS SIGHT

the field. The photograph illustrates a drift sight cover made for the PB4Y-1 installation by FAW-2.

BUAER has initiated production changes in PB4Y-2, PV-2, and PBM-5 airplanes to install a protective cover for the B-3 drift sight. It is not proposed to make these changes retroactive as construction of a suitable canvas cover can be and has been easily accomplished in

1. When found desirable, water resistant canvas covers be made locally.
2. A slight amount of padding be added.
3. It be plainly marked "Drift Sight—Keep Covered When Not in Use."
4. It be secured in some manner on or near the sight mounting so that it may not be lost when the sight is in use.
5. Crew members be cautioned not to use the drift sight as a hand-hold and that only authorized personnel handle the sight.

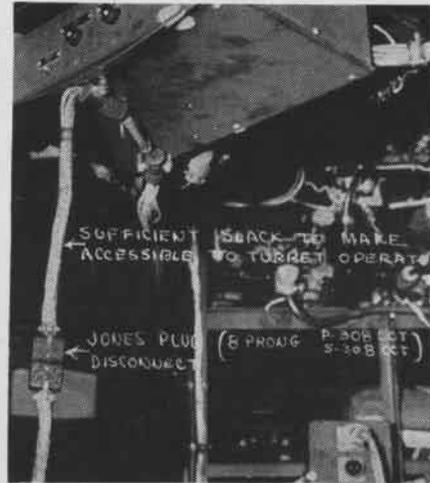
Headquarters Squadron 14-2, Fleet Air Wing 14 reports two instances in the Martin 250CE-17 turret of the PB4Y-2 where the AN/AIA-2 interphone cordage has been broken by operating the tur-

JONES PLUG SERIES 300 IS RECOMMENDED

ret in one direction and winding up cordage until wire parted from the excessive strain.

The HEDRON recommends that a Jones plug, series 300 eight or ten prong assembly, be inserted in the C70/AIA-2 station box cordage to top turret.

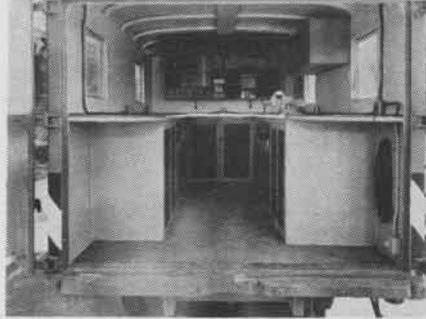
A 1½-ton Chevrolet truck chassis rigged with a van-type body carries three spares for each part of a Link trainer and its automatic device attachments. The van is also equipped with

TRUCK VAN CONTAINS A LINK WORKSHOP

a work shop complete with electrical attachments operated off a 110-volt AC extension. This shop is used for repair work in the field.

The mobile unit maintains a monthly schedule visiting each air station in the district, that possesses Link trainers. Good parts are given in exchange for broken or defective ones. The replaced parts are later returned to the main shop at North Island for repair and eventual re-issue. Three trained maintenance men with the mobile unit give technical assistance or install new parts when required.

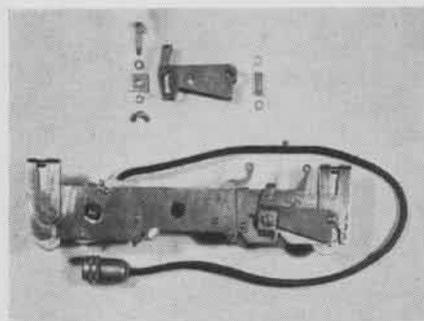
This bracket provides a means for positioning bomb lugs close to the after stops of the shackle at all times. The lugs thus are located close to the open sides of the suspension hooks, thereby obtaining greatest possible hook-opening moment and effecting bomb release before the extension of the forward hook has rotated sufficiently to strike the bomb body. Tests show that with the use of the bracket, positive release is obtained at dive angles up to 70° rather than at the maximum angle of 30°, for which the shackles were designed.

SIMPLICITY OF INSTALLATION IS FEATURE

The bomb lug displacing brackets, discussed in NAVORD OMI V19-44, for improving the bomb release characteristics of Bomb Shackles, Mark 4 and Mods, now are available. Release failures and excessive release lags are being encountered when bomb lugs bear against forward stops of bomb shackle at the instant of release.

install them as soon as practicable. Installation is quite simple and requires only a few minutes for each shackle. They are available at all major supply points under stock No. 3-B-2625-250, and each bracket is packaged complete with all necessary parts for assembly to the shackle.

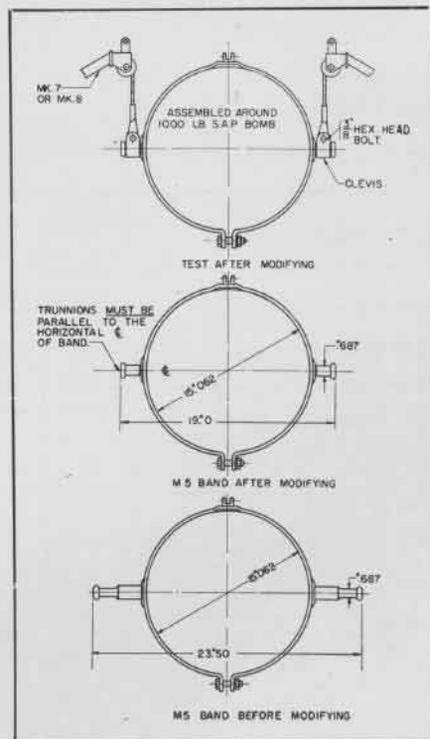
equipped to provide either one displacing gear that will engage trunnions having 23".5 spacing or two displacing gears having forks designed to engage trunnions of 19".0 spacing. By modifying the trunnion band, M5, so that distance between the ends of the trunnions is reduced from 23".5 to 19".0, it is possible to install two 1000-lb. SAP bombs in the SB2C.

MODIFICATION MAKES TRUNNION SMALLER

At present, the distance between the ends of the trunnions on this band is 23".5, which permits engagement with displacing gears having forks with a similar distance between them. SB2C type aircraft are

No work should be attempted on the trunnion band, M5, until the band has been removed from the bomb. Using a hack saw, cut trunnion from band as close as possible to the weld, then grind or file smooth the surfaces of the band where trunnions were cut off. Machine or grind the base of each trunnion until its overall length is reduced to 1".718. Then shorten trunnions by butt-welding to the trunnion band, making sure they are in correct alignment and that distance between ends of the trunnions does not exceed 19".0. Check band for proper fit in displacing gear forks.

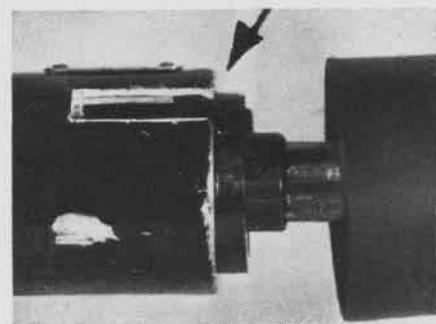
Reports reaching BuOrd indicate that some charger valves on 20mm guns installed in SB2C-3's fail to function properly, owing to an accumulation of rust. Inspection showed the charger valves were rusted so badly they could be actuated only with difficulty and would not "pop

CHECK VALVES REGULARLY. BUORD URGES

Such a condition indicated presence of water in this area, and upon inspection of the plane, it was revealed that water leaks through the opening of the armored access doors, just forward of the windshield, and falls on the valve at this point. It also was found that the rubber cap recently incorporated on the charger valves to protect this unit against dust and moisture is not adequate protection.

As a means of correcting this situation, all activities are urged to have the charger valves checked, cleaned and oiled at regular intervals. One squadron installed deflectors above these valves to turn aside any water leaking through to the gun.

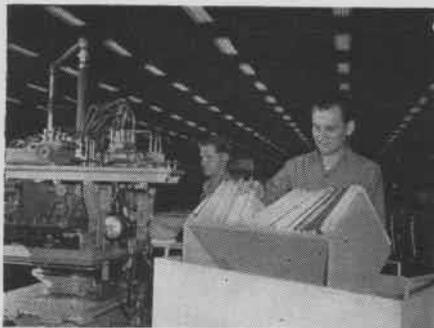
NAS SAN DIEGO—Accessories division of the A&R Department has constructed several rolling book racks which are in use on the floor of the shops. The racks are designed to be rolled easily about the shop, holding technical books at a convenient height. Books are retained by a bar that secures them by passing through punched holes in the lower left corner.

RACK MAKES PUBLICATIONS ACCESSIBLE

NAVAER manuals. The racks were successful in encouraging use of NAVAER overhaul instructions by making them easily available to the men they were written for, men with sleeves rolled up doing the work. The racks also proved to be a great time-saver.

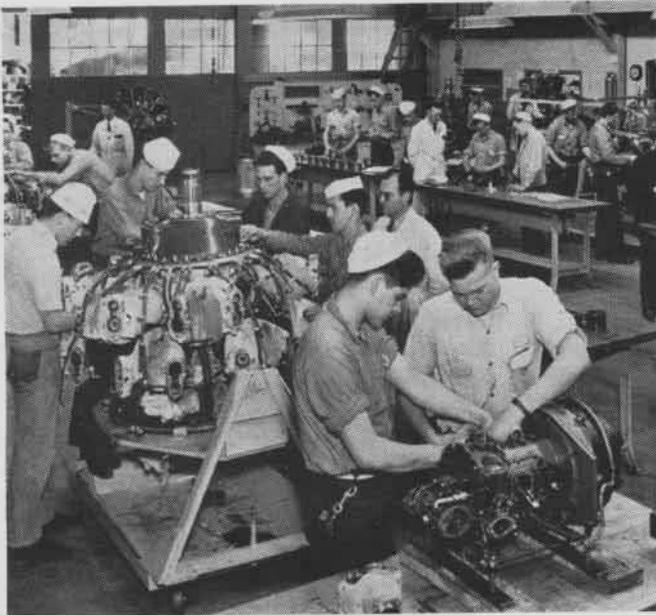
Engine laboratories teardown at NATS line maintenance school teaches the students nomenclature and proper usage of tools

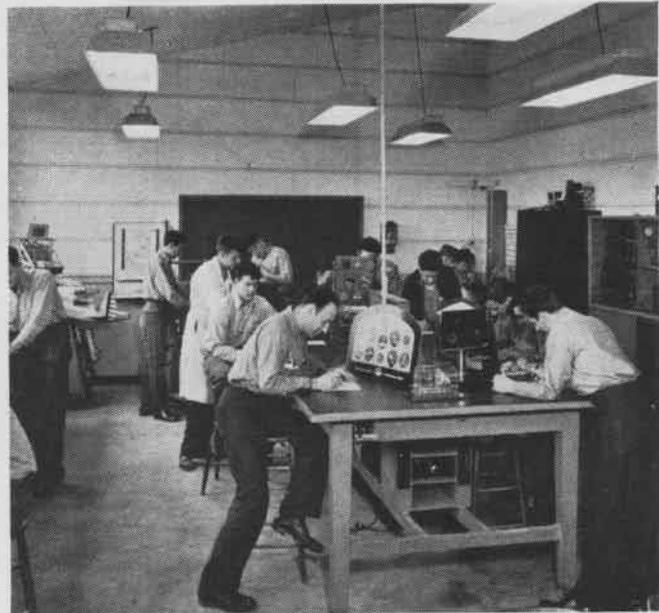
In the instrument laboratory, civilian instructors teach care and maintenance of instruments, how to install and interpret them

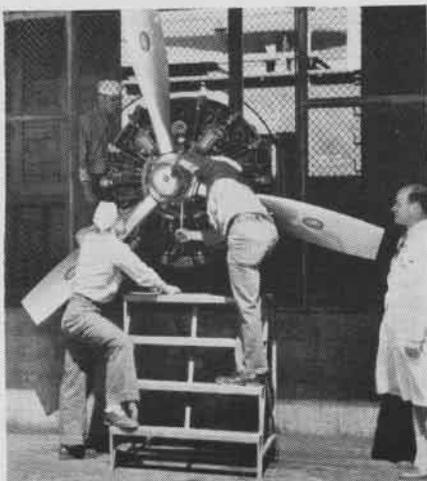
Engine test stand gives students chance to trouble shoot, and perform engine run-ins

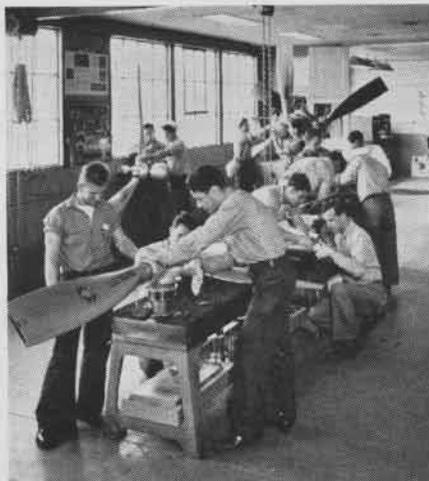
Students disassemble and adjust Hamilton hydromatic propeller, and work on electrics

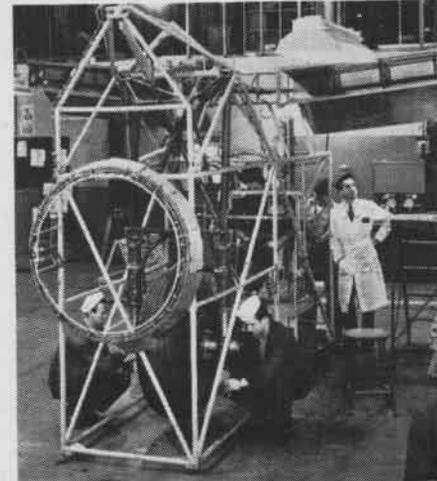
Hydraulic shop gives full training in all phases of system; cutaway helps in work

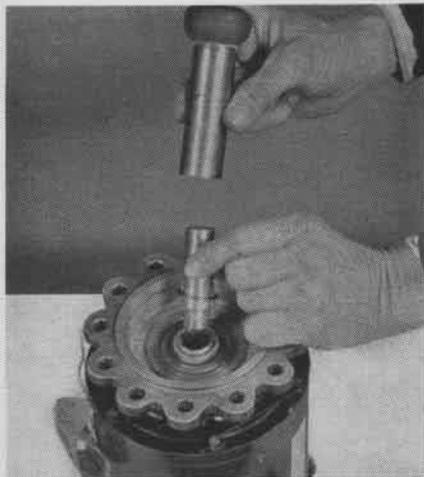
INSTALLATION PROBLEMS ARE ELIMINATED

ring and shaft. These problems have been eliminated by a generator shaft, lock ring for installing P-2 and NEA-3 eclipse generators, and was a suggestion submitted under the Navy Employees' Suggestion Program.

Previous methods of installing lock rings with screw drivers or pliers were unsatisfactory as there was danger of injury to fingers and damage to lock
