NAVAL AVIATION

CVE Air Department  
Jap Coastal Defenses

May 15, 1945

## JAP COASTAL GUNS

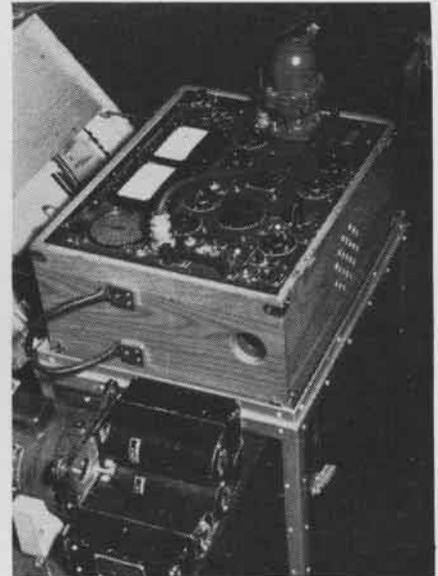
A combination cabinet and stand, constructed of angle iron and masonite with hand-wrought aluminum trimmings, was

DEVICE AIDS INSTRUCTION AND TESTING

built to accommodate various units such as the master motor, contactor, electrical conduits and fixtures necessary for testing.

Since the ST-1300 test rig is a portable unit and was not designed for instructional purposes, instructors at NAVAL AIR TECHNICAL TRAINING CENTER, 87TH AND ANTHONY, CHICAGO, found it difficult to set up the rig for their shop instruction.

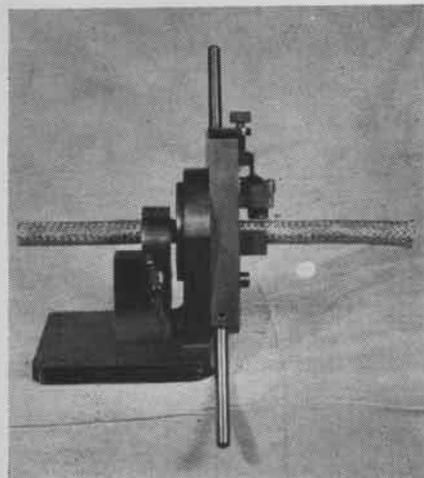
STRIPPING CABLE ARMOR IS SIMPLIFIED

rear is clamped tight in the cable; the v block in front is adjusted to support the cable; then the cutter holder is screwed down until the blade penetrates the armor to the required depth where it is locked in position.

The cutter head is then revolved one complete revolution, completing a cir-

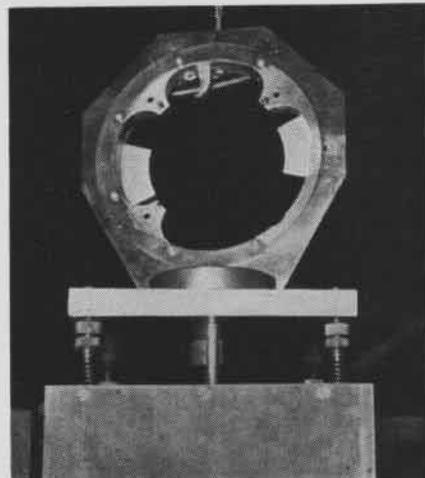
for this purpose. With the gyro thus set the clamps are released by operation of cam lock, and the instrument is now locked in position for work or adjustment.

GYRO MAY BE FIXED WITHOUT REMOVING

reduced to a minimum. Perhaps the most outstanding advantage of this device is that the gyro may be adjusted without removing it from the test stand during the testing operations. This suggestion was submitted under the Navy Employees' Suggestion Program.

It is obvious that by substitution of locating pins in place of clamping screws and by the incorporation of a quick acting clamping mechanism that the time required for positioning and holding the gyro for test operations is
