NAVAL AVIATION

APRIL 1948  
RESTRICTED

# SUPER SPOOK

Some of the engineering highlights of the *Banshee's* development are presented in this article. The information comes from a paper written by Albert A. Utsch, Chief Design Engineer for McDonnell and Vernon Outman, Chief Technical Engineer for M.A.C.—a couple of guys who were there at the time.

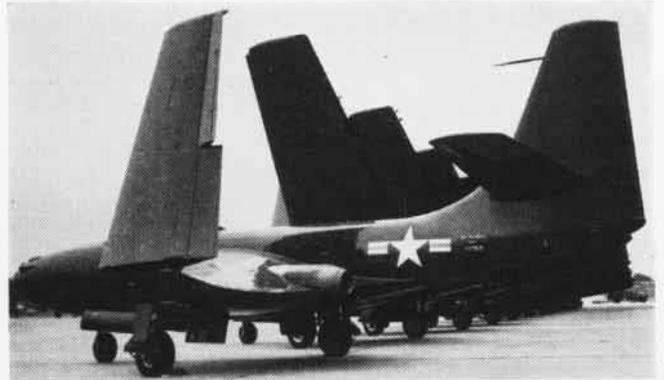
THE BANSHEE FOLDS ITS WINGS IN THE SAME MANNER AS THE PHANTOM

The *Banshee* went farther than just folding its wings to conserve space aboard a carrier. Incorporated on the plane is a unique "kneeling" device. The nose gear retracting mechanism is operated to lower the nose of the plane until it comes to rest on a set of previously affixed casters. This action raises the airplane's tail sufficiently to allow the nose of a similarly-kneeled *Banshee* to be nested under it. The plane is returned to its normal level position by operation of the nose gear extension mechanism controlled by the pilot. The *Banshee* in its "kneeled" position may be moved about on its nose caster and main wheels.

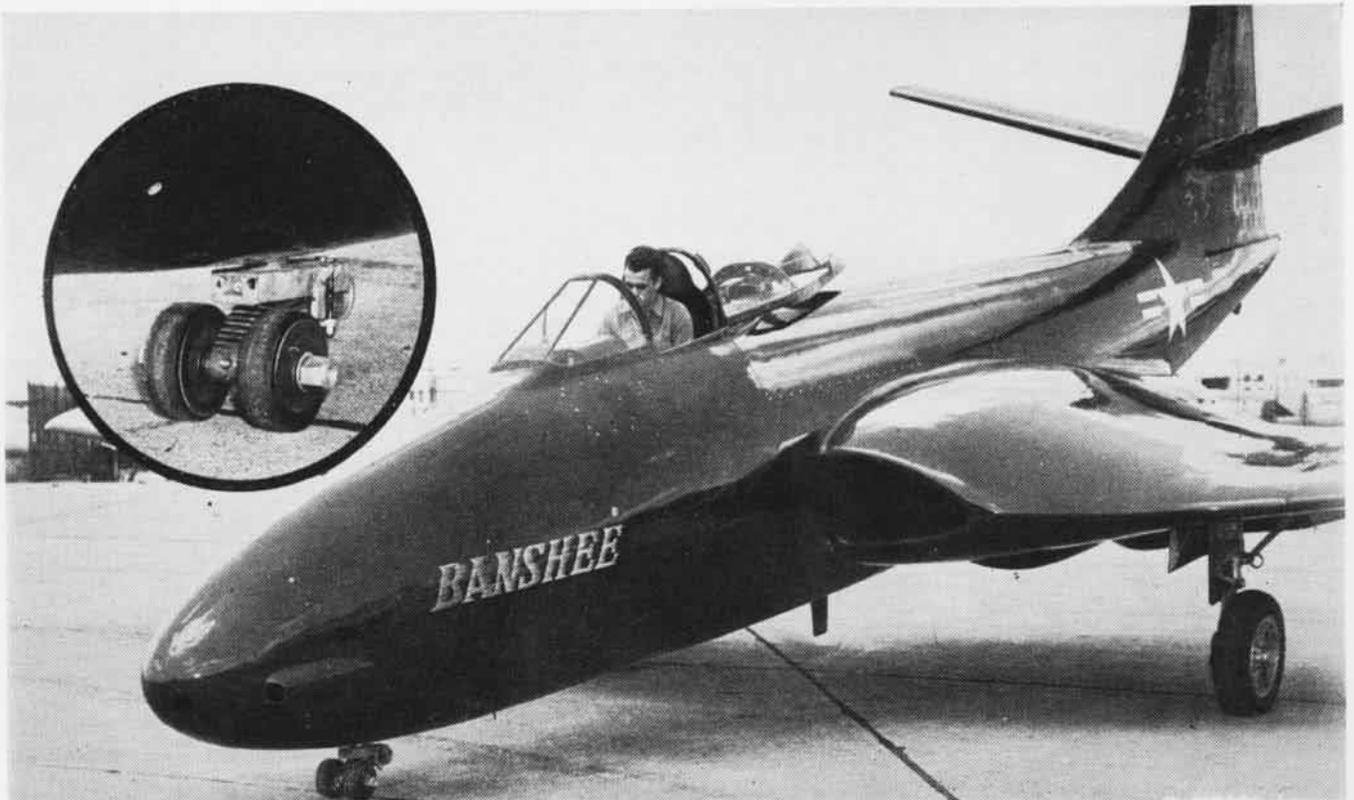
KNEELED ON A SPECIAL AUXILIARY CASTERING NOSEWHEEL THE XF2H-1 CAN FIT WELL UNDER THE TAIL OF ANOTHER SIMILARLY KNEELED BANSHEE

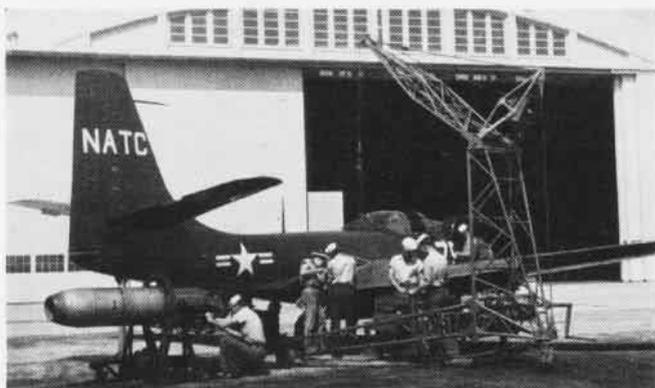
STANDS ARE NEVER NEEDED FOR WORKING ON PHANTOM OR BANSHEE

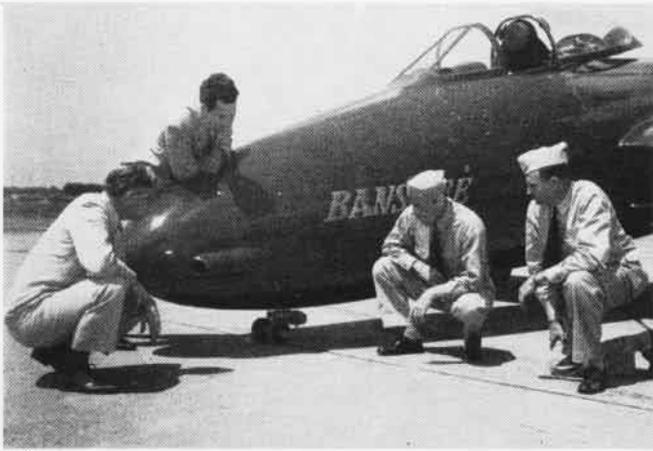
GUN PORTS ARE IN LOWER NOSE WHERE BLAST IS SHIELDED FROM PILOT

The expenditure of ammunition by the guns causes quite a cg travel. This is reduced by retaining the expended cases and links in a compartment below the guns. This feature does away with the need for lengthy jettison chutes and there is no danger of ejected brass hitting the firing plane or others in formation.

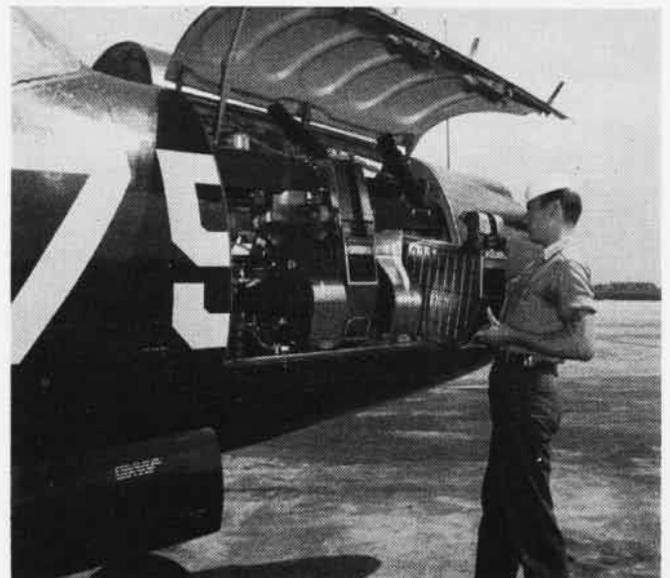
LOADING AMMUNITION ABOARD PHANTOM OR BANSHEE IS SIMPLE TASK

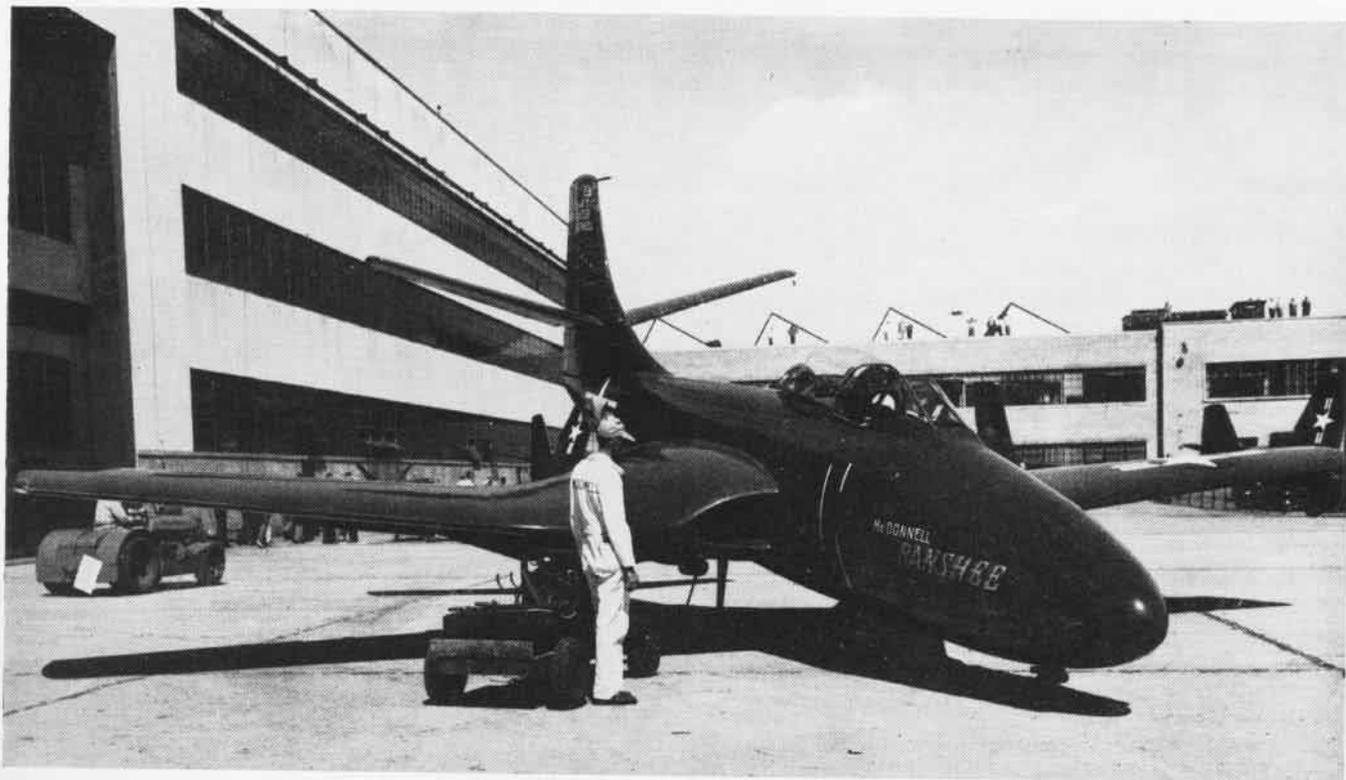
KNEELING ON ITS NOSEWHEEL THE BANSHEE CAN BE TAXIIED AROUND CARRIER DECK WITHOUT DANGER TO GROUND PERSONNEL FROM EXHAUST FUMES

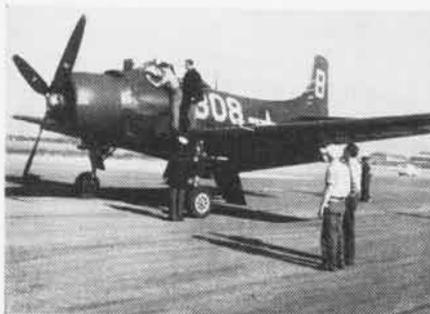
Damage was limited to approximately six inches being worn off the trailing edge of the bottom dive flap, and the plane was back in commission the next day. We feel that this technique saved many man hours of work and costly repairs to the empennage, hook, tail wheel assembly, and rudder, and so we pass it along for what it's worth to the other AD squadrons.

Incidentally, the tail wheel wouldn't extend due to a material failure in the hydraulic shut-off valve assembly.

At this point the C.O. joined him in the air, and after going through the emergency procedure again with negative results and talking the situation over, it was decided to try a wheels landing using the bottom dive flap as a tail skid in the event that the tail wheel was not down by the time the fuel indicator registered fifty gallons.

Accordingly, the pilot split his dive flaps and simulated a landing procedure at altitude to feel the plane out. Control and stall characteristics of the plane in this condition were favorable, and the pilot felt confident that he could effect a landing successfully. When his fuel supply reached the predetermined level the tower was called for a deferred emergency landing and a long straight-in approach was begun. The pilot brought the plane in at about 85 knots and made an excellent landing.

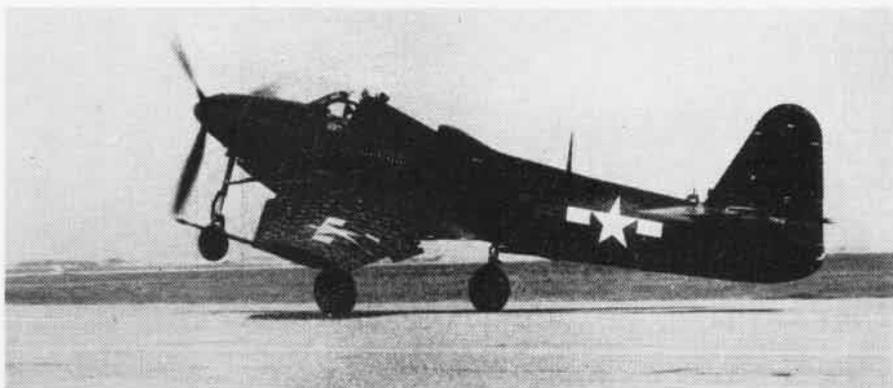
This Navy L-39 is a converted Bell P-63 and is being used by NACA at Langley Field to investigate the flight characteristics of swept-back wings. Note the very high angle of attack as plane touches down. The string tufts on wing are photographed in flight by an automatic camera installation. Flight qualities of the plane are pretty good, but with power off the glide path is somewhat steeper than most.

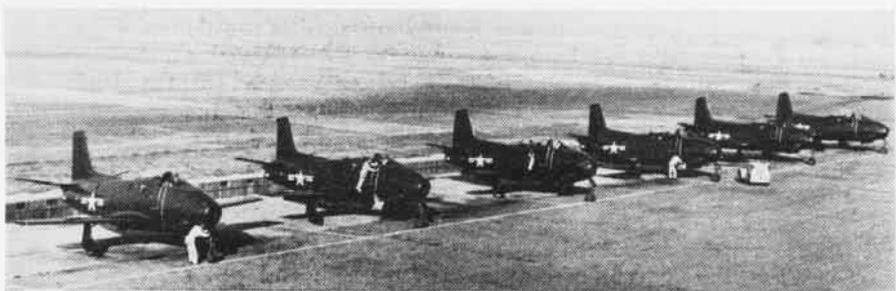
Squirt jobs in quantity. This is the largest number of FJ-1 aircraft to be photographed in one spot at one time. These 550-mph fighters have been assigned to naval fleet squadrons in San Diego. In this picture they are lined up at the North American plant at Los Angeles airport before delivery to pilots who will fly them

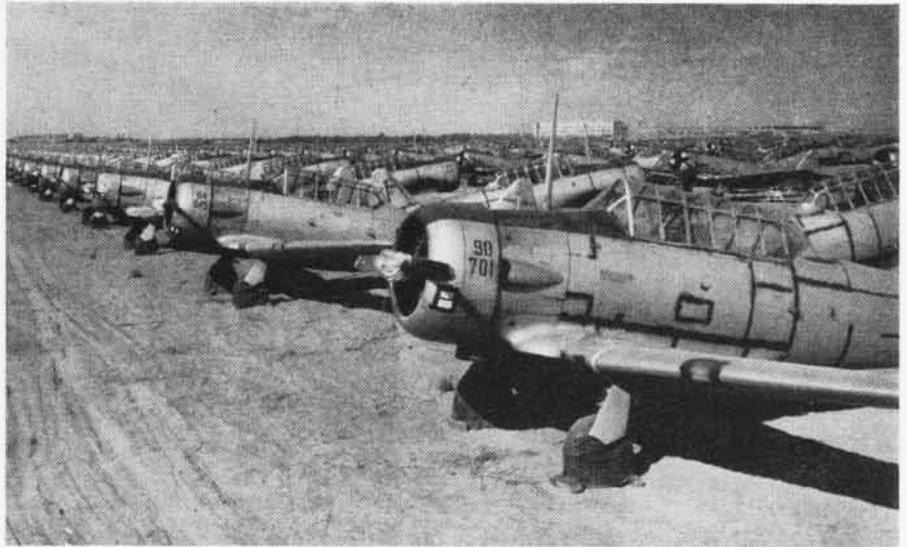
HOW MANY SNJ'S CAN YOU SPOT IN THIS VIEW OF OUTDOOR STORAGE AT NAF LITCHFIELD PARK?

THE ARIZONA climate is good for man or machine. In fact, the Navy found conditions at NAF LITCHFIELD PARK so well suited for outdoor preservation of aircraft that this facility has become a major storage point. There are a good many airplanes shown in the picture of SNJ's above, and views of other type planes on different sections of the station are equally impressive.

Litchfield Park is 18 miles west of Phoenix and 400 miles from the sea. The facility consists of 491 acres of cleared desert, with a 6000-foot runway, the largest hangar in the state of Arizona, and a compact building arrangement. Flying conditions are ideal, with at least 360 flying days a year. Fourteen officers, 244 enlisted men, and a recently increased complement of civilians are carrying out the present accelerated storage program.

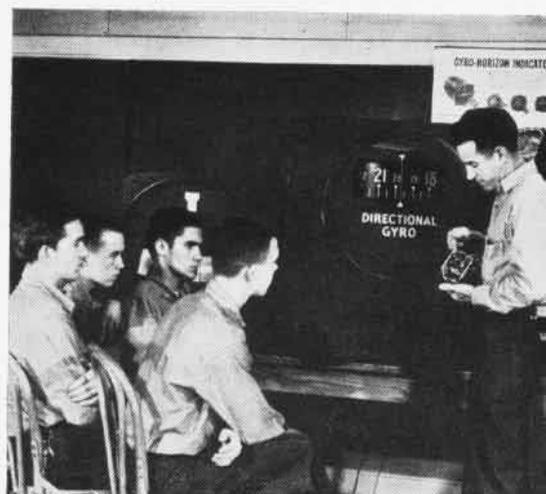
**Big training gyro** helps Taylor, ACMM, teach Benefield, Hutchins, Dinos, Bates

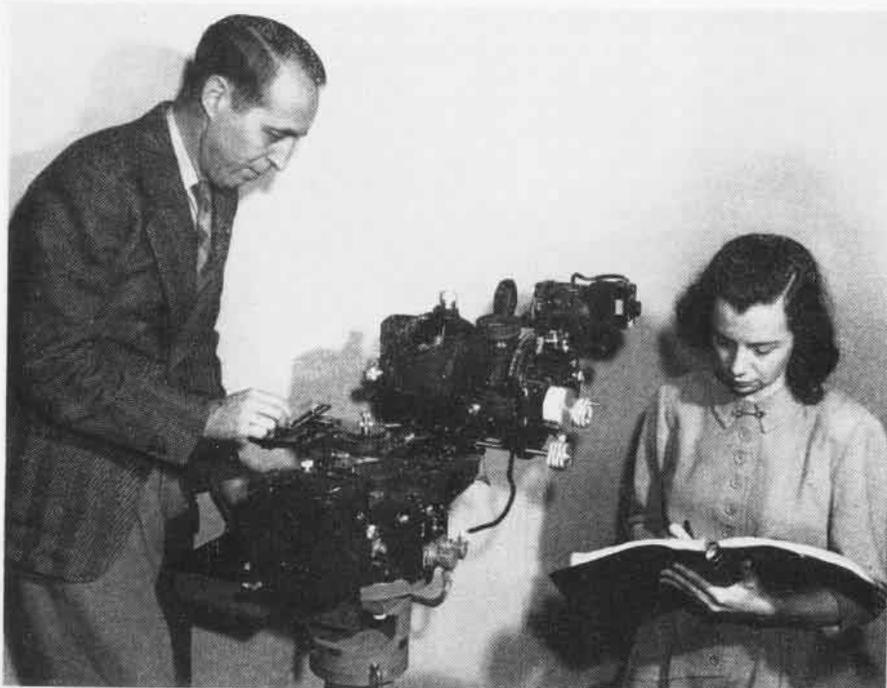
WORKERS CHECK NORDEN BOMBSIGHT COMPUTER; SIGHT WAS ONE OF PLANT'S WAR PRODUCTS

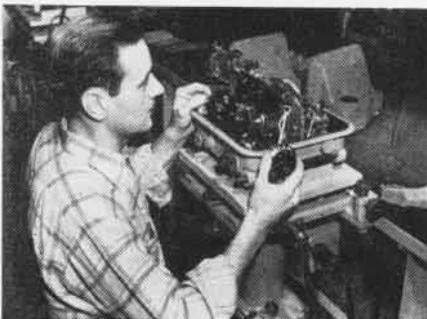
SETTING CAGING SYSTEM ON MK 14 GUN SIGHT

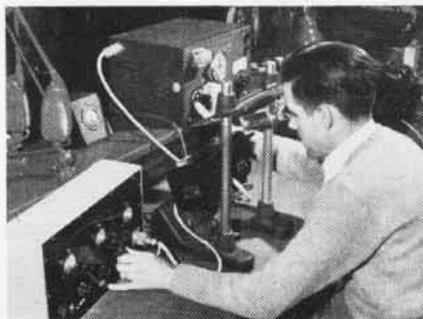
CHECKING RANGE UNIT ON MK 18 PLANE SIGHT

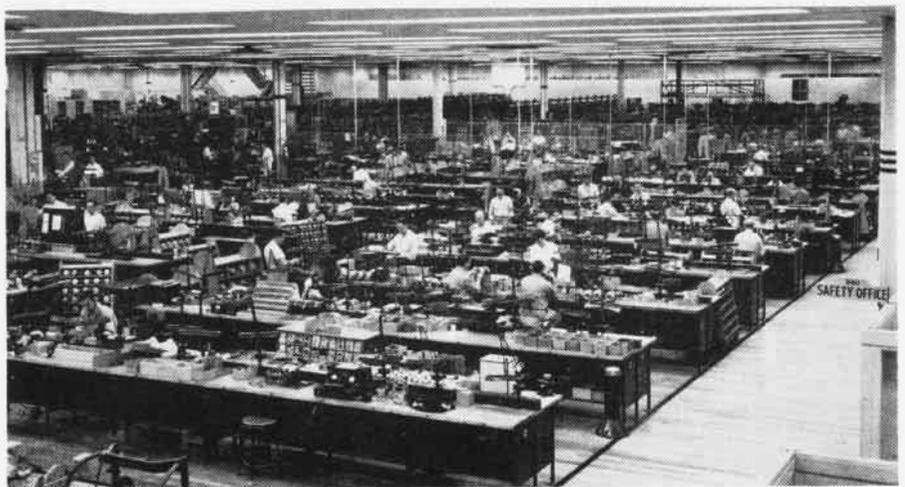
THIS OVER-ALL VIEW OF SYNCHRO ASSEMBLY ROOM GIVES IDEA OF SCOPE OF NOP, INDIANAPOLIS

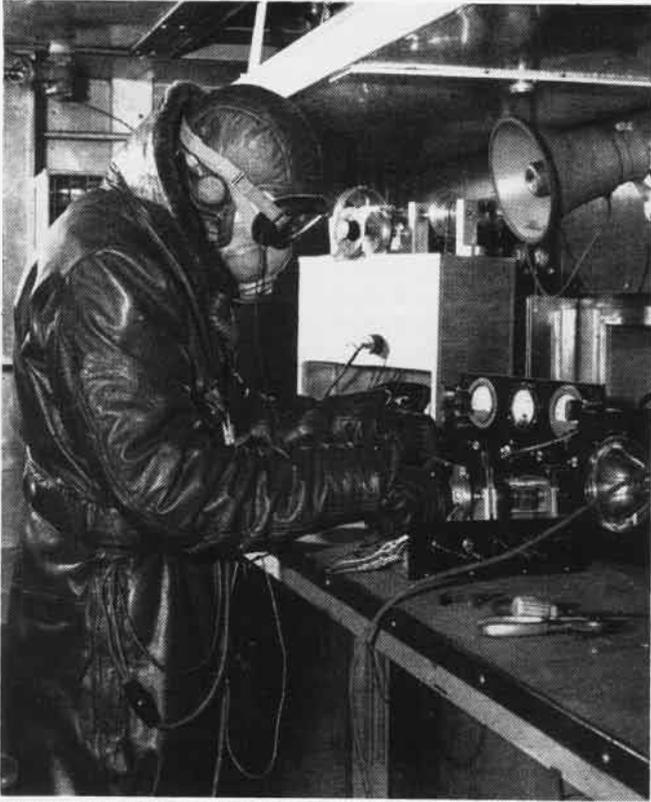
PRESSURE CHAMBER EMPLOYEE WEARS HEATED FLYING SUIT DURING TEST

the war, research and development work was done in a detached building at the plant. One of the outstanding facilities of this laboratory is an altitude and pressure chamber. In it instruments are tested under conditions of high speed, climbing and diving.

The pressure chamber permits use of instruments in temperatures as low as minus 70° and at vacuums equivalent to 50,000 feet. Tropical climates can be produced with temperatures of 150° F and humidities of 100%. Simulated

dive rates of 800 mph and climb rates of two miles a minute make this chamber outstanding among others of its kind. Operators in the chamber wear electrically-heated suits of goat skin, heated gloves, boots, socks and goggles.

Under altitude conditions oxygen masks are used to permit operations up to 35,000 feet simulated. Teletalk and plane intercom systems permit communication with co-workers on the outside.

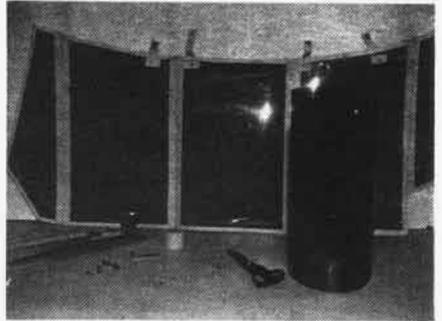
NEW AMBER FILTER UNIT FOR USE IN JRB'S

The Special Devices Center has developed a new method of constructing the amber filter unit for JRB's, which is used to cover cockpit windows during blind flying training under simulated conditions. This compact unit may be folded into a small canvas container.

With slight dimensional modifications, this unit can be made for installation in any of the multi-engine aircraft used by the Navy.

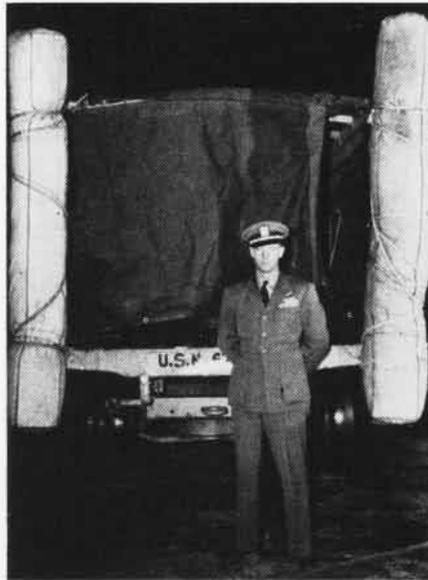
LT. CDR. R. FAUBER AND HIS 'SOFT FENDERS'

VR-3, PATUXENT RIVER—Confronted with several instances of minor damage to aircraft caused by ground equipment during loading and unloading operations, Lt. Cdr. Robert S. Fauber of VR-3 solved the problem in a typical seagoing man's fashion. He simply applied the "buffer" principle, used to prevent similar damage caused by ships scraping against docks, and devised "soft fenders" for the trucks.

These fenders are constructed locally of 30 weight, white canvas and are packed with horse and cattle hair, salvaged from old mattresses and cushions. It is estimated that

the cost per fender is approximately \$55. The fenders give the trucks a strange appearance, but repairs and delays due to damaged skin are being lessened, particularly during the winter when loading aprons are icy.

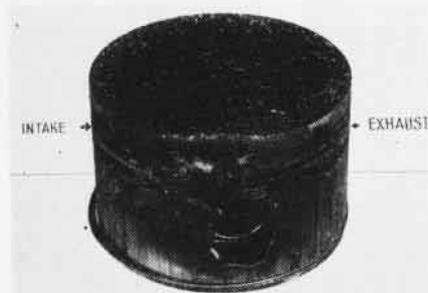
EXCESSIVE POWER CAUSED BURNED OUT PISTON

In the last four months, however, 15 R-2000-9 engines have failed as a result of burned pistons. Investigation by BUAER as to the cause of failure resulted in the same conclusions and recommendations as indicated in VR-5 RUDM Serial No. 25-47 dated 20 November 1947, a portion of which is quoted:

"Disassembly inspection revealed the #13 piston burned away as shown in enclosure (A) (see photo). In an attempt to determine the cause of this failure, an investigation of power settings used on previous flights was made. It was then discovered that on flight . . . which was immediately prior to the one during which the failure occurred, excessive power settings had been used due to extreme icing conditions and turbulence.

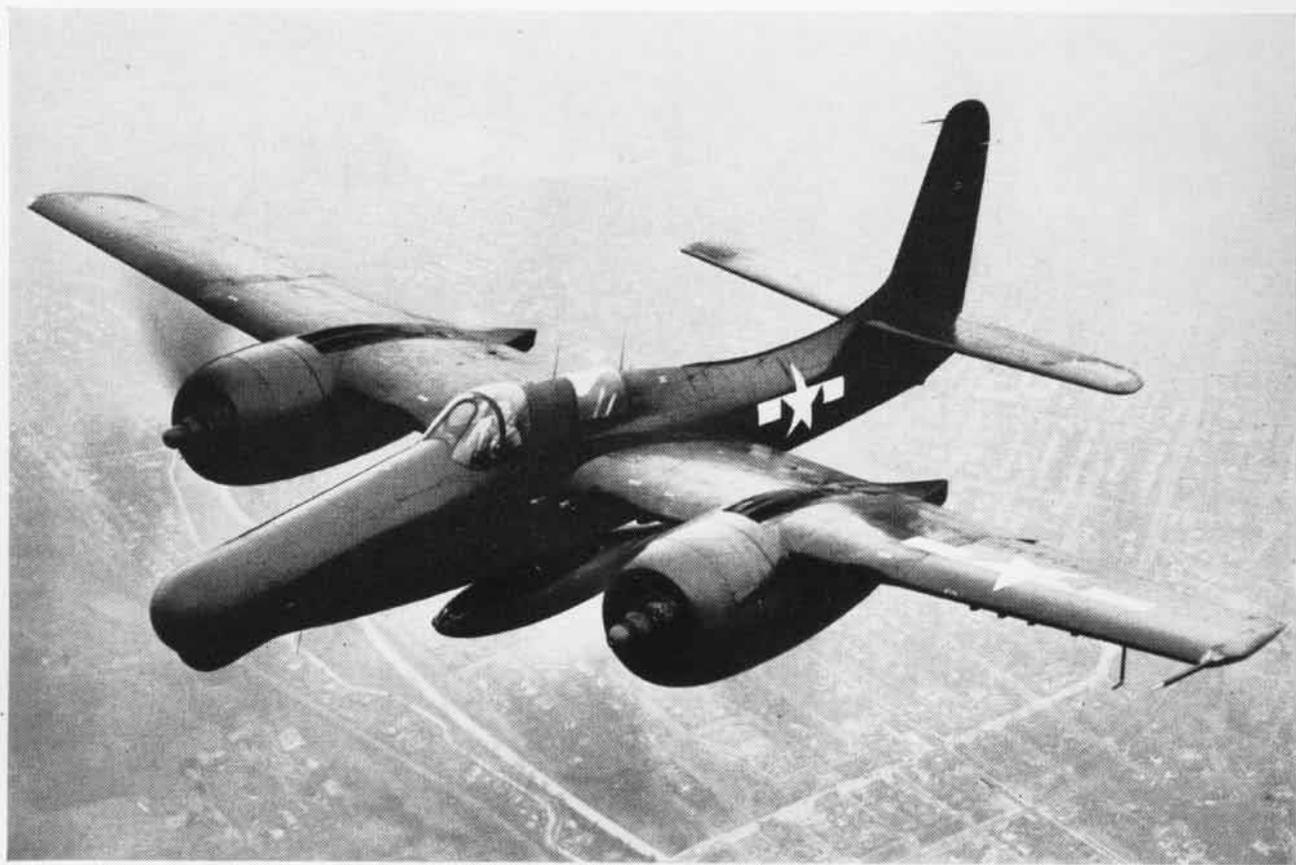
## NIGHT AND DAY

These two recognition pictures represent the old and the new. You may spot the one above for fighter, but do you know what kind and why the long snout? Anyone recognize the lower one? *Ans. on opposite page.*
