From: Commander Carrier Air Group ONE HUNDRED ONE  
To: Commanding Officer, U.S.S. BOXER (CV-21)

Subj: Action Report of Carrier Air Group ONE HUNDRED ONE  
(17 March 1951 - 21 April 1951)

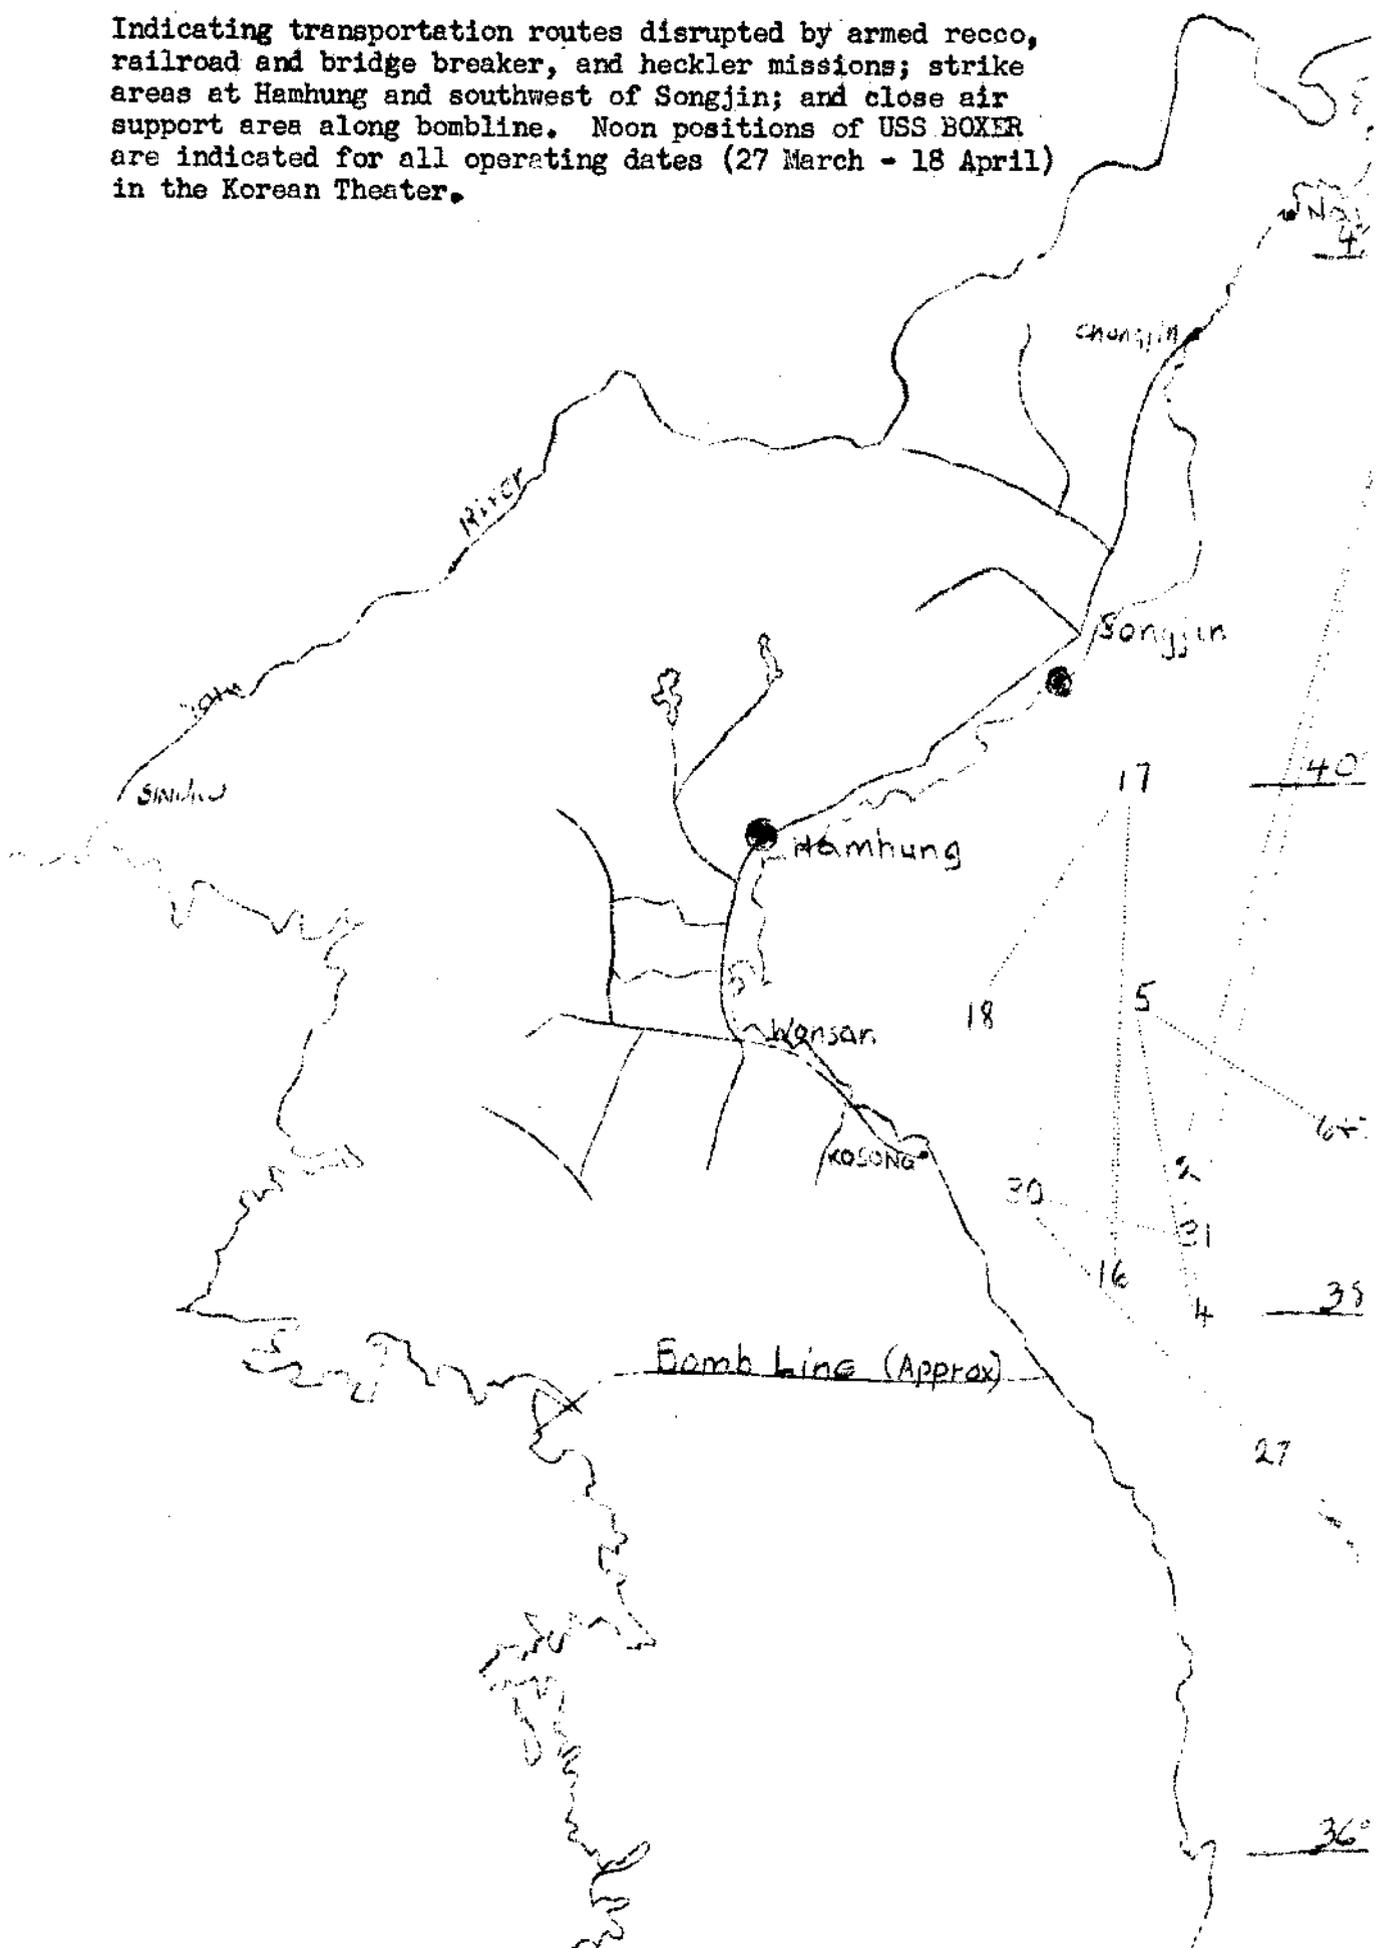
## KOREAN THEATER

Indicating transportation routes disrupted by armed recon, railroad and bridge breaker, and heckler missions; strike areas at Hamhung and southwest of Songjin; and close air support area along bomblines. Noon positions of USS BOXER are indicated for all operating dates (27 March - 18 April) in the Korean Theater.
