Lava Lament

The Trouble with Troubleshooting

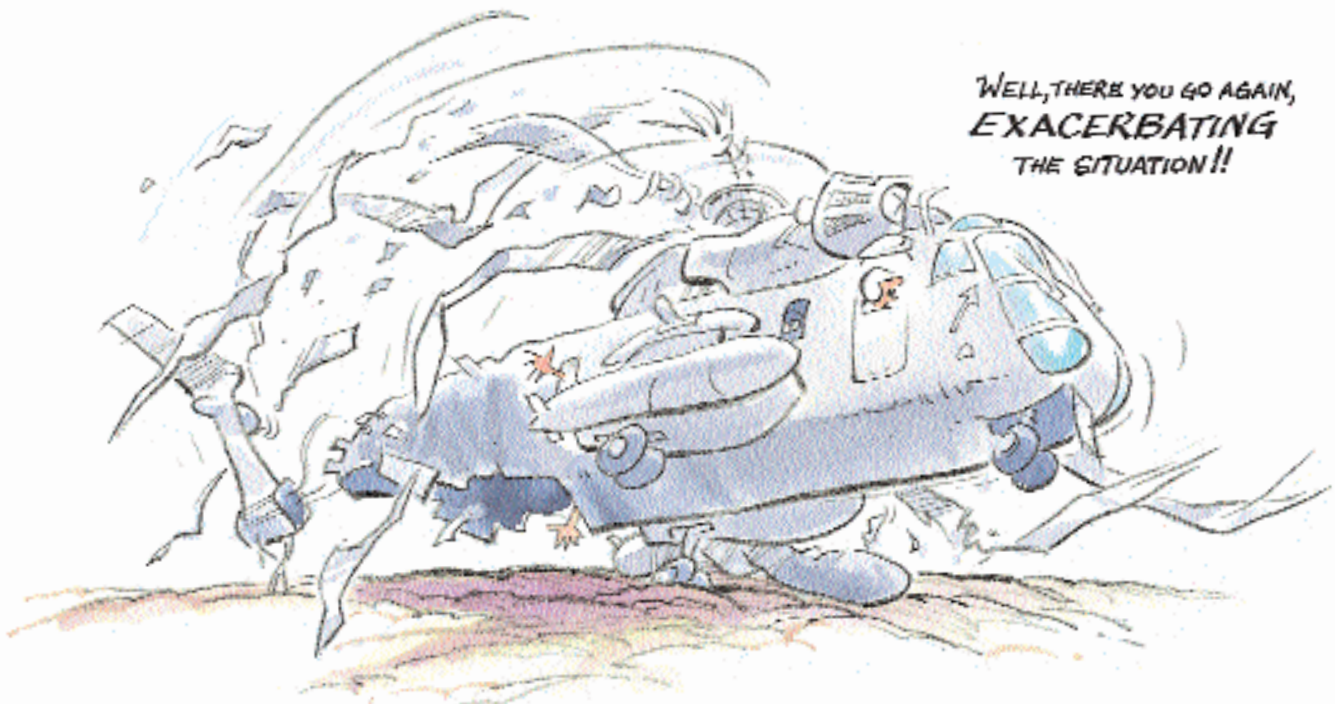
Instead, the helo struck the lava field short of the landing zone with little forward airspeed or vertical velocity. The tail rotor and left main mount struck lava rock. Simultaneously, the tail skid lodged in the lava rock causing it to fail aft. The tail rotor blades disintegrated on impact. The tail pylon separated from the aircraft, which then lifted 10 feet off the ground and began rotating counterclockwise.

The *Sea Stallion* struck the ground a second time and rolled nearly inverted. The engines continued to drive the main gear box

and rotor head throughout the sequence, arcing the fuselage around until all the blades were completely sheared off from the rotor head.

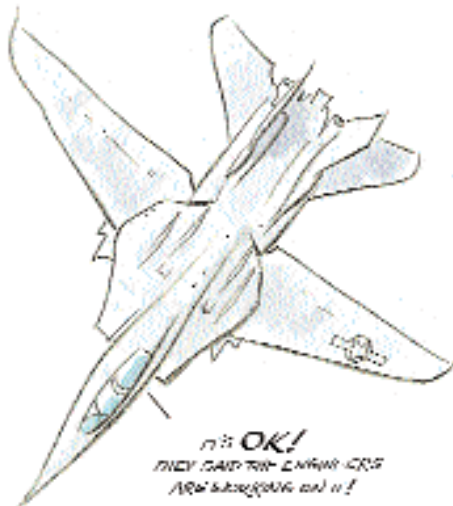
The pilot depressed the master reset button and tried to engage the DLC but this didn't correct the problem. There were no caution lights illuminated. The pilot then pulled out and reset the pitch-and-roll computer circuit breakers. In effect, this disabled the inboard and outboard spoilers except for the left

outboard No. 4 spoiler which was visually confirmed as being up with no other left wing spoilers deflected.

The F-14 began an uncommanded left roll to 20 degrees left wing down. The pilot applied right and forward stick, right rudder and asymmetric thrust on the downwind engine. The aircraft became wings level with 10 degrees pitch up beyond the normal approach attitude. The pilot noted, but could not identify, a number of caution/advisory lights that came on during the rolloff.
