H. L. Hunley Recovery Operations

Edited by Robert S. Neyland and Heather G. Brown

A Collaborative Project of: Naval History and Heritage Command, South Carolina Hunley Commission, and Friends of the Hunley

Naval History and Heritage Command Washington, D.C. 2016 Satisfactory and important as have been the performances of the navy at this interesting period, they are scarcely more wonderful than the success of our mechanics and artisans in the production of war vessels which has created a new form of naval power.

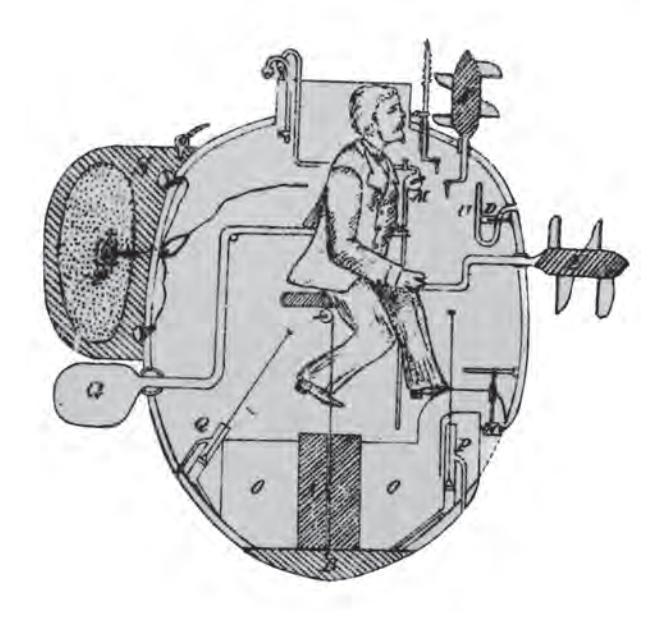
Figure 2.1. This widely published 1875 drawing of Bushnell's Turtle by Francis M. Barber is based only on written descriptions of the vessel, and likely contains many inaccuracies, particularly in the propellers, which were likely closer to standard screw propellers.

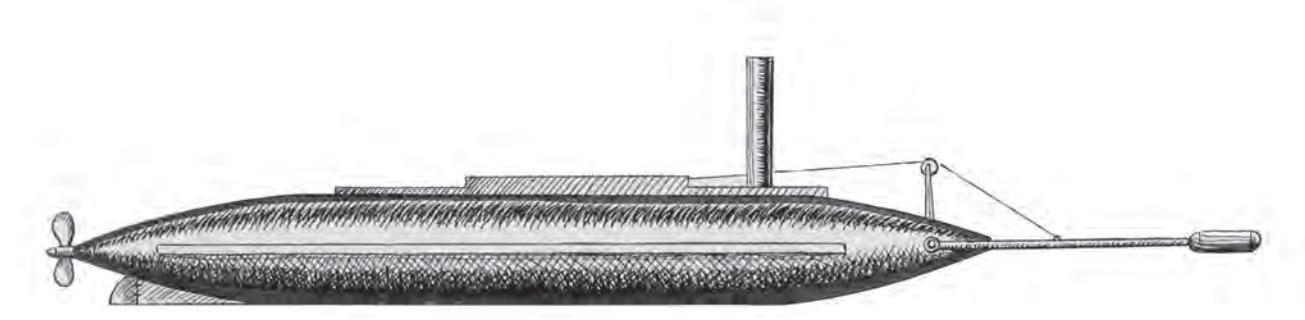
Figure 2.11. A 1960s reconstruction of a Confederate torpedo boat designed like CSS David, with spar torpedo deployed. (NHHC Photo Archives #NH 95242)

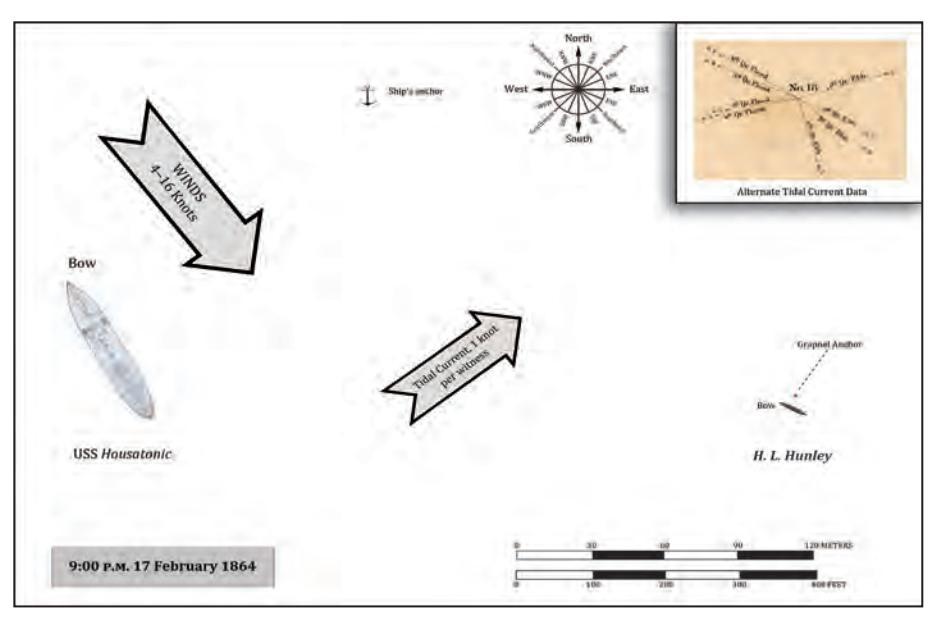
Figure 3.6. The positions of the Hunley *and* Housatonic *wreck sites are shown in relation to the directions of wind and current at the time of the sinking. (Diagram by Alicia Massey and H. G. Brown; contains detail from USCS 1856)*

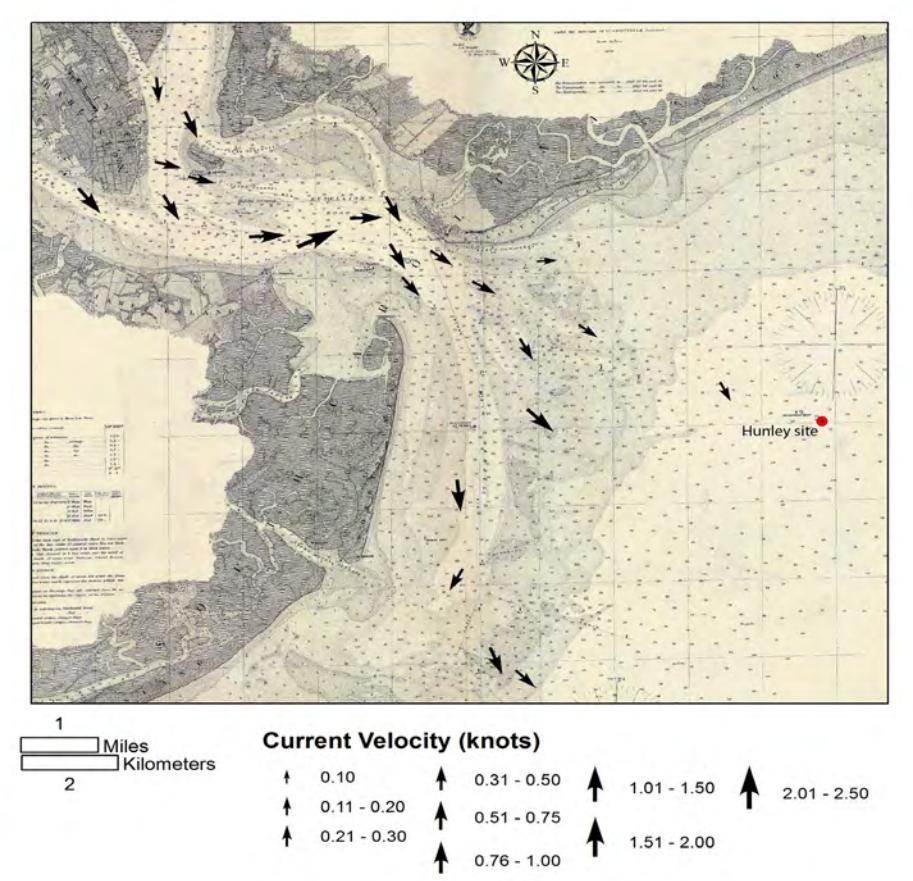
Figure 3.8. The fourth quarter ebb current flow in the vicinity of the Charleston Harbor entrance depicted on 1870 Coast Survey chart (USCS 1870), with currents extracted from 1856 Coast Survey chart (USCS 1856). (Map annotations by M. Scott Harris).

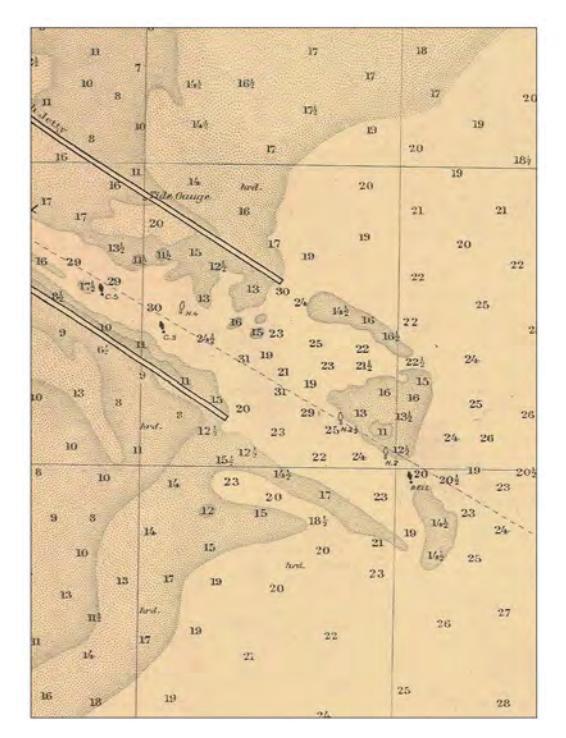
Figure 3.9. Sediment distribution at the mouth of the jetties in 1900, showing build-up of delta-like conditions extending east toward the Hunley site. (Detail from USCGS 1900)

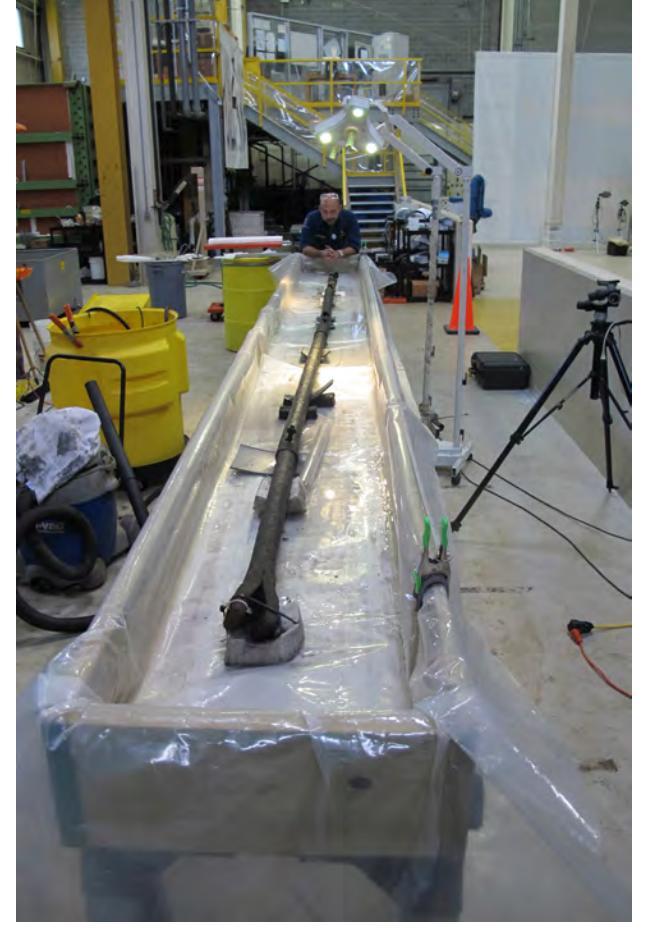
Figure 7.1. The bay area of the wet laboratory held a variety of custom treatment tanks, such as this unusually long one built to hold Hunley's torpedo spar. (Courtesy of FOTH)

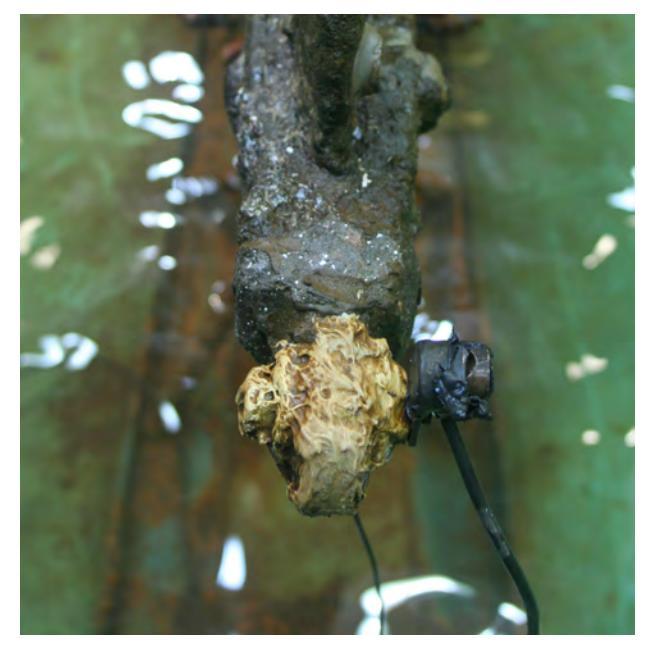
Figure 7.4. A negative cable for the impressed current system was attached to the bow where the spar was once mounted. A coating of epoxy protected the exposed metal. (Photo by H. G. Brown, NHHC)

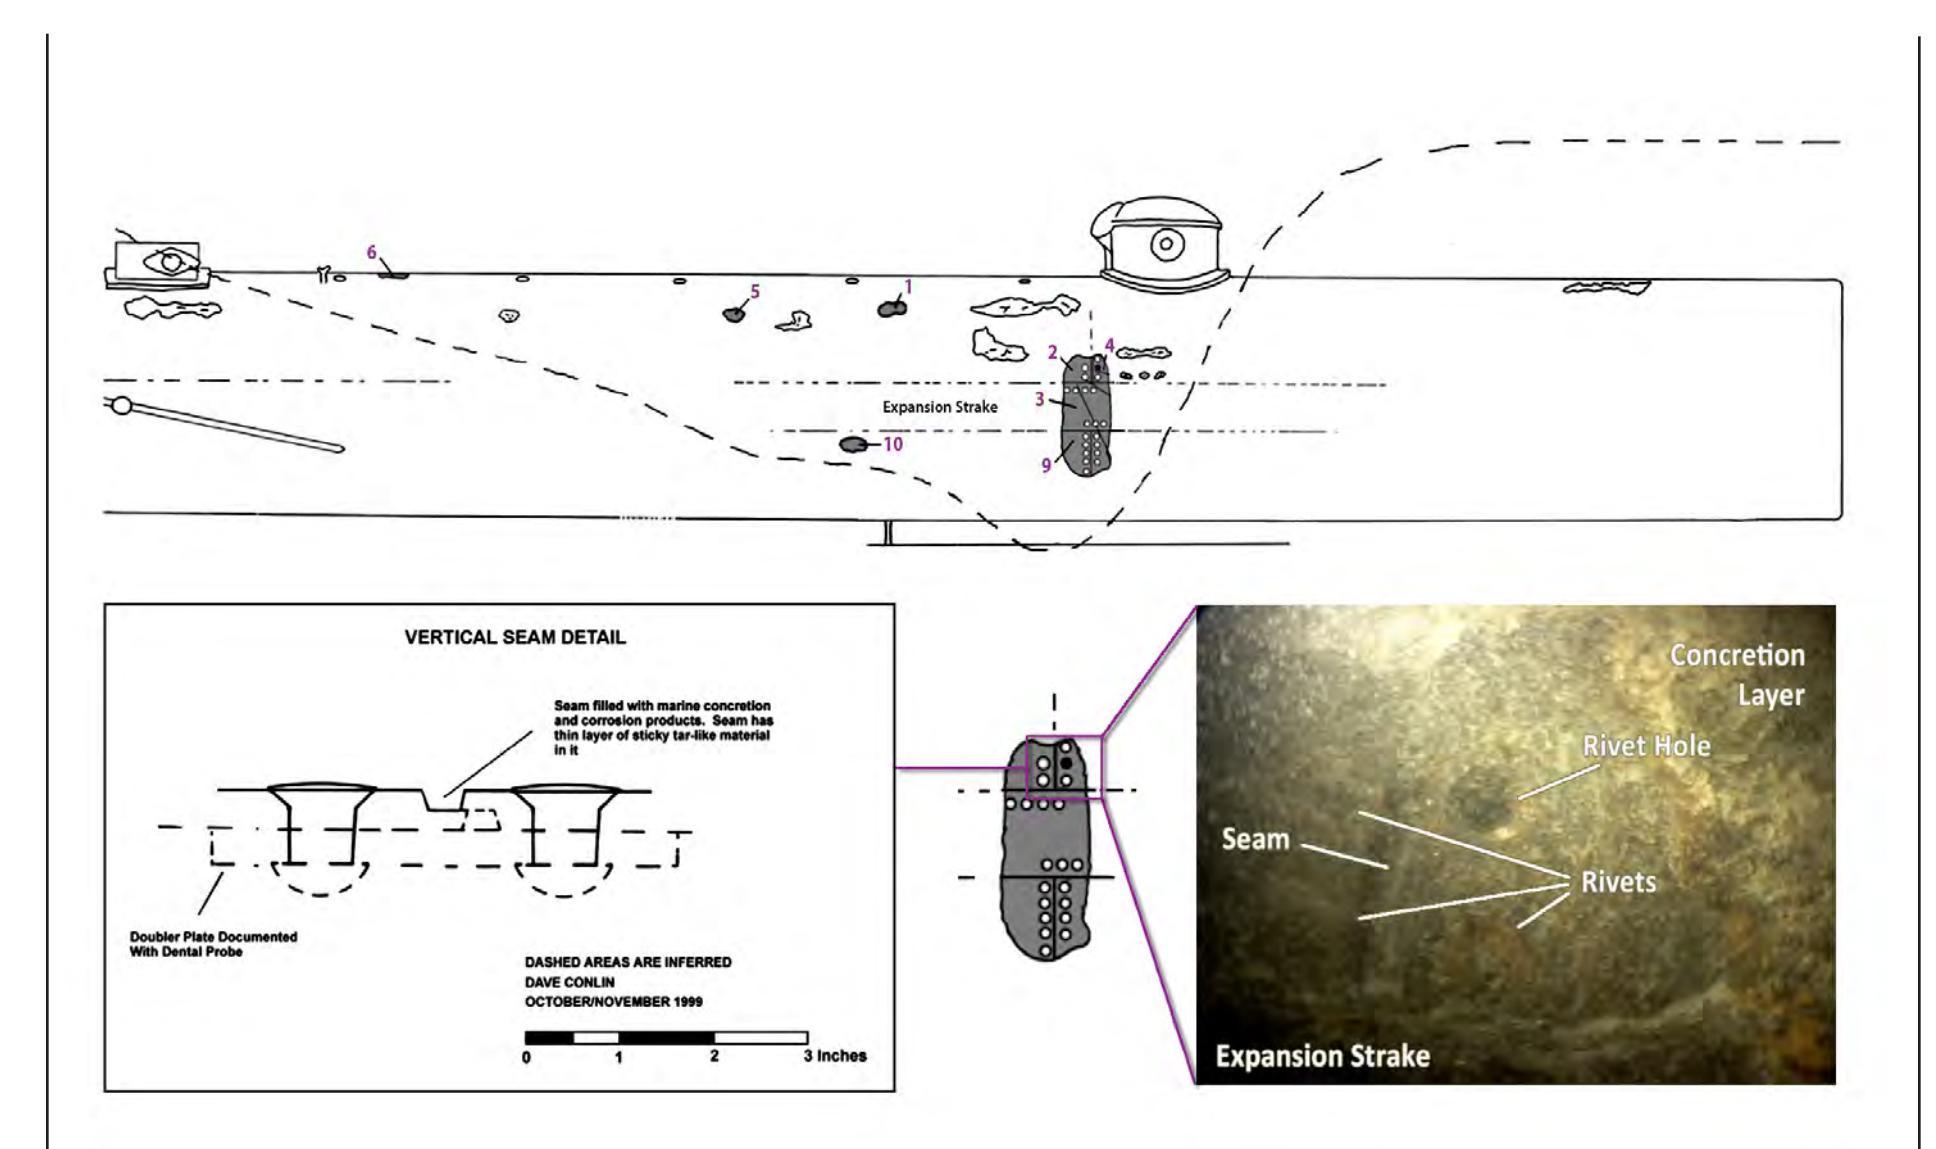
Figure 8.1. Portside view showing thickness testing locations 1–6 and 9–10 (Areas 7 and 8 were located on the starboard side). The area where a vertical plate seam intersects with the expansion strake (photo, lower right) provided a wealth of useful data for the finite element analysis. The missing rivet allowed for limited investigation of the interior seam structure (reconstruction, lower left). (Diagram and photo by David L. Conlin, NPS)

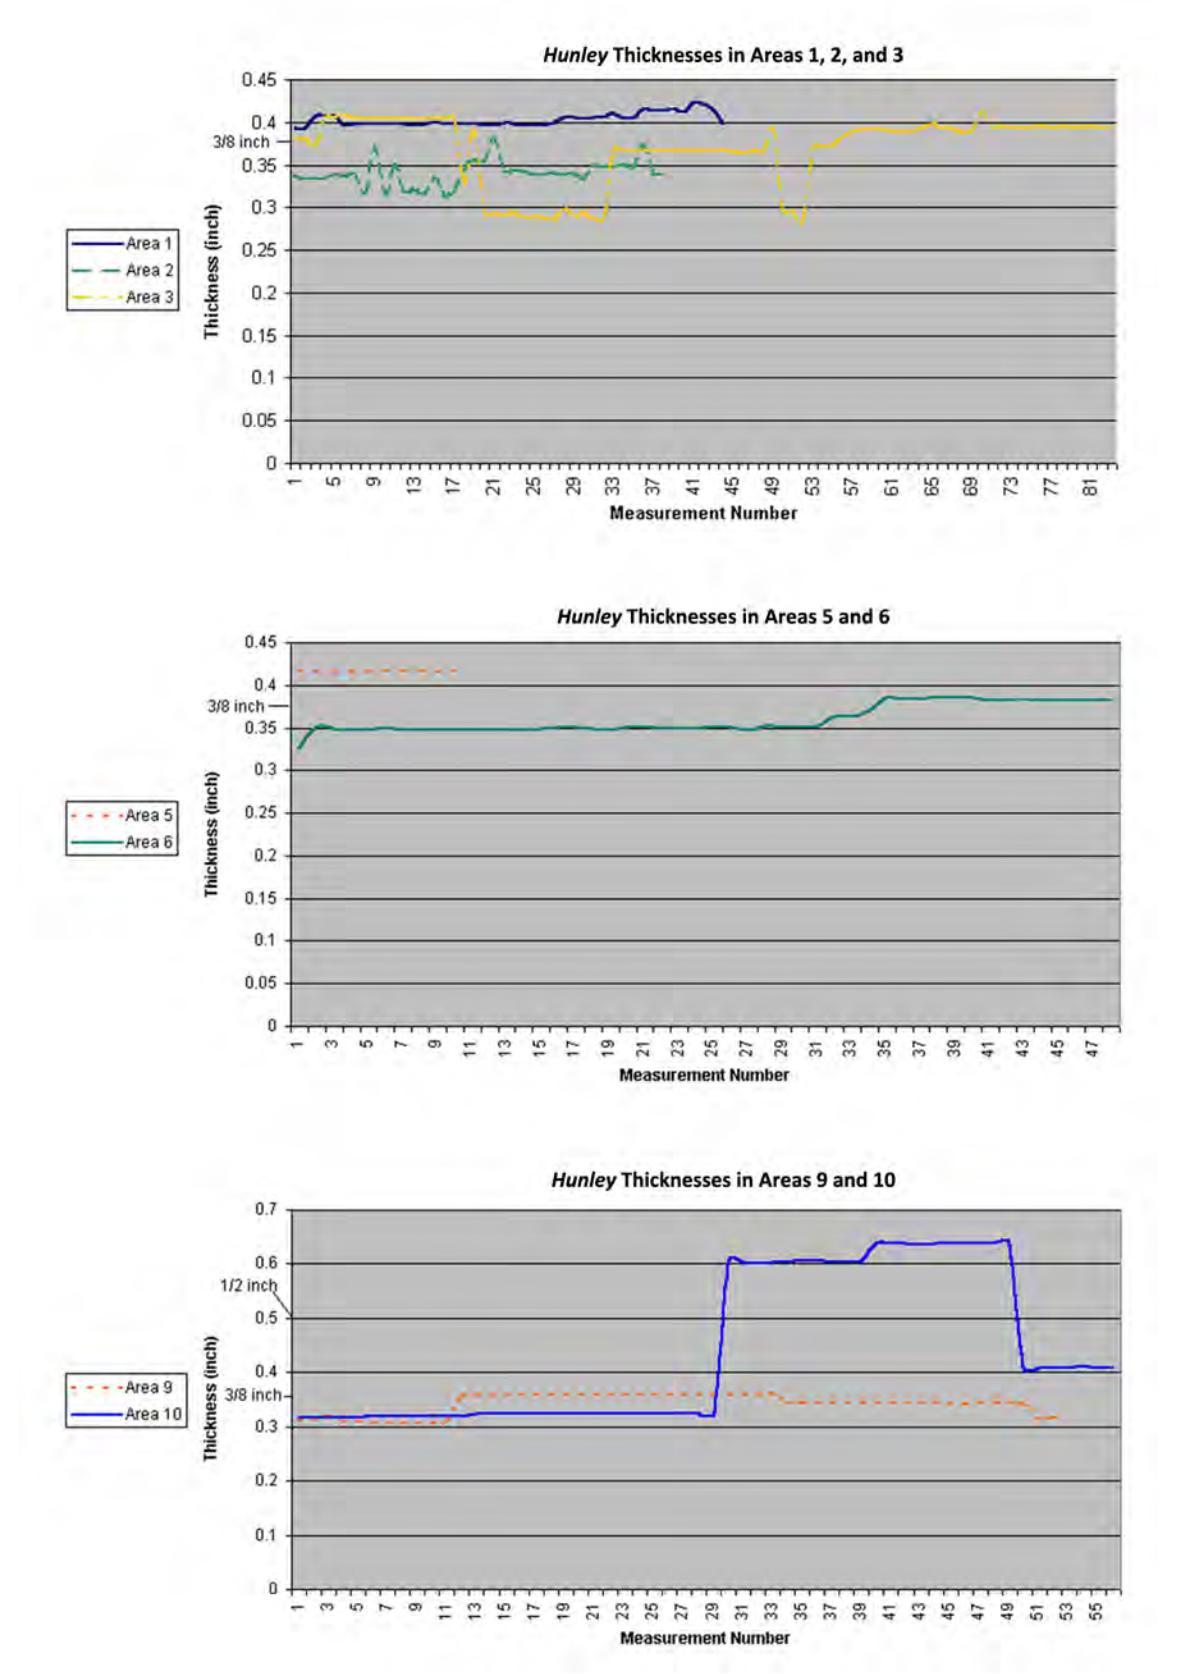
Figure 8.3. Graphs of the ultrasonic thickness readings from the port side of Hunley's *hull. (Graphs by David L. Conlin, NPS)*

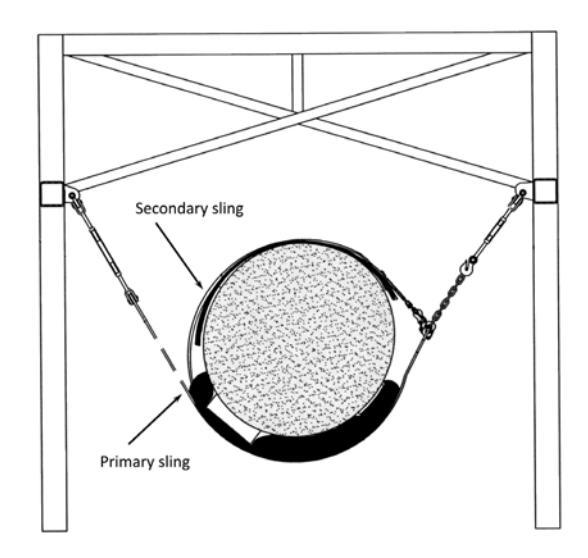
Figure 9.8. Diagram showing proposed placement of secondary slings for added stability. (OII 2000b: App. F)

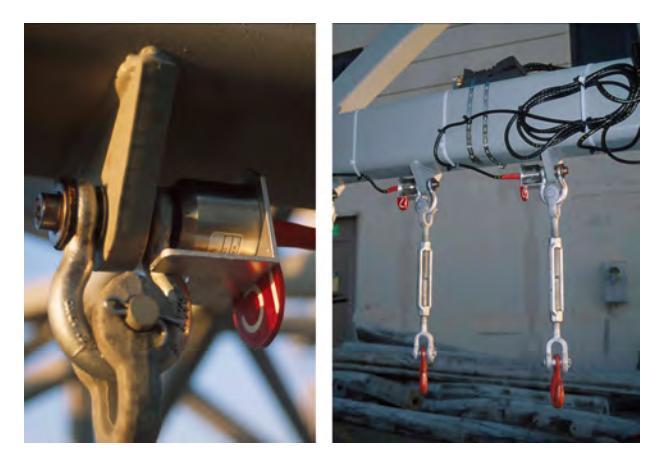
Figure 9.10. Turnbuckles in place on the frame with load cells rigged. (Courtesy of FOTH)

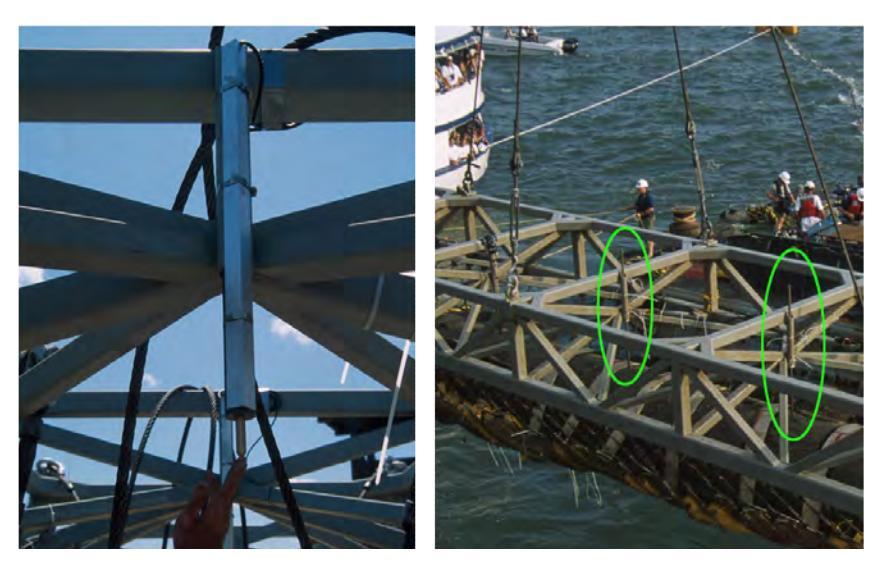
Figure 9.12. Linear variable displacement transducers (LVDTs), left, were planned for monitoring any longitudinal displacement of the hull. Two LVDTs were replaced with rods for manual monitoring (right). (Courtesy of FOTH)

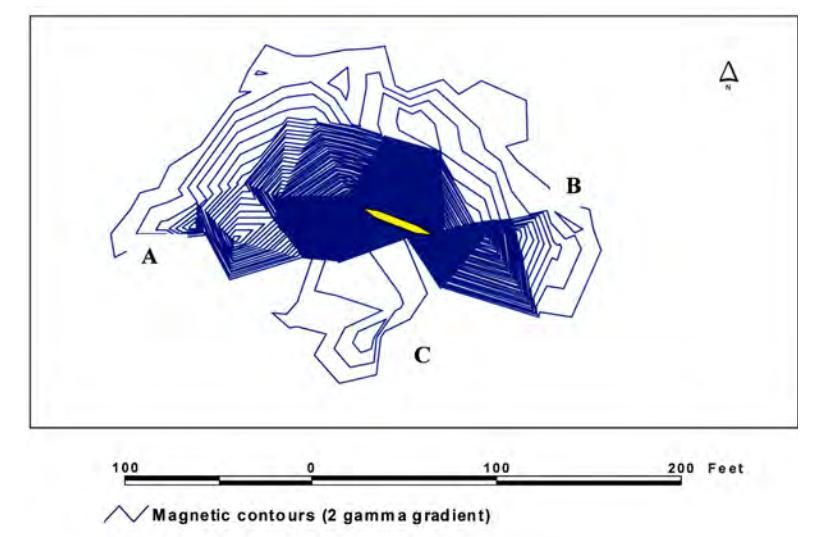
Figure 10.2. Magnetometer readings around the Hunley *site. (Detail from Murphy 1998:60)*

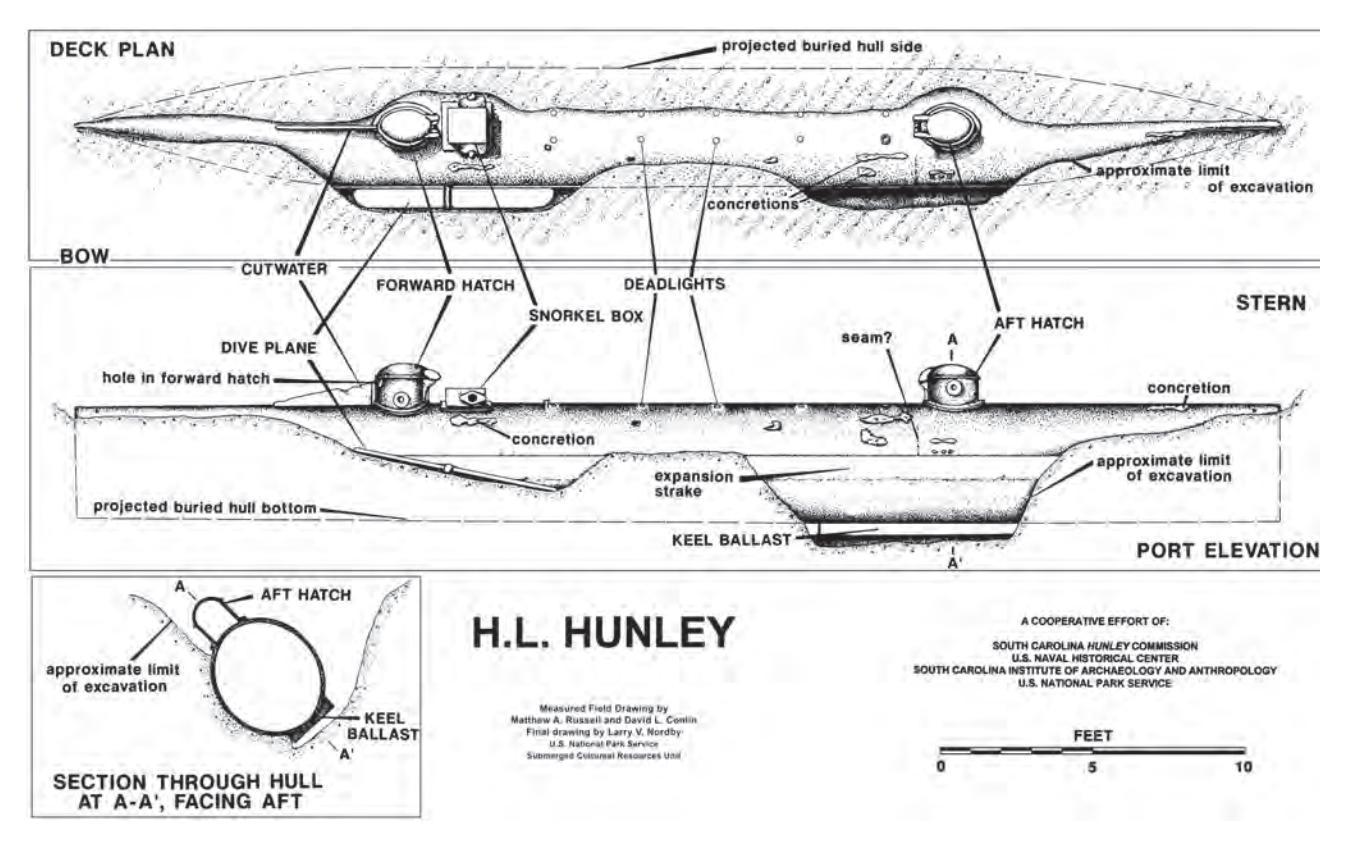
Figure 10.3. Site plan developed based on the 1996 investigation. (Murphy 1998:77)

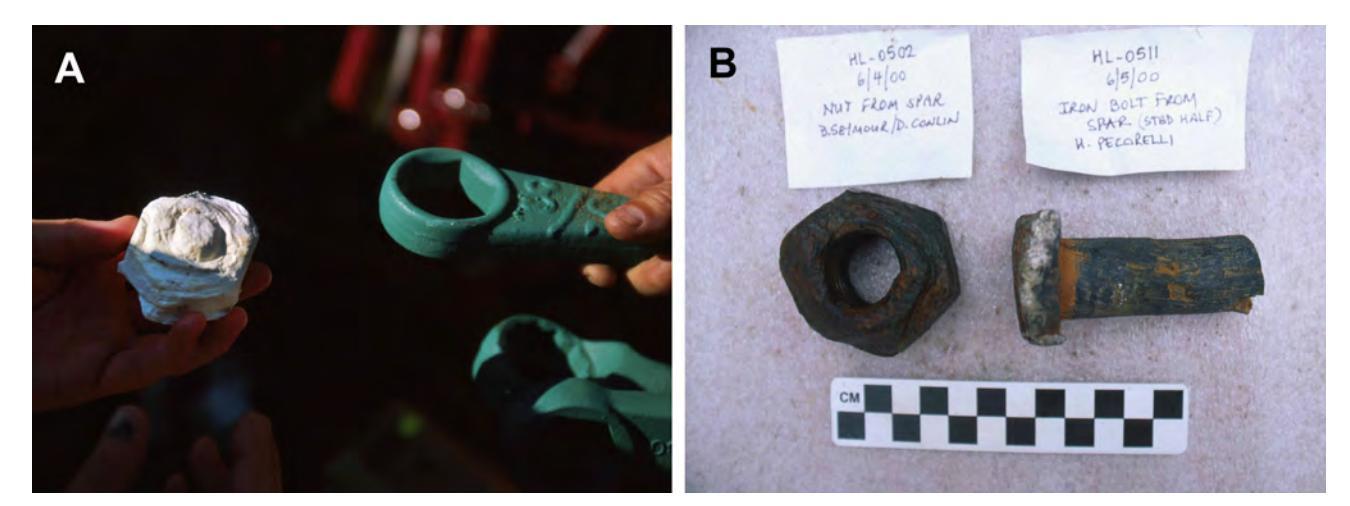
Figure 10.14. Mold of bolt (A) and recovered bolt (B) used to attach spar to main body of the hull. (Courtesy of FOTH)

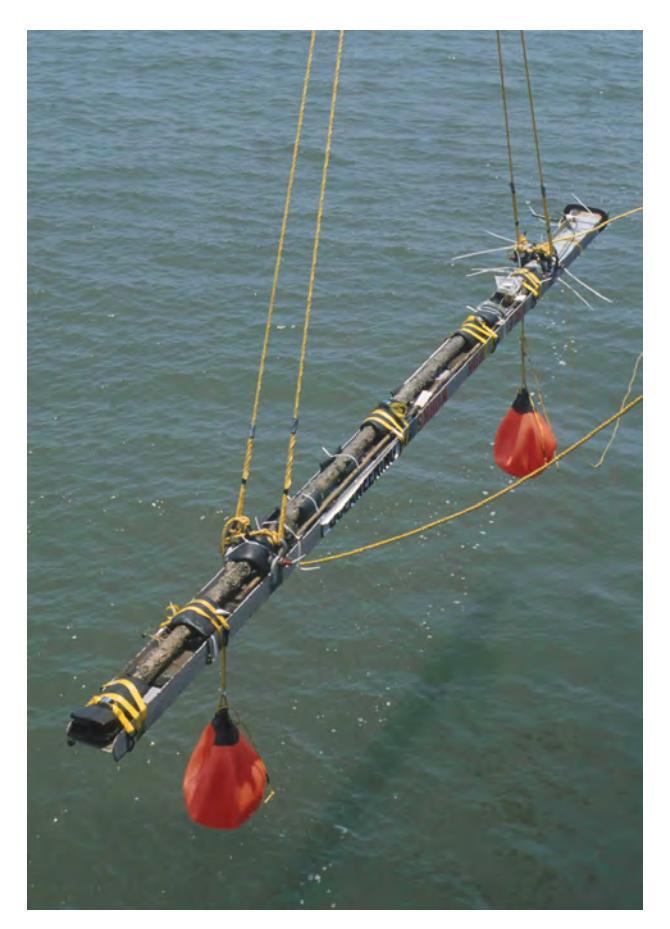
Figure 10.15. Hunley's torpedo spar was removed from the bow and raised separately to protect it from damage. (Courtesy of FOTH)

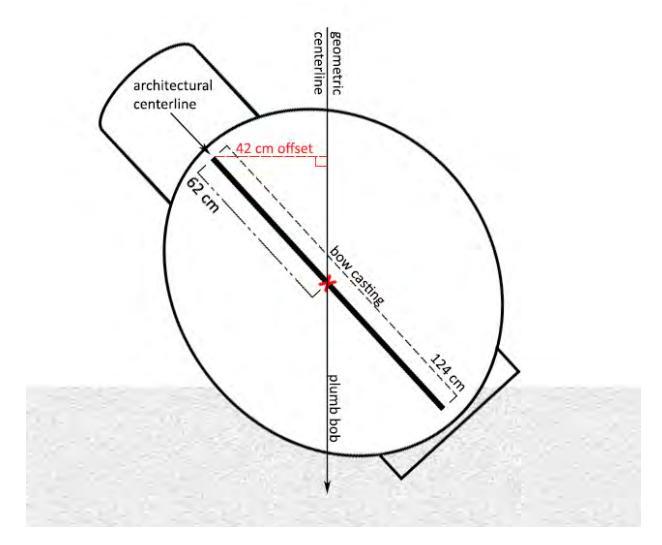
Figure 10.16. Measurements taken to determine the geometric centerline of the hull as it lay on the seabed. (Diagram by H. G. Brown, NHHC)

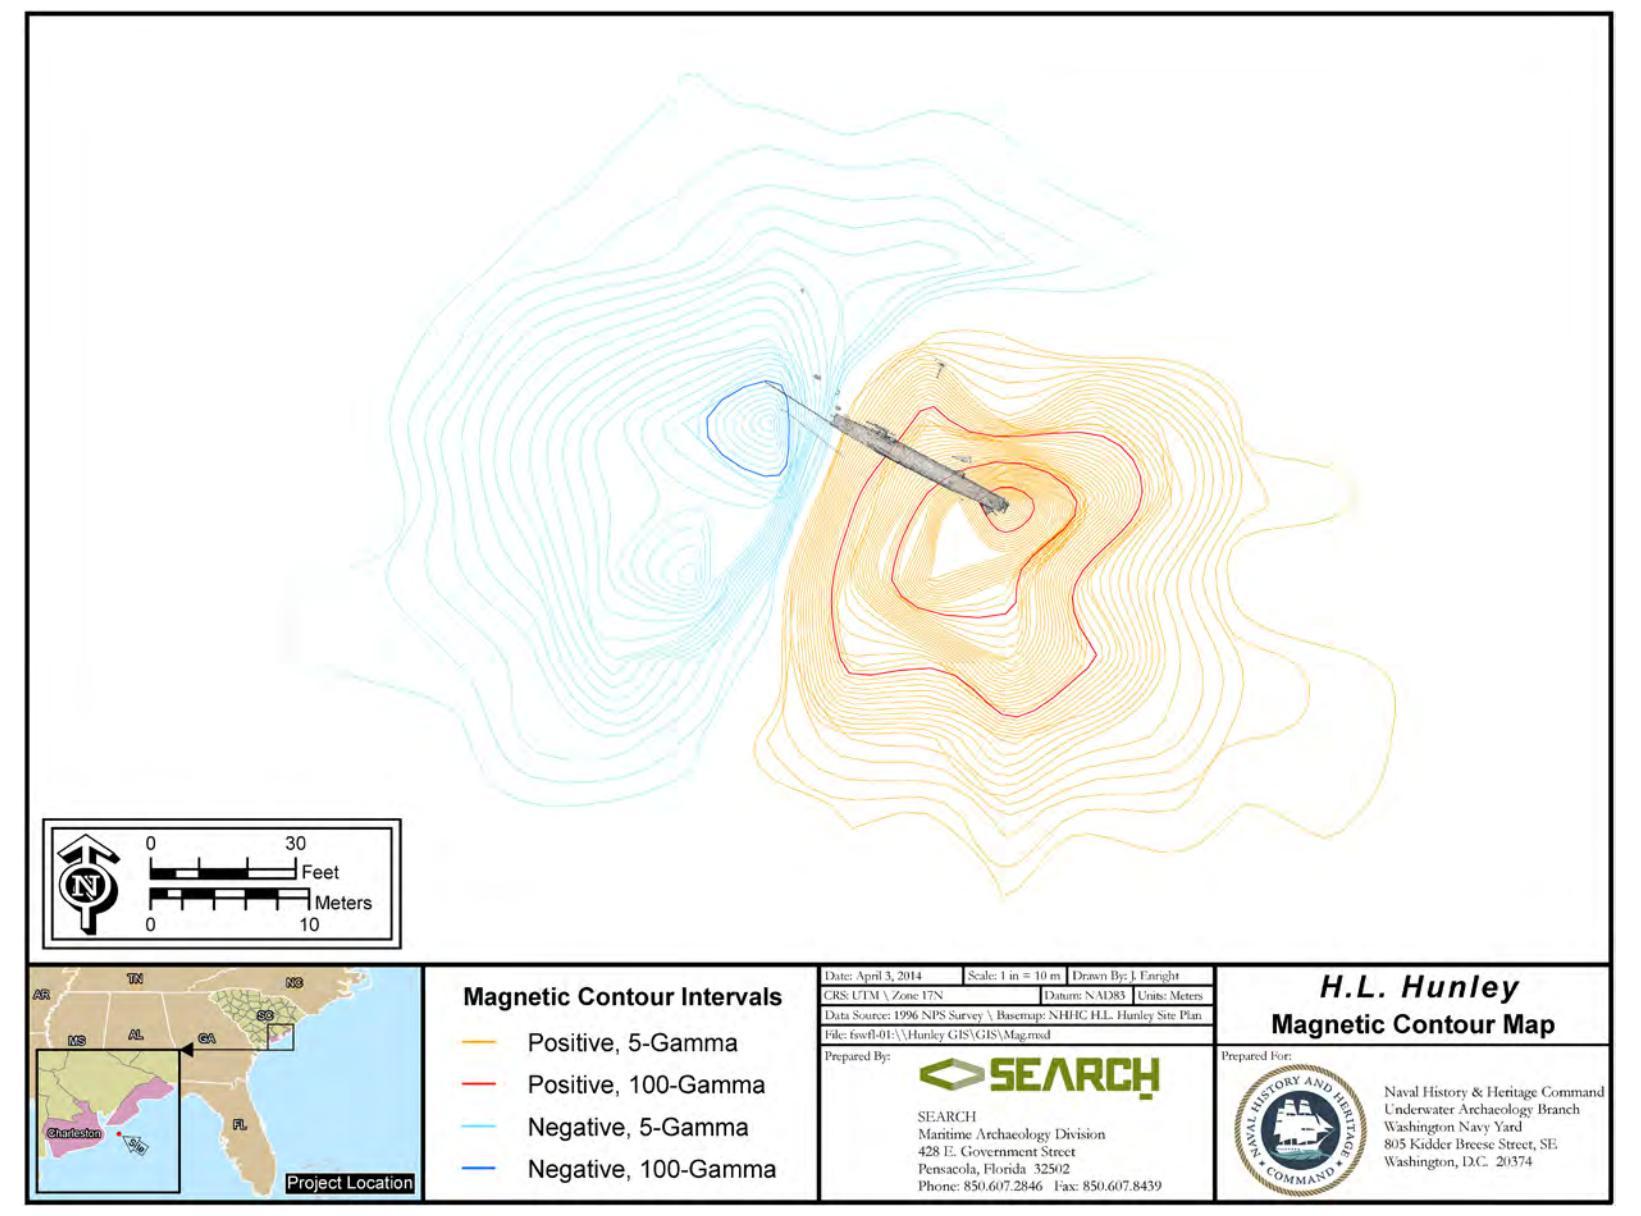
Figure 11.2. Magnetometer data from 1996 overlain on the post-recovery site plan. Deeply buried material, such as the grapnel anchor and cutwater, did not show distinctive signatures in the shadow of the readings from the hull.

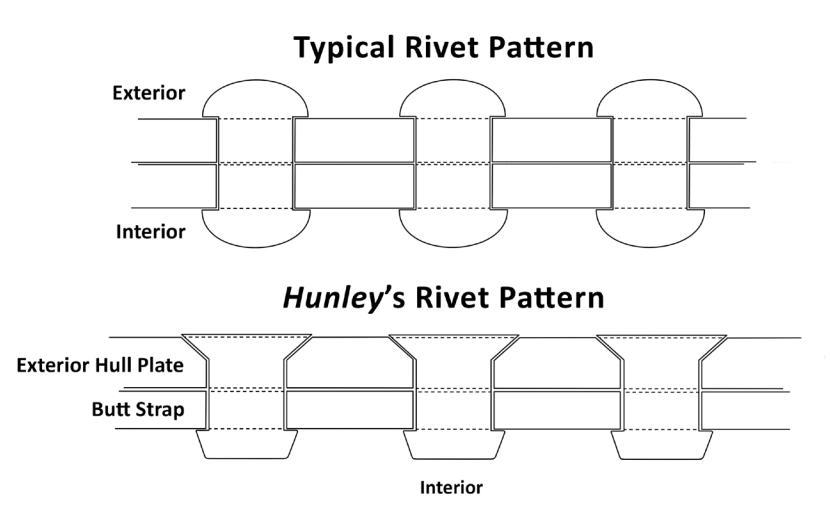
Figure 12.3. Diagram of the riveting style used on Hunley *compared to the more standard industrial riveting method common at the time.*

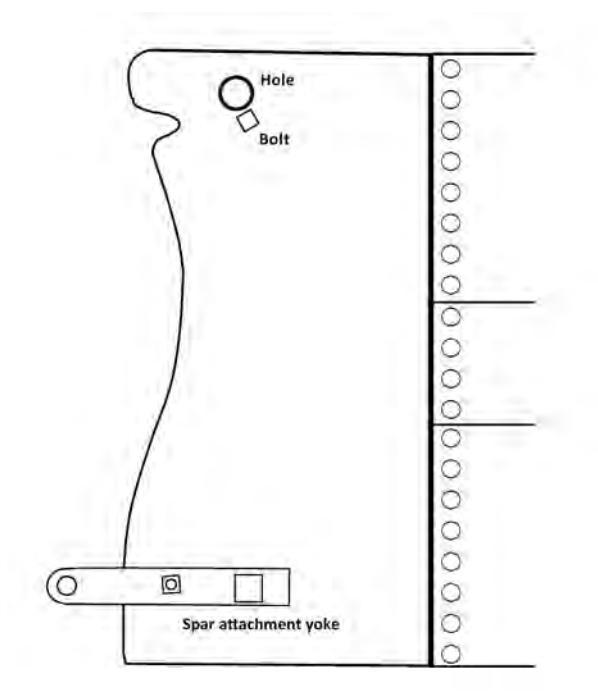
Figure 12.6. Portside view of the bow casting, showing deterioration of leading edge (rivet spacing approximate). (Diagram by Mari Hagemeyer, NHHC).

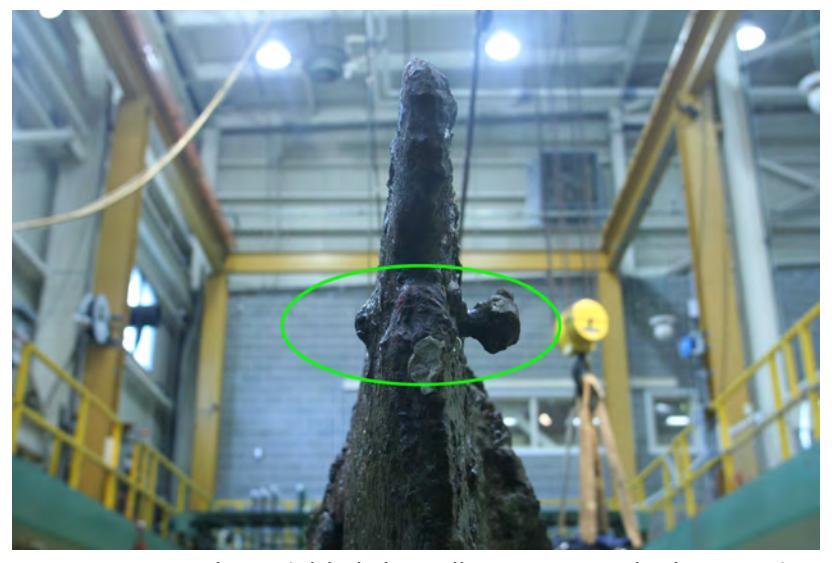
Figure 12.7. A substantial bolt laterally penetrates the bow casting. (Photo by H. G. Brown, NHHC).

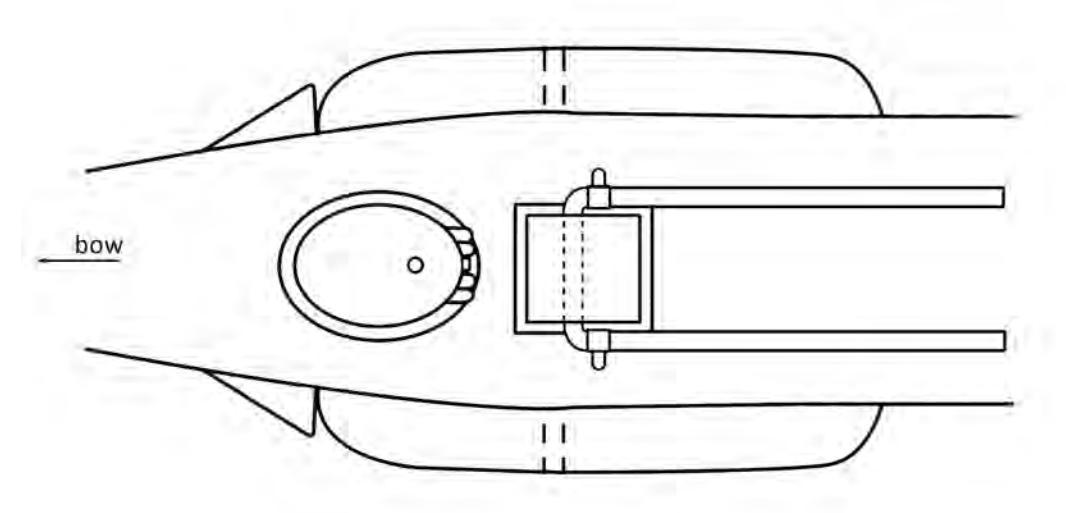
Figure 12.13. Idealized plan view showing position of diving planes and their protective skegs, in addition to the forward conning tower and snorkel box. (Diagram by Mari Hagemeyer, NHHC).

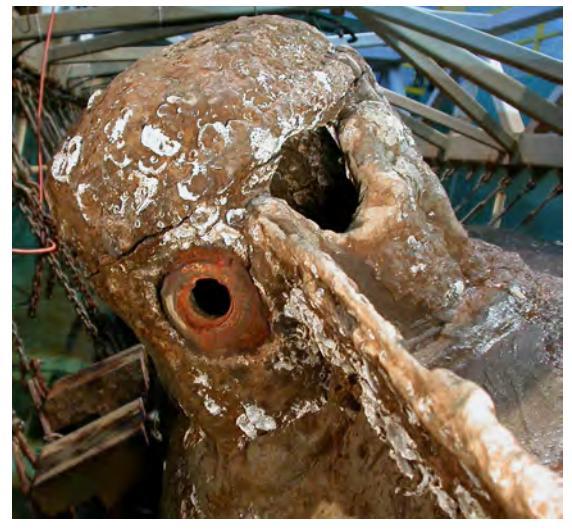
Figure 12.17. Hole in the forward conning tower encompassing the total loss of the port viewport (Courtesy of FOTH).

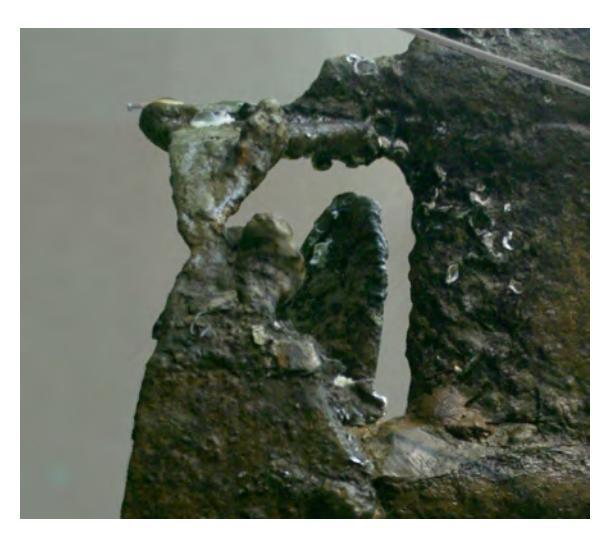
Figure 12.20. Damage to the top starboard quarter of the propeller shroud. (Photo by H. G. Brown, NHHC).

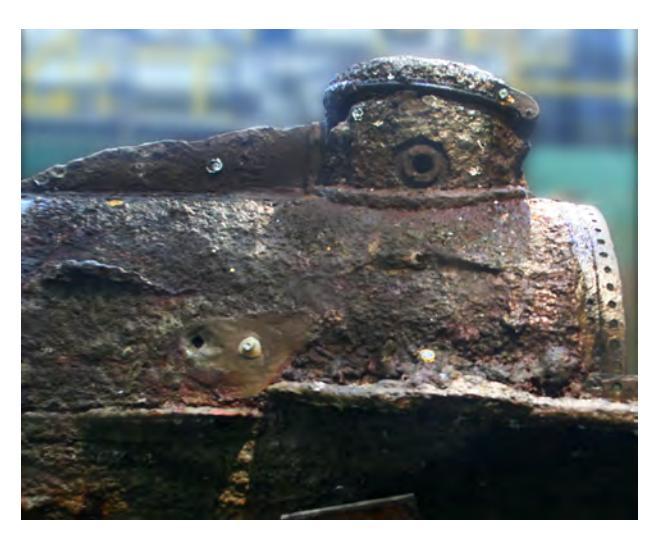
Figure 12.21. The port side diving plane is in a slightly raised position. (Photo by H. G. Brown, NHHC).

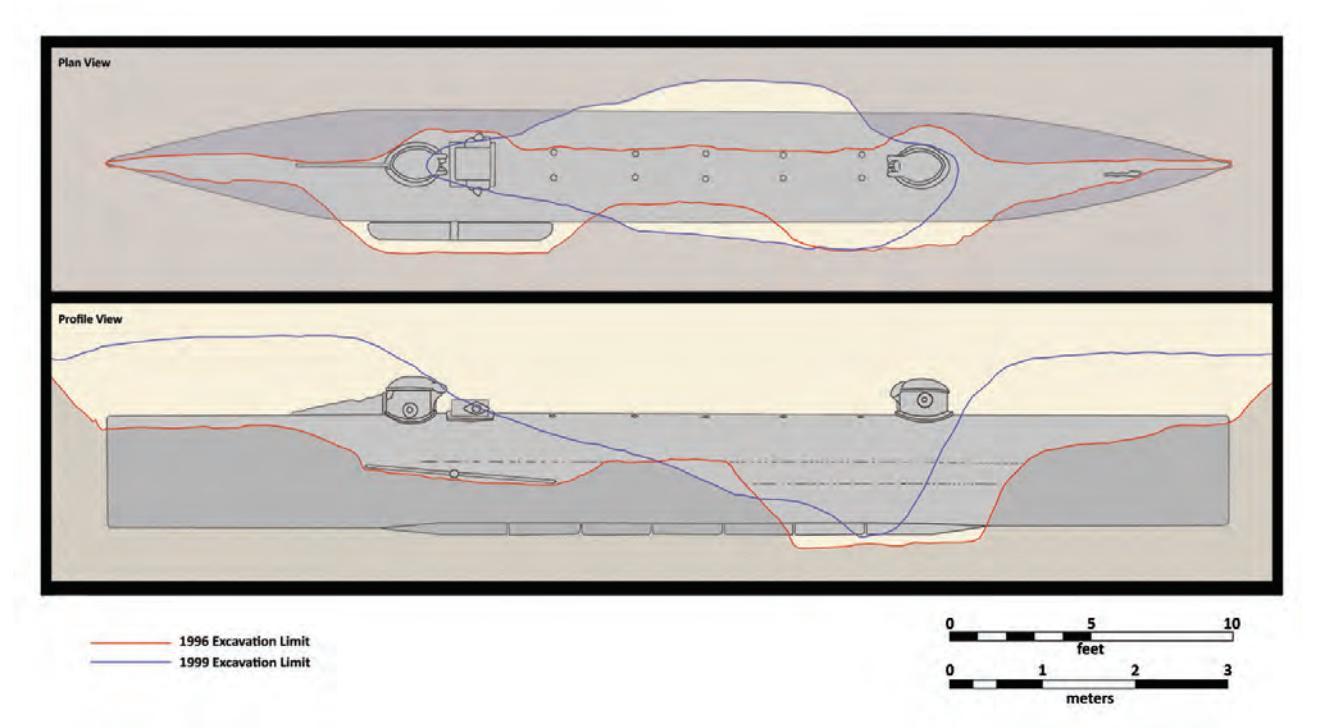
Figure 13.5. Areas of sediment disturbed during the initial assessments of H. L. Hunley. (*Diagram by H. G. Brown, NHHC*)

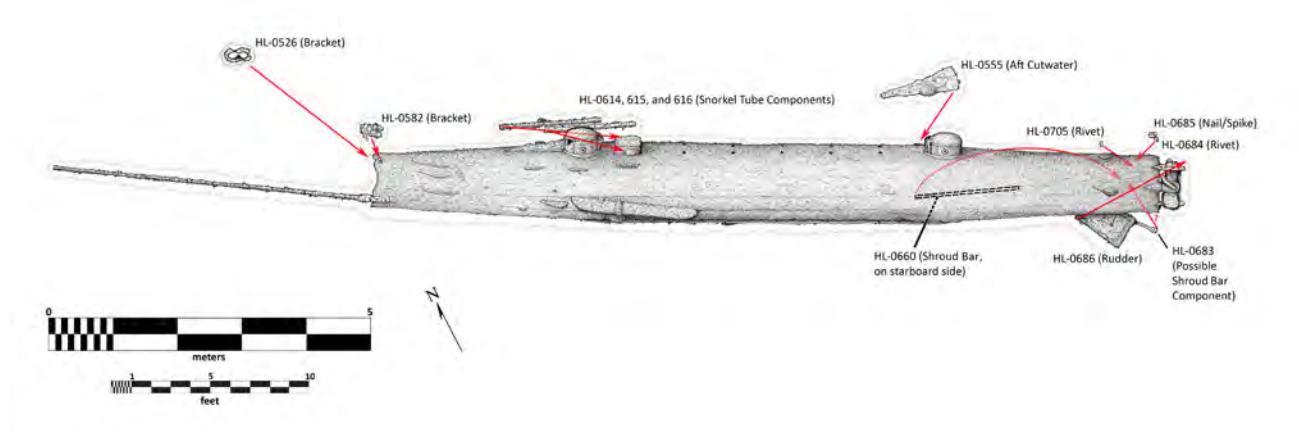
Figure 13.11. Site plan showing locations of the disarticulated components, with red arrows indicating their point of origin. Due to the steep cant of the wreck, the shroud attachment bar (HL-0660) appears to be beneath the hull in this view. (Site plan by James W. Hunter III, annotated by H. G. Brown, NHHC)

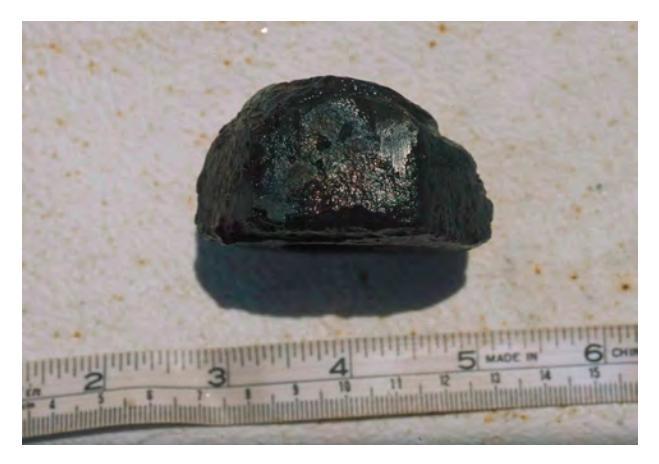
Figure 13.12. Erosion is evident on the outer surface of the nut that connected the spar to the hull at the base of the bow casting on the port side. (Courtesy of FOTH)

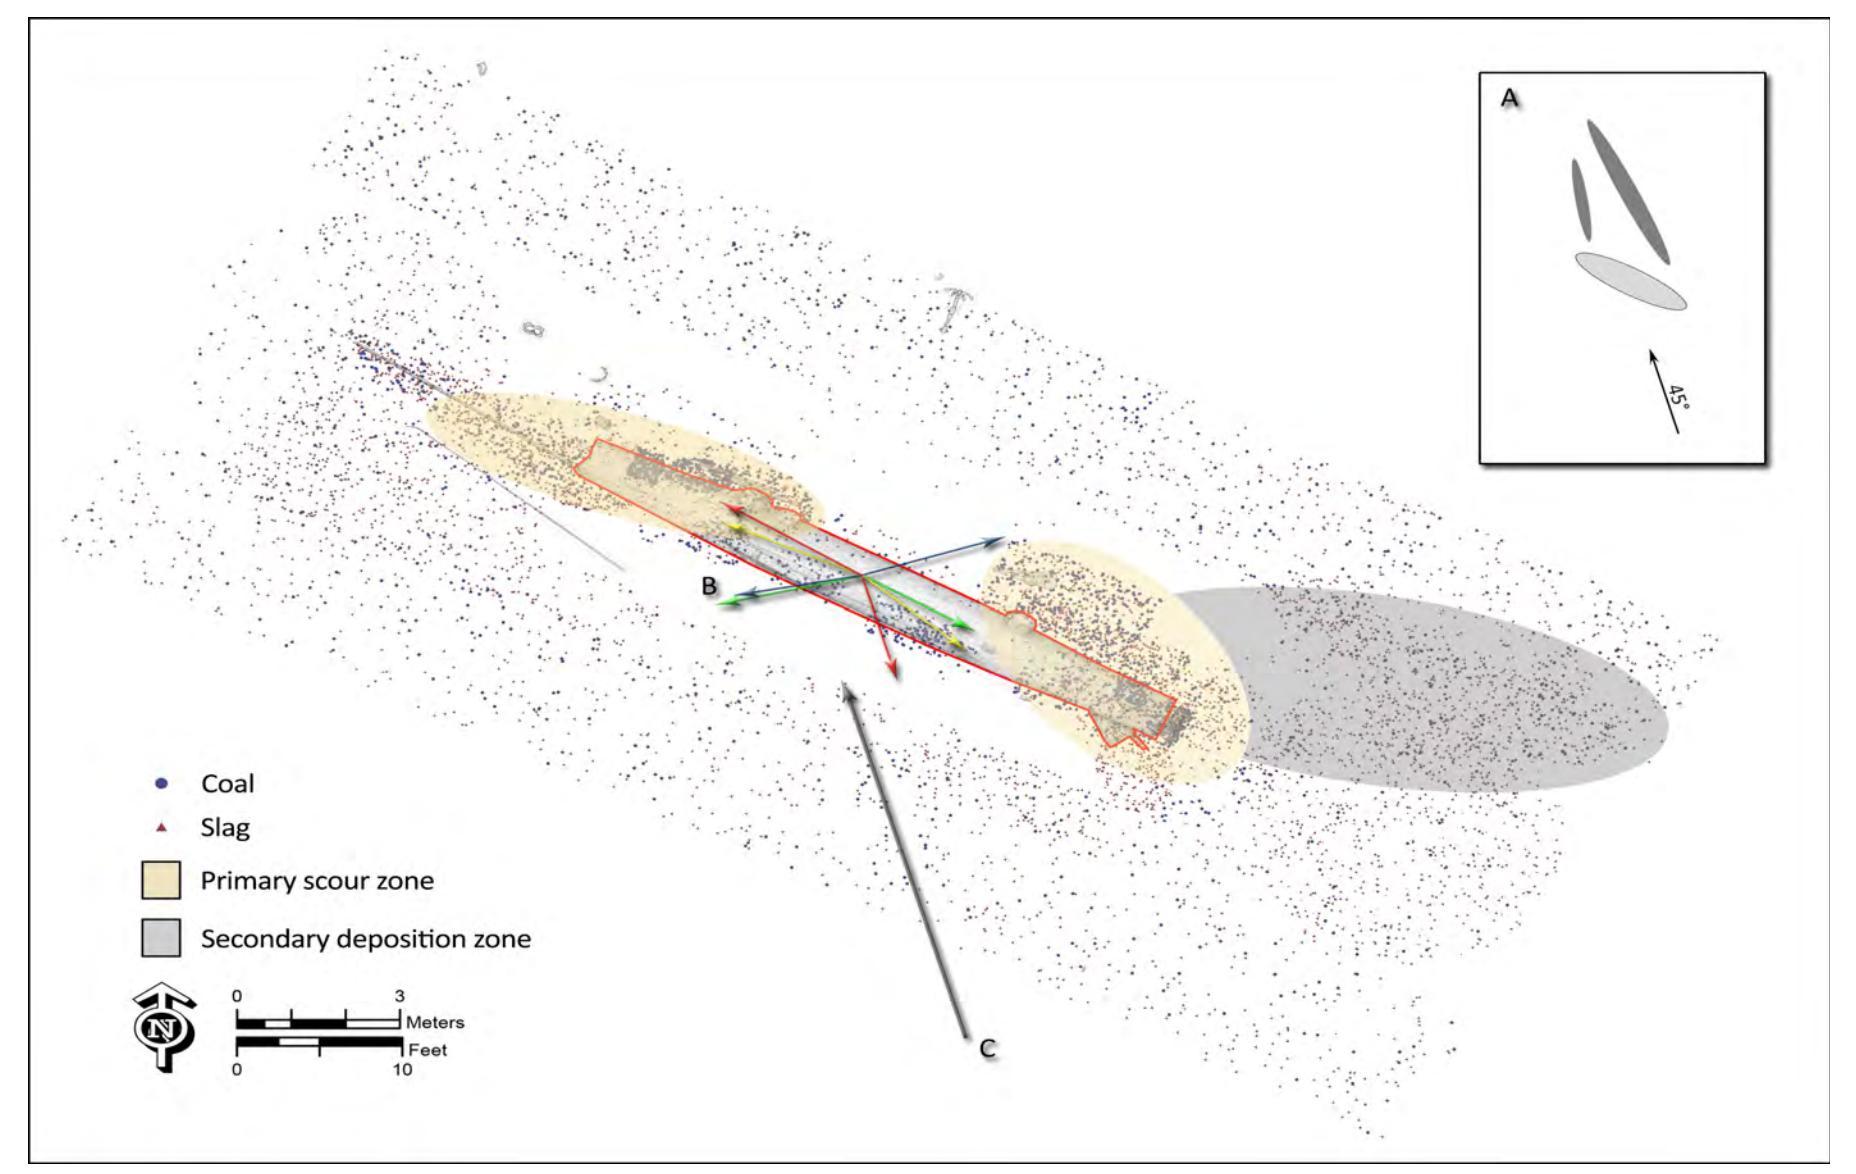
Figure 13.16. Idealized projections demonstrating asymmetrical, convergent scour pattern similar to those identified at the Hunley site are based on an angle of incidence of approximately 45° (A). Comparing 1856 current data from a nearby station (B) shows no vectors that correspond to the projected angle of incidence (C) required to generate the documented scour areas, suggesting storms coming up from the south may have been a significant factor in the formation of the site. (Coal and slag distribution map provided by J. Enright, SEARCH Maritime Archaeology Division, annotated by H. G. Brown, NHHC)
