H. L. Hunley Recovery Operations

Edited by Robert S. Neyland and Heather G. Brown

A Collaborative Project of: Naval History and Heritage Command, South Carolina Hunley Commission, and Friends of the Hunley

Naval History and Heritage Command Washington, D.C. 2016 Satisfactory and important as have been the performances of the navy at this interesting period, they are scarcely more wonderful than the success of our mechanics and artisans in the production of war vessels which has created a new form of naval power.

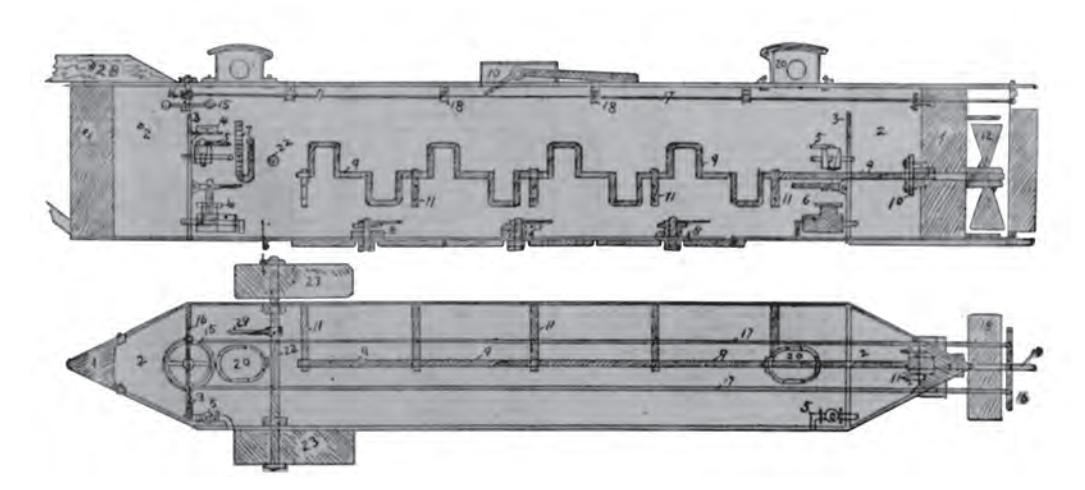
Figure 14.1. Published drawings of H. L. Hunley based on sketches by William Alexander (ORN 1.15:338)

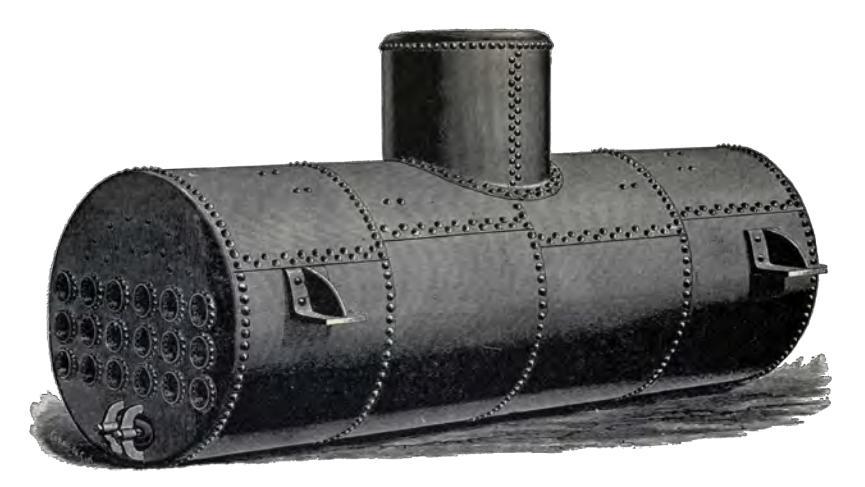
Figure 14.8. This flue boiler from Hutton (1897:443) provides an example of the number and position of rivets penetrating a typical boiler plate, making reuse challenging.

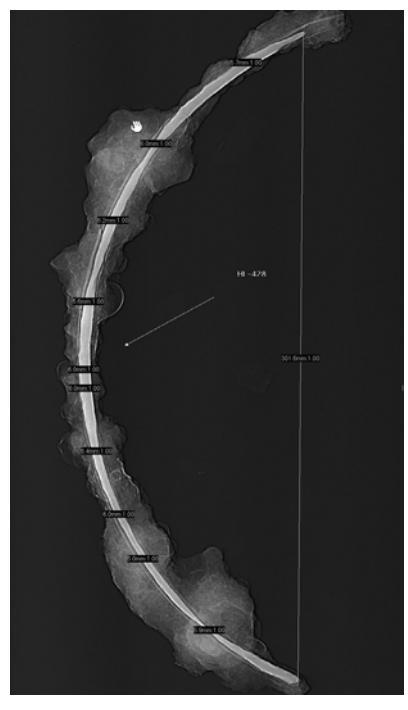
Figure 15.1. Radiograph of HL-0428, the largest fragment of a heavily concreted curved iron rod. (Courtesy of FOTH)

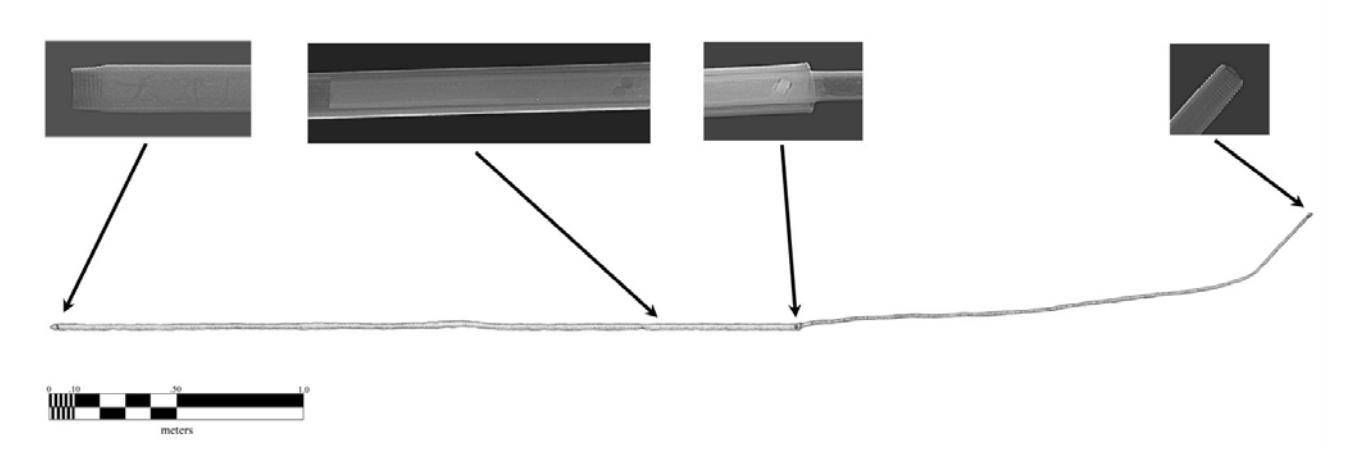
Figure 15.2. Galvanized steel rod found near the submarine's bow. Radiographic images show structural points of interest. (Illustration by James W. Hunter III)

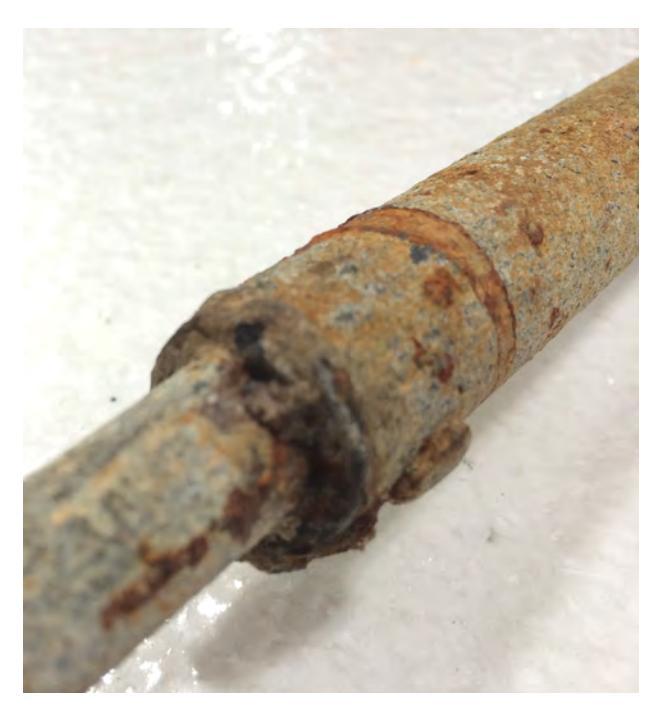
Figure 15.3. Photograph of the joint shows a band of rust incidicating the position of a possible clamp or bracket. (Photo by Michael Scafuri, courtesy of FOTH)

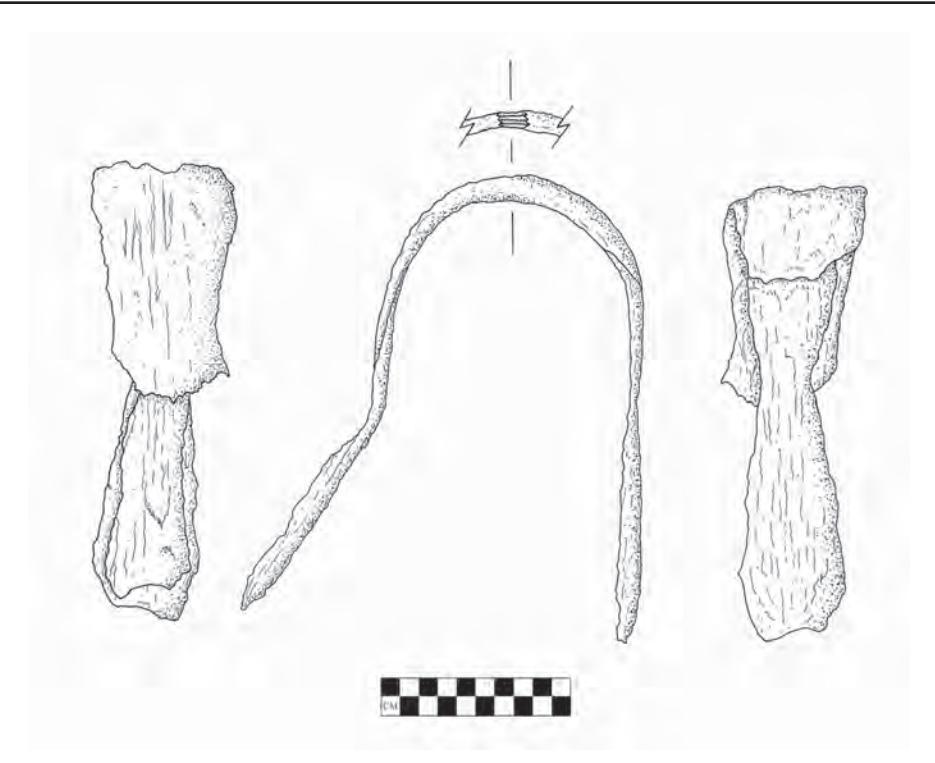
Figure 15.7. Aft spar assembly bracket (HL-0582). (Illustration by Bruce Thompson.)

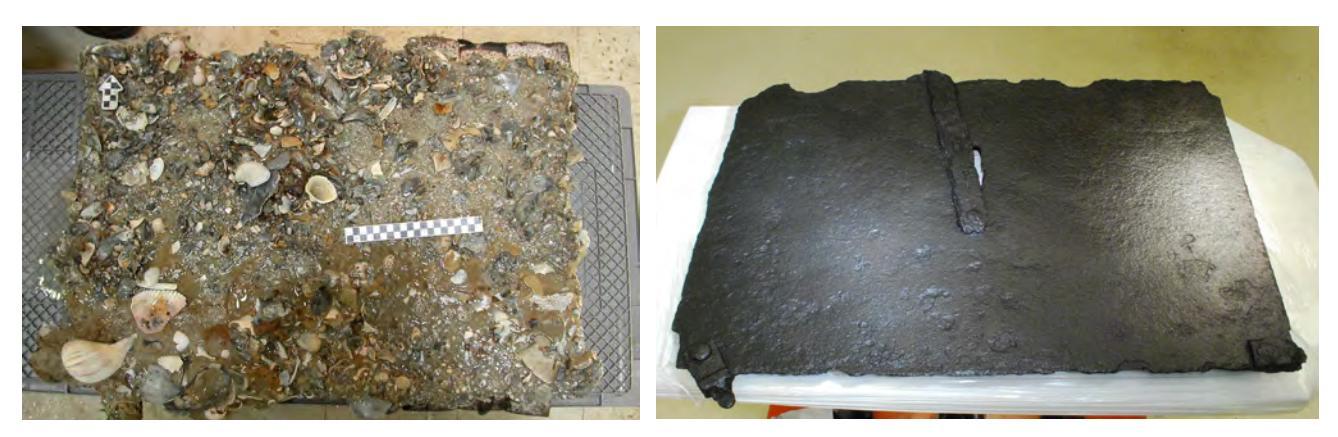
Figure 15.13. Port side of rudder (HL-0686) before conservation (left) and after conservation (right). (Photos by M. Scott Harris (left) and Johanna Rivera (right), courtesy of FOTH)

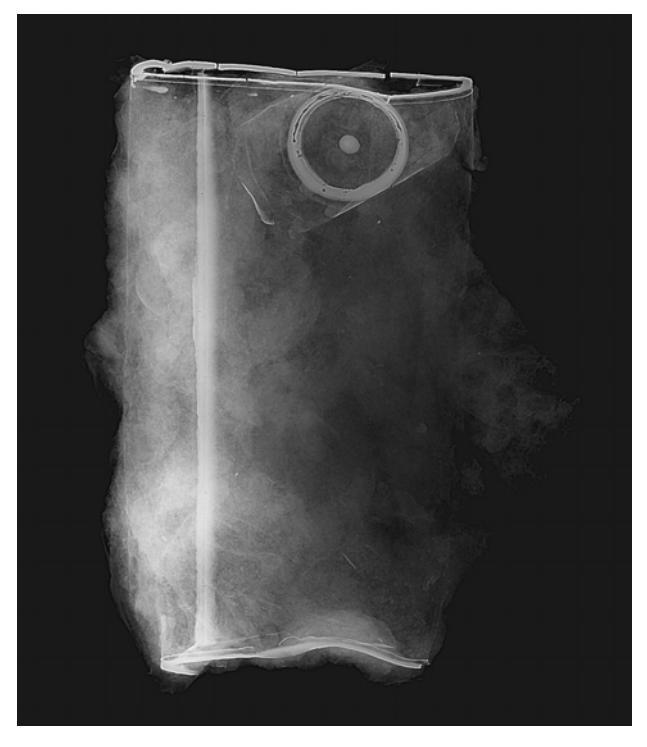
Figure 15.17. A radiograph of the heavily concreted HL-3667 shows a preserved vented cap typical of late 19th century manufacture. (Courtesy of FOTH)

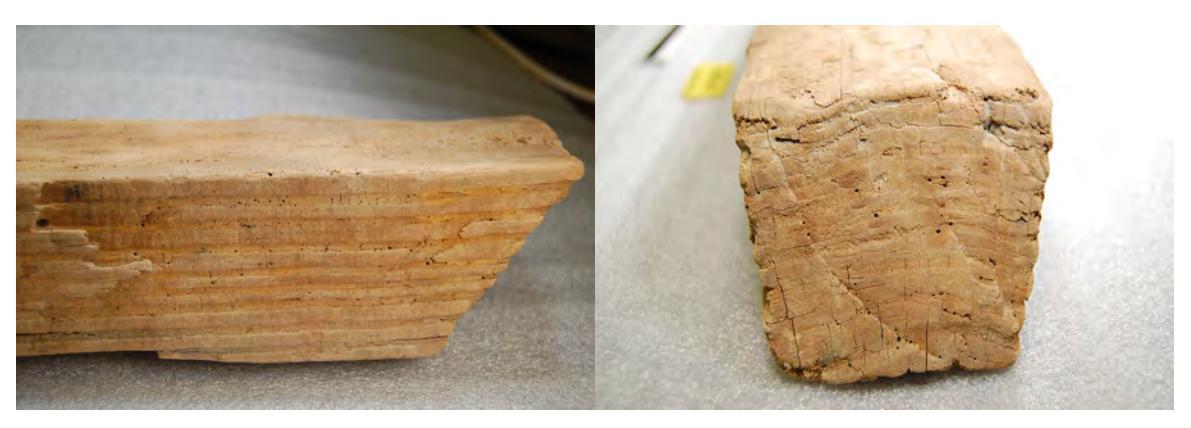
Figure 15.22. Side view showing angled cut (left) and cross section (right) of HL-0505. (Photos by Johanna Rivera, courtesy of FOTH)
