NAVAL AVIATION

NEWS

End of the Jap Fleet
VF(N) Camera Tallies
Marine Navigators

Sept. 15, 1945

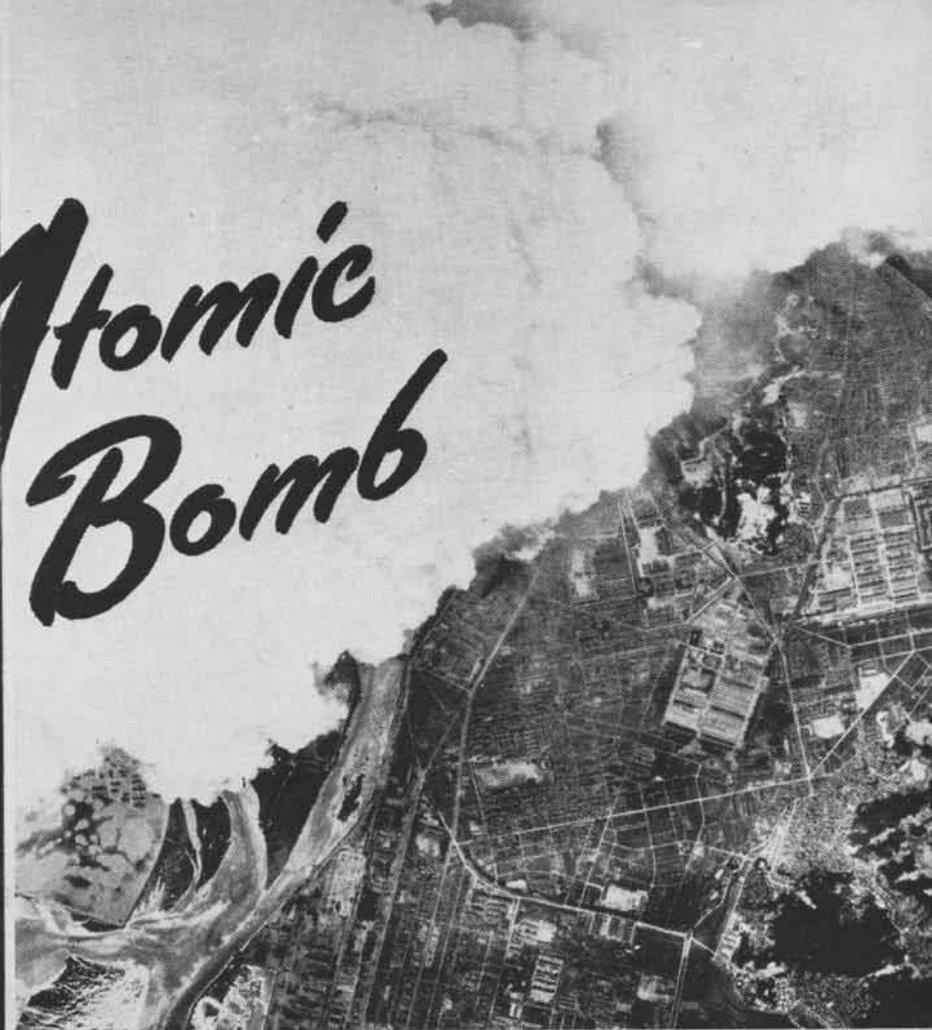
1 After the atomic bomb struck, dust and smoke in a 20,000 ft. high mushroom, hovered for hours over city of Hiroshima.

2 Later the same day reconnaissance showed city still ablaze. Damage was roughly comparable to big B-29 attack.

3 Hiroshima. 60 percent of its area burned or blasted, photographed from 25,000 ft. one day after the atomic bomb fell.

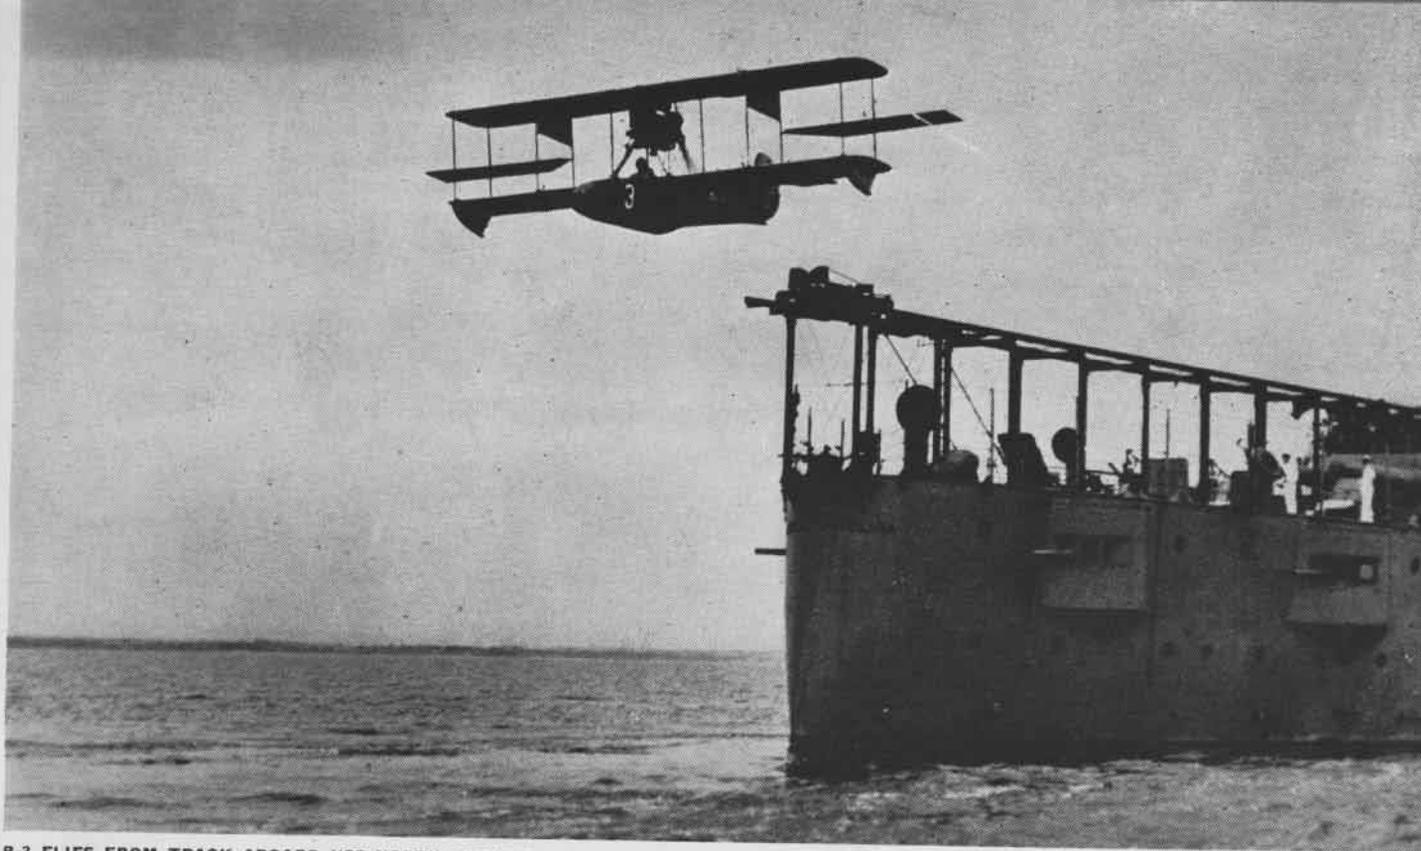
B-3 FLIES FROM TRACK ABOARD USS NORTH CAROLINA, ONE OF SEVERAL CRUISERS EQUIPPED WITH THE LAUNCHING DEVICE BY 1916

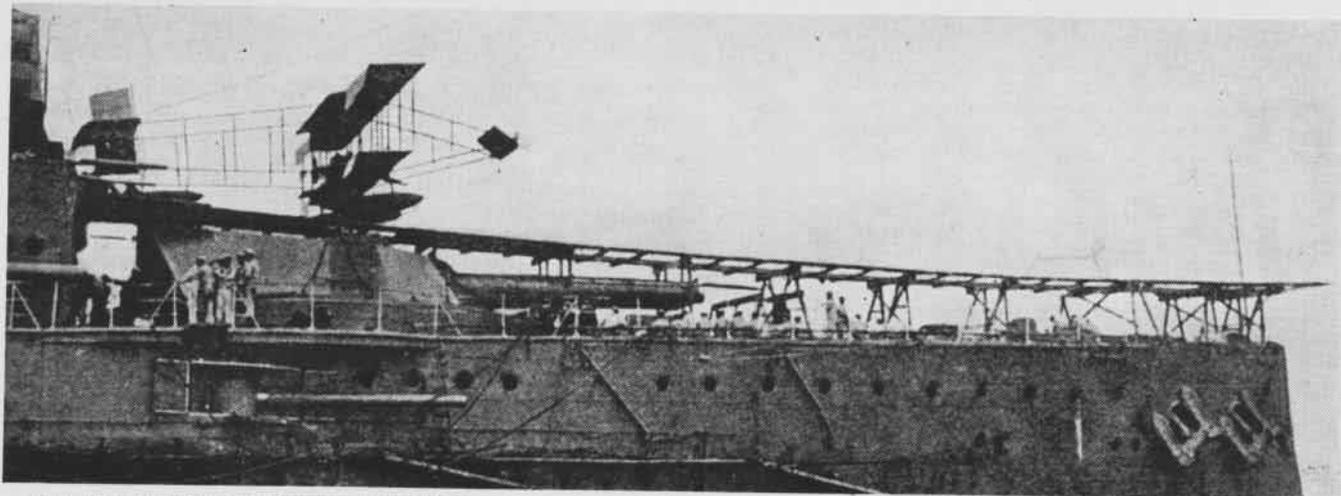
FOLLOWING ELLYSON'S SUCCESSFUL CATAPULT LAUNCHING IN 1912, TRACKS WERE ERECTED ABOARD SHIPS FOR OTHER TRIALS AT SEA

"This device is the most important achievement since wheels were put on land machines," commented Glenn Curtiss, who viewed the test. Before "Spuds" Ellyson died, 17 years later, he saw the launching device for which he had risked his life attain world wide use, both in naval and commercial aviation.

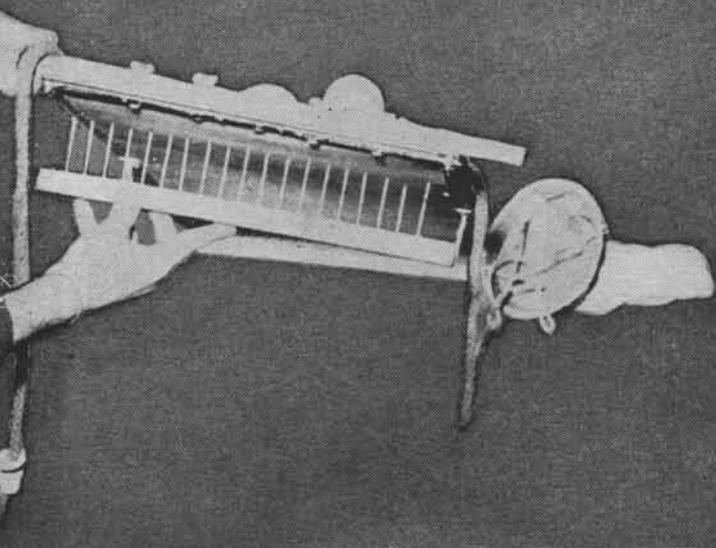
1 Simple loading and operation makes the float line faking board the ideal answer to raft release from PBV and PBM aircraft. First step is the insertion of faking guides in board ends

The board, 17½" x 54½", accommodates 150 feet of floatable line, faked down with the aid of guides. The guide is removed and clamps, held in place by thumb screws, are secured over the bights at either end. On the board's reverse side, the raft, which may be of any size, is mounted by means of a double bight of line, secured to the board with a rip-cord ring. This double

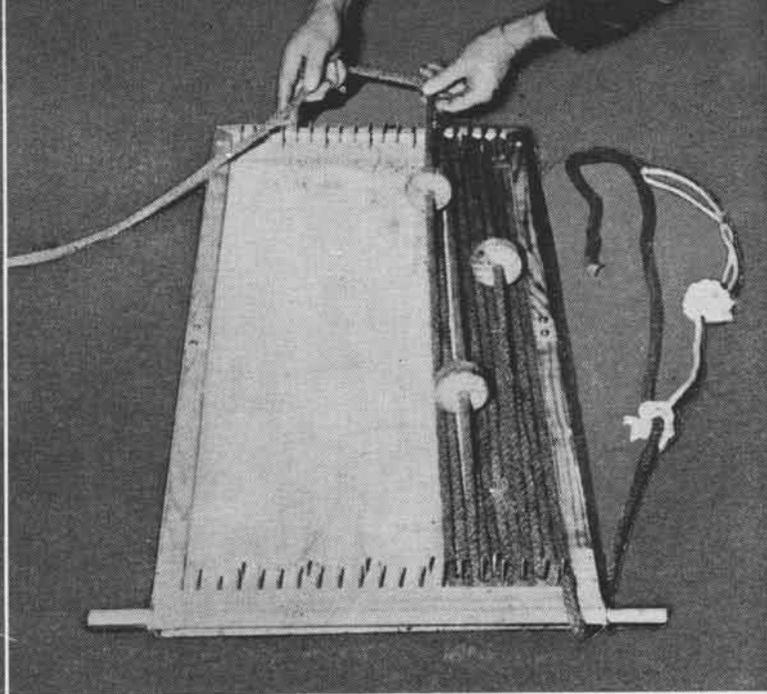
2 Careful attention to shipshape faking assures a smooth flow of line when released. The piece of white line attached to the float line is for lashing the raft on the board's other side

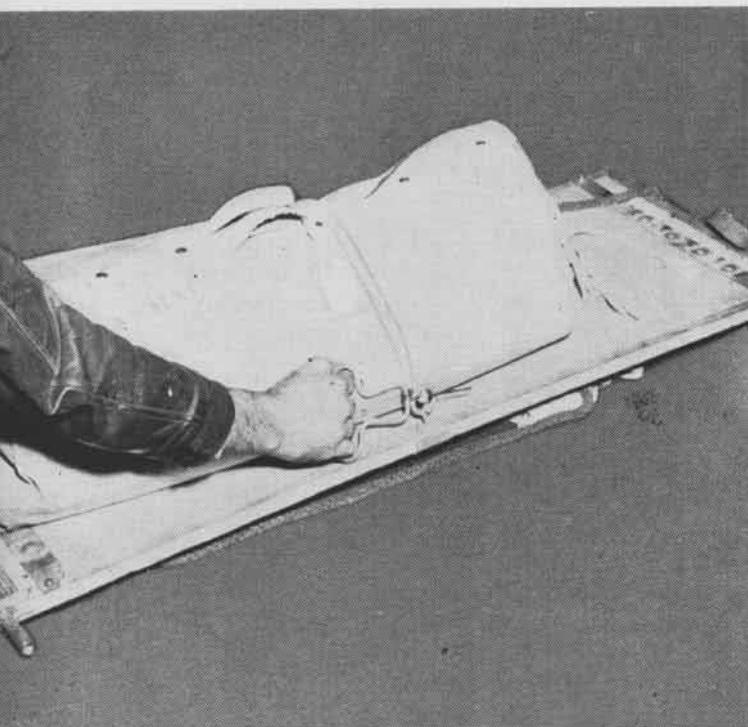
5 Bungee drawn across the raft is secured to a simple metal eye by a rip-cord ring. When the board is placed upright in the plane's tunnel hatch, the equipment will be ready for instant use

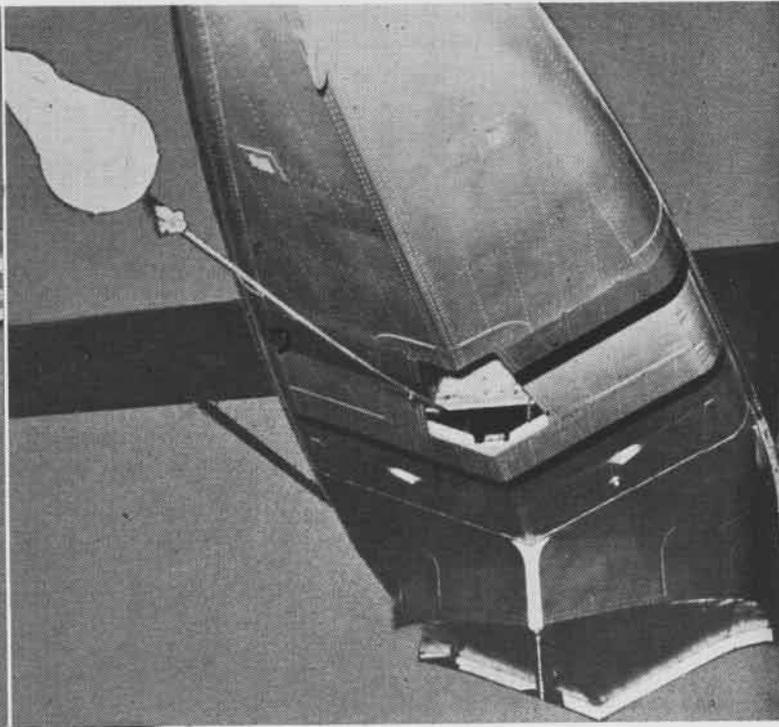
6 Pilot gives the word to pay out line, and the man in the hatch begins by easing tension on the first thumb screws. The wind sock leaves the hatch and the first fakes are pulled into the sky

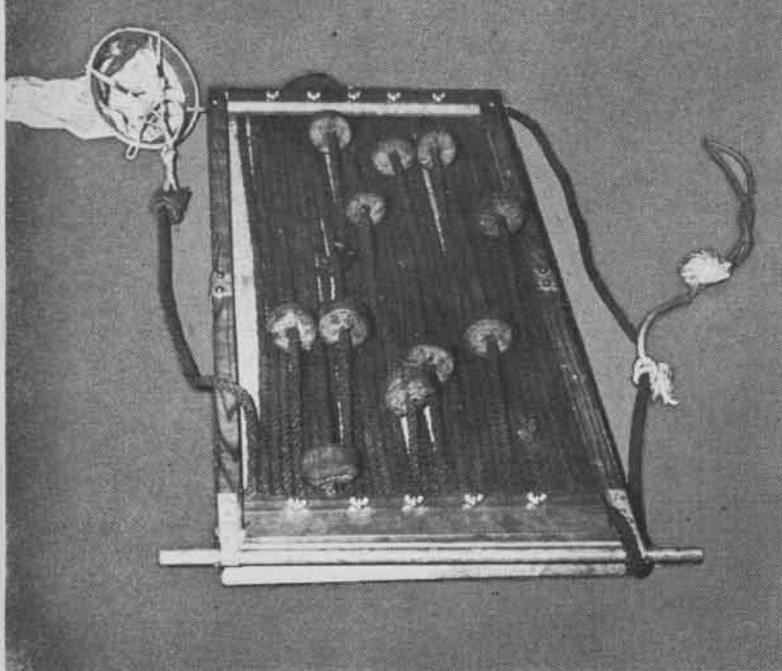
3 Faked down, guides removed, metal strips secured over the bights with thumb screws, the float line is ready. When the line is released, thumb screws will be turned to proper tension

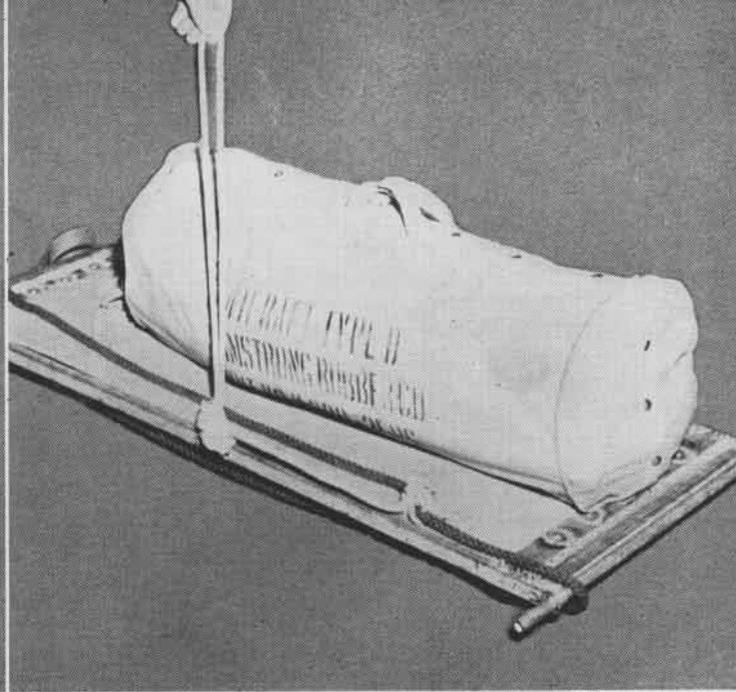
4 Rafts of any size are accommodated by the board. The bight of white line, secured at one end to the float line, will be drawn across the raft to hold it firmly against the faking board

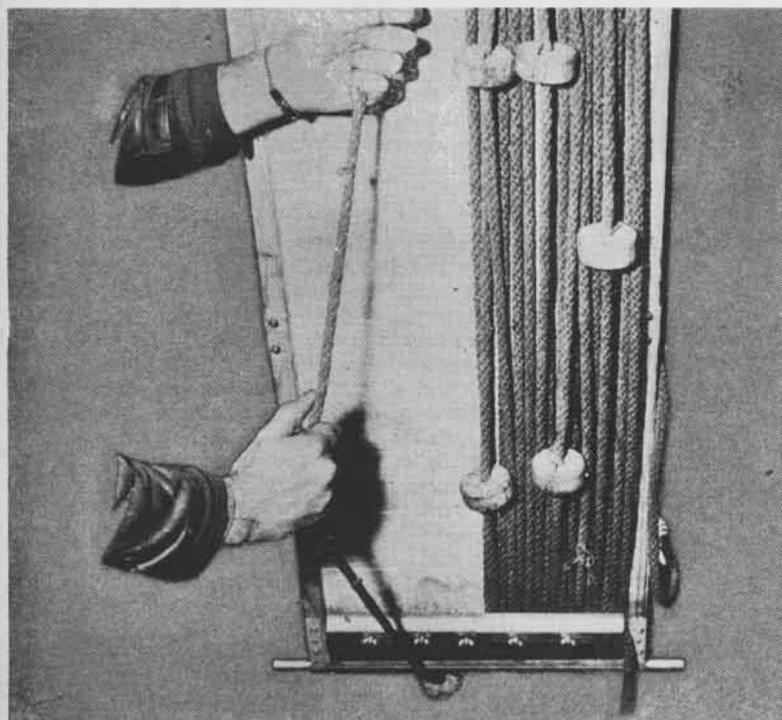
7 Control is maintained over the line by adjusting tension on the clamps and by simple caution in making sure that the line is payed out a fake at a time. The sock tugs steadily at the line

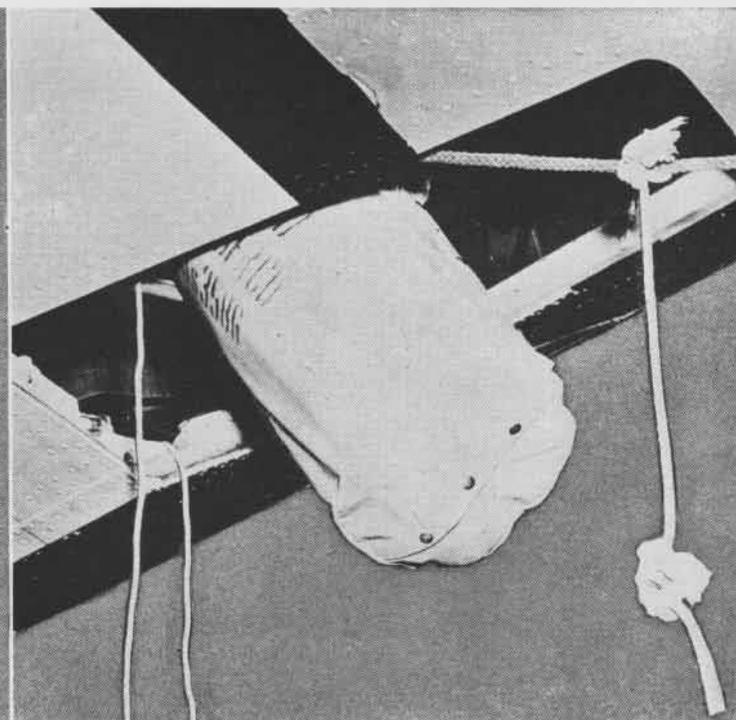
8 Payed out line is stopped by the same bungee securing the raft. Pilot gives the word to "drop" when he is in position, the rip-cord ring is pulled, and the equipment leaves the hatch

- d. Waits for the "drop" order, while windsock tension is taken up by the stopper holding the raft. At the word from the pilot, who has reached target, he pulls the rip-cord ring. The raft does the rest.

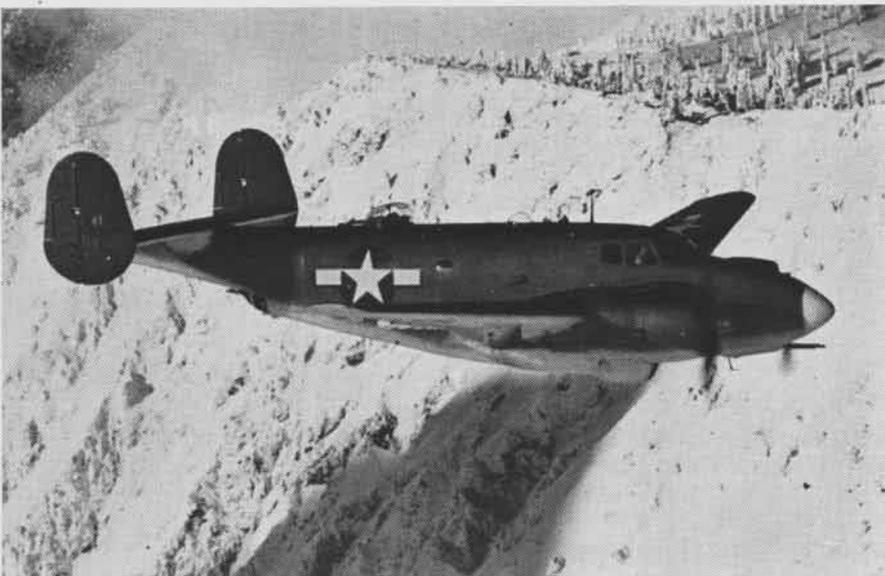
MORE RECENT PHASES of war in the Pacific saw the Navy calling into combat the deadly new FV-2 Harpoon. Speed, long range and fighting prowess were combined in this land-based, medium bomber, designed for the combination of attack and reconnaissance which figure in the technique of search. With its 10 .50 cal. machine guns the FV-2 proved deadly for strafing. Its better than 300 mph. speed is combined with high maneuverability.

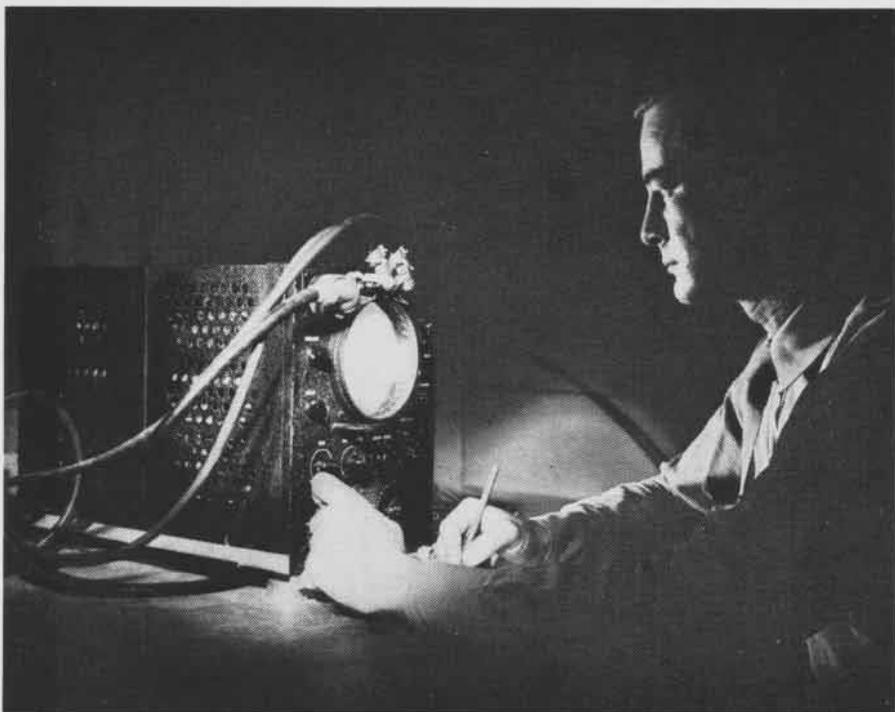
In the study of long range navigation (Loran) a student is taught basic fundamentals and receives instruction in the use of charts, tables and equipment. Frequent alignments and calibration of the equipment is stressed as well.

LONG RANGE NAVIGATION AND USE OF LORAN IS STRESSED BY MARINES AT EL CENTRO

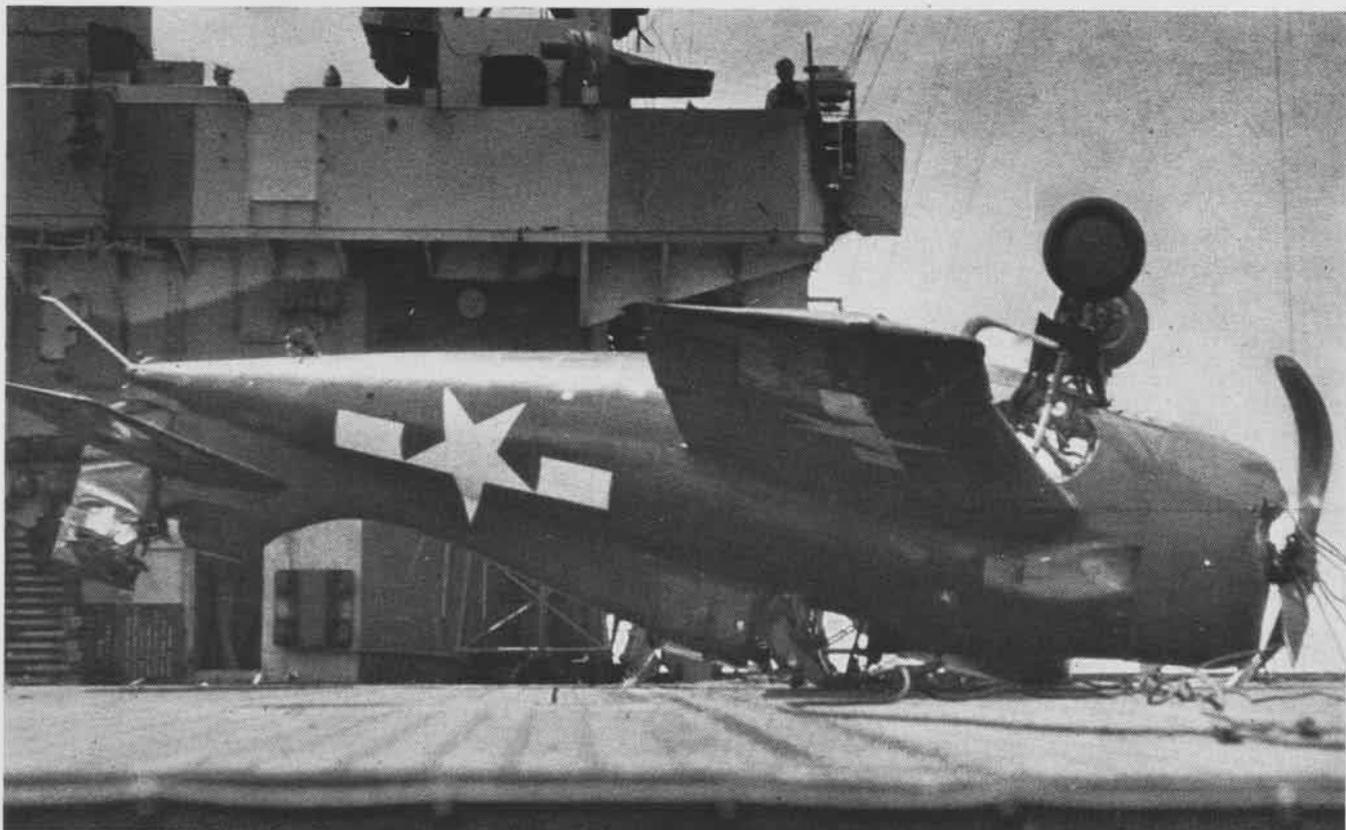
THIS WAS A TOUGH JOB FOR MAINTENANCE MEN ABOARD A JEEP CARRIER BUT WITHIN A WEEK THEY HAD THE PLANE READY TO FLY

In a majority of cases, parts seldom mate properly after they have been used, due to the stress on skin and structural members. But in this instance, the parts matched perfectly down to the last rivet hole, attesting to the excellent production methods.

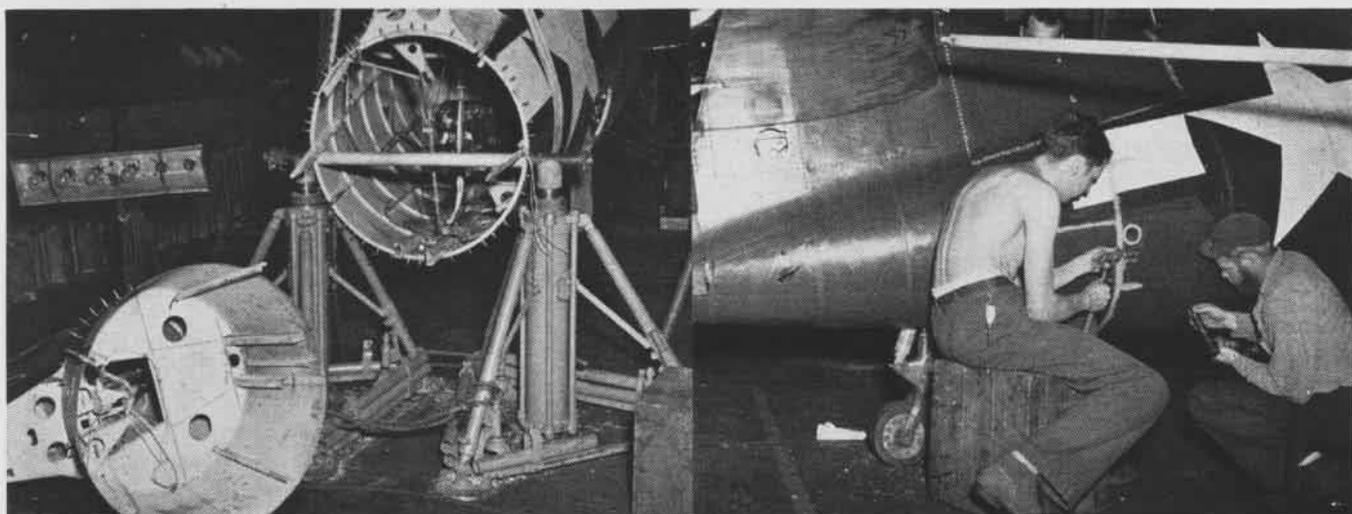
AN FM2 WAS BADLY NEEDED SO SPLICING WAS CALLED INTO PLAY

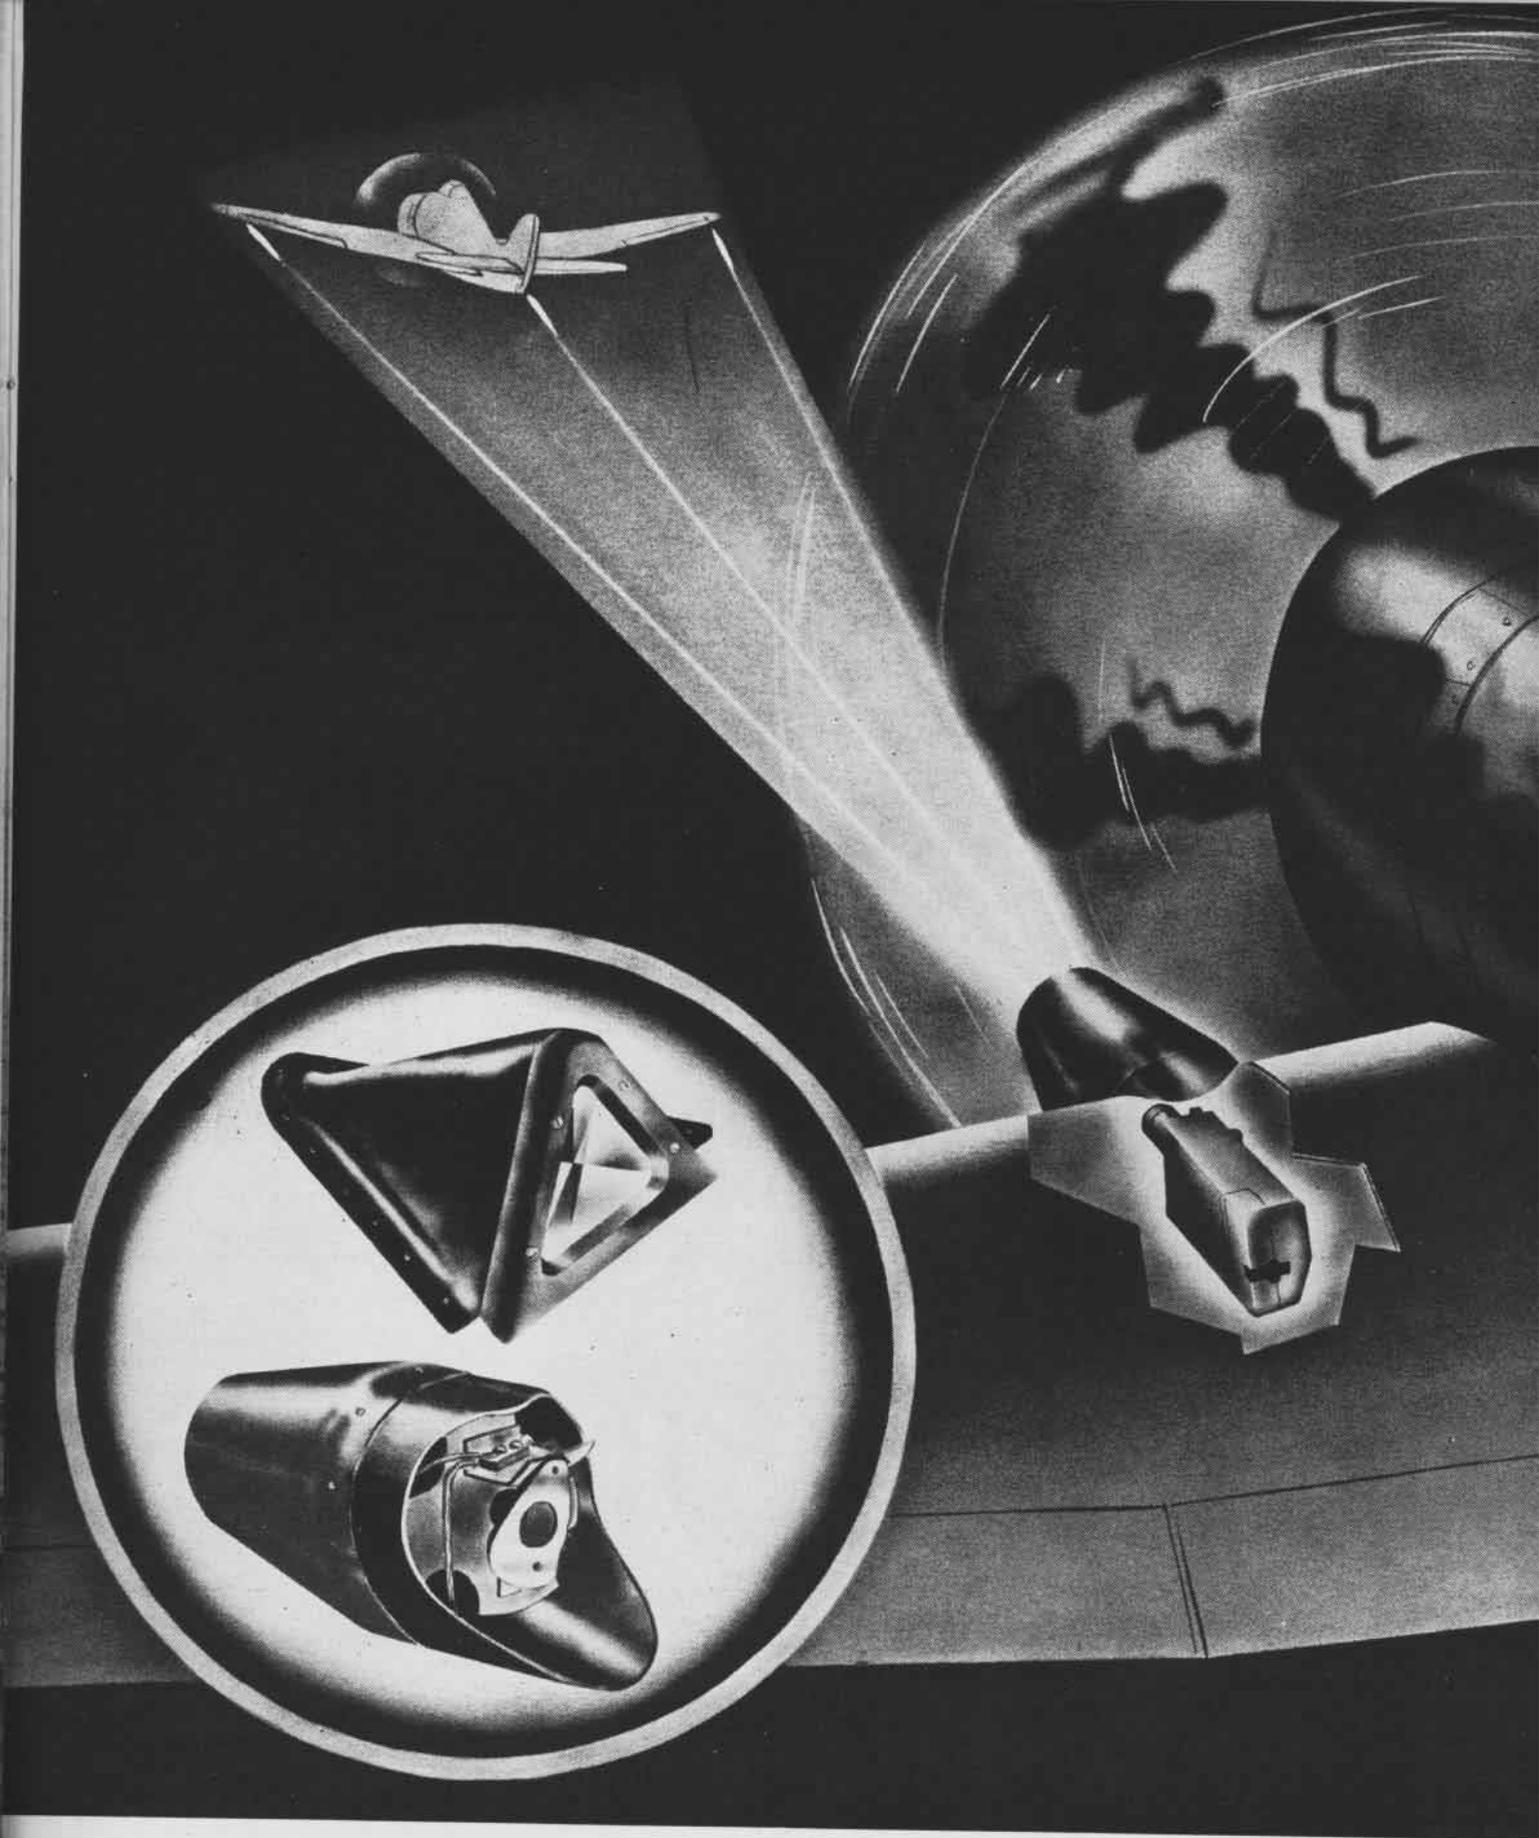
"They do it with mirrors". Night fighter pilots, using BuAer's new camera development, can make attacks on target aircraft, take pictures of their simulated gunnery and assess their aiming and attack tactics afterward. An ingenious prism arrangement on the wing tips and tail of the target plane throws back the light

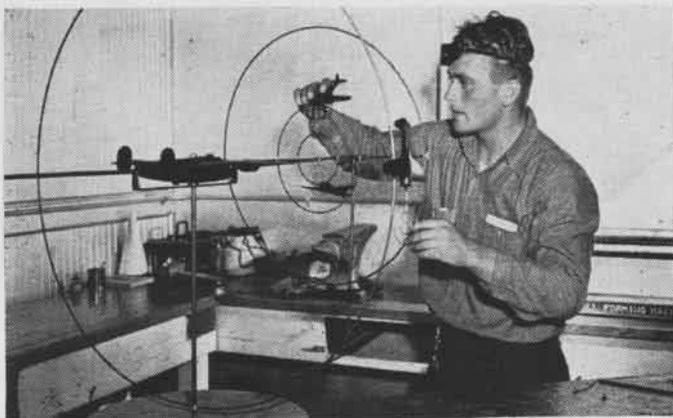
Fighter pilots taking refresher courses in gunnery at San Diego find fixed Gunnery Approach Angle Demonstrator valuable aid

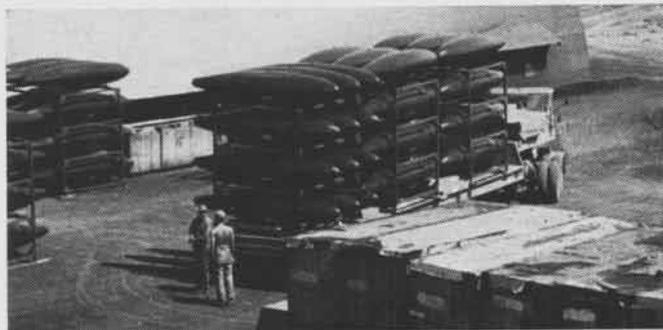
BEFORE 150 gallon droppable fuel tank requires 15 times as much shipping assembled as a knock-down tank

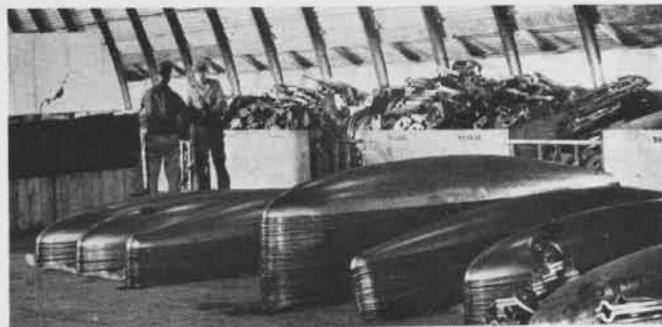
AFTER Knock-down tanks save precious cargo space. Overseas unit does the assembly job for Naval Aviation

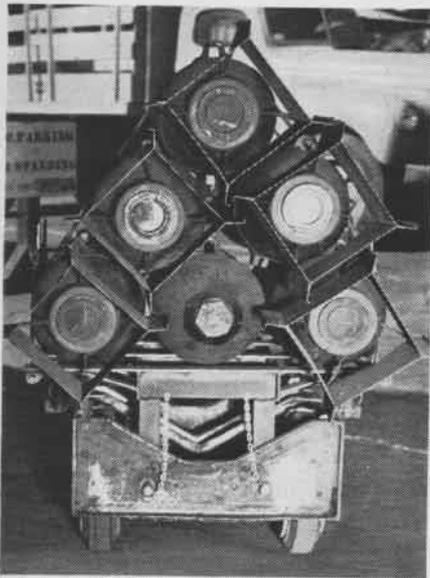
There are two parts to this adapter. The basic adapter, as shown loaded with six 100-lb. bombs, forms the main part. It is constructed of welded steel flats and angles and is attached to the skid by toggle

MARK 1 SKID CARRIES 6 100-LB. GP BOMBS

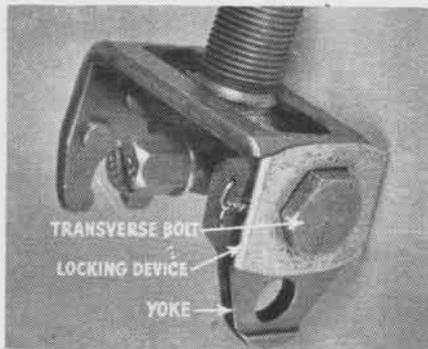
Post, Rear Mounting, MARK 4 MOD 0, provides for rapid mounting and dismounting of the aft end of a fixed caliber .30 or caliber .50 machine gun and permits horizontal and vertical adjustments for boresighting. A transverse bolt, locked

in position by a wedge-type device permits horizontal boresight adjustment.

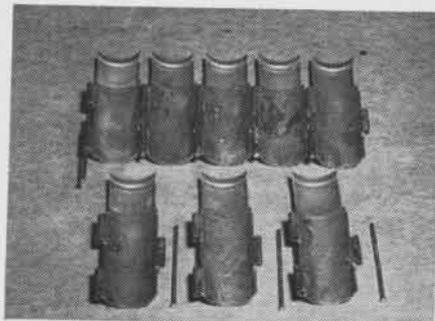
REMOVE CUPS AND WELD 3 TUBES TO BELT

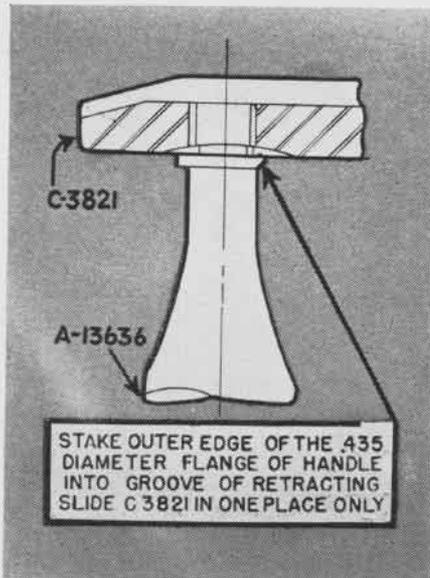
METHOD OF STAKING HANDLE TO SLIDE
