Scratch One Seahawk

Divert Debacle

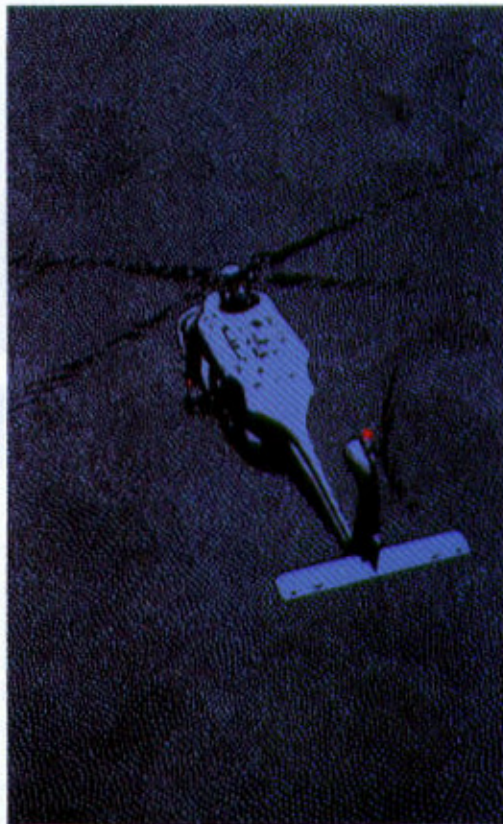
An SH-60F *Seahawk* with two pilots and two aircrewmen on board launched on a night sortie from an aircraft carrier as a secondary plane guard. The aircraft proceeded beyond a five-mile radius of the ship where it conducted search and rescue and navigation training. Later, this helo, with three hours of fuel remaining, was called in by departure control to assume plane guard duty inside the five-mile perimeter. At this point, the helo was at 150 feet altitude with the radar altimeter hold engaged, 13 miles from the ship.

The pilot acknowledged the summons. Maintaining 150 feet, departure control directed the helo to take up a heading of 350 degrees and climb to 500 feet. The crew did not acknowledge this transmission but the *Seahawk* did initiate a climb. At approximately 300 feet, the SH-60F began a descent, apparently unrecognized by the crew. The helo continued downward and crashed into the water at a rate of descent of about 2,500 feet per minute.

when you're down low without much maneuvering room. At one point, the copilot pushed the cyclic automatic flight control system release button instead of the intended intercom (the buttons look alike and are on the collective), which may have been a factor. It's also quite possible that the *Seahawk* suffered a trim failure, causing loss of altitude hold and the consequent, unanticipated descent.

scan pattern is a must in today's high-performance flyin' machines—whether you're high or low, fast or slow, particularly when you're operatin' in the dark.

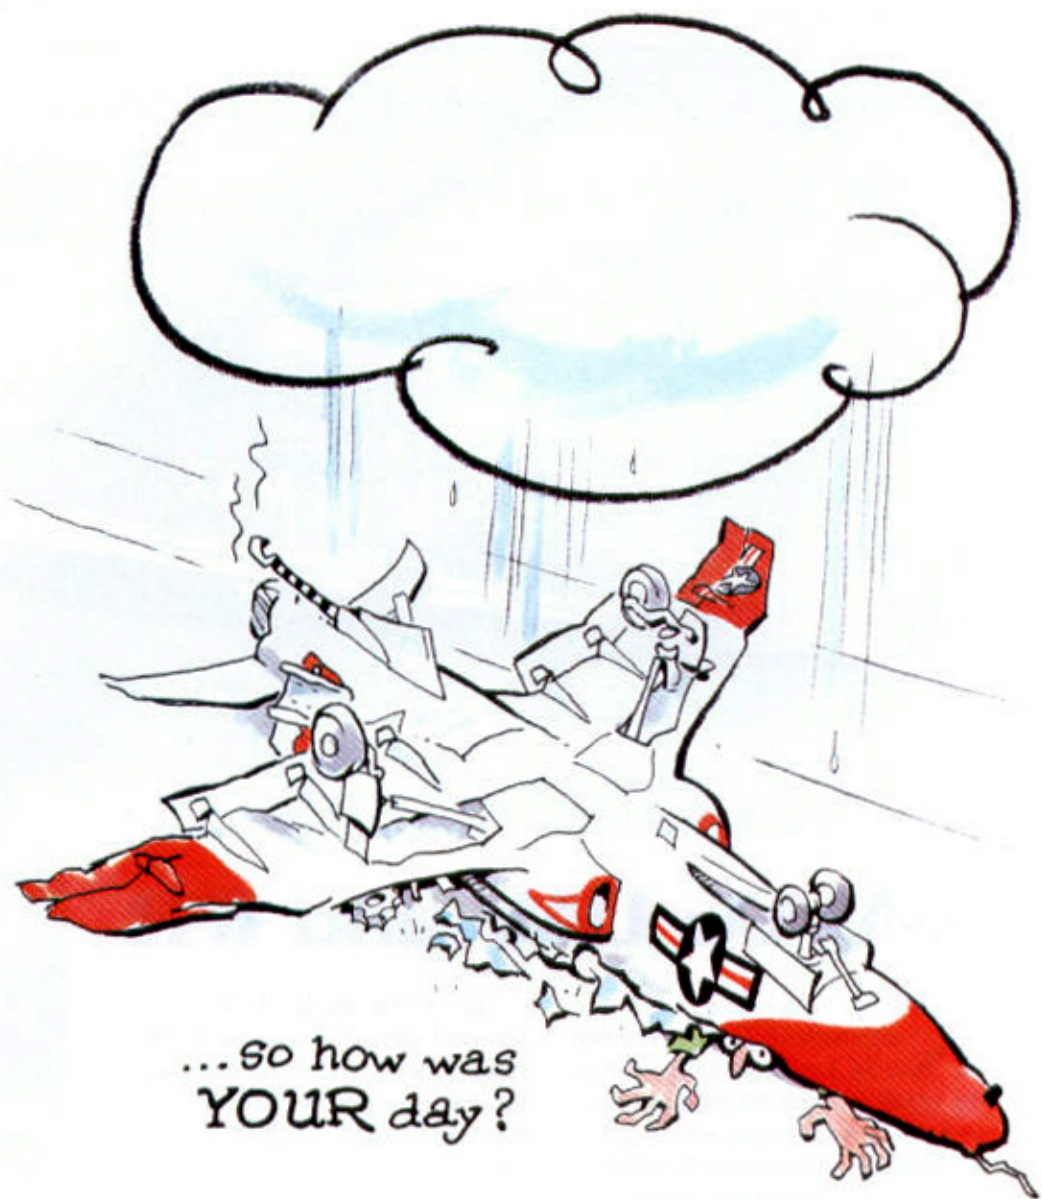
The flight descended and broke out of the weather and into the clear at 2,600 feet, over water, with the runway visible 10 miles in the distance. The instructor reminded the student to drop his gear and flaps at seven miles. The student had failed to perform his feet-dry checks prior to the approach, however, and didn't complete his landing checklist on final. Although he verified that his gear and flaps were down and speed brakes extended, he had omitted the aircraft anti-skid from the checklist and the system was not actuated. Also, the student was surprised to note the field did not have a Fresnel lens for landing.

He touched down nearly 2,000 feet from the approach end and hit the brakes while rolling out at 115 knots. Because anti-skid was deselected, the starboard main landing tire blew. The student was unable to counter the T-45's swerve to the right. The *Goshawk* departed the runway and flipped over. The student struck the instrument panel but suffered only minor lacerations and abrasions from the impact and from the shattered canopy. A physical exam revealed

the student was fatigued, dehydrated and poorly nourished at the time of the accident.

What can ole Gramps say about checklists but USE THEM! Blowin' a tire on a fast rollout is absolutely no fun. And it can be disastrous when you're exhausted, hungry and badly need a drink of water. The lead/safe pilot wasn't a lot of help here. "Task saturated" is the term used nowadays to describe a situation

Another thing: we all know how students bust their brains and their behinds in the tough pursuit of golden wings. Tellin' them to step down from the flight schedule when they've been up and workin' for a dozen or so hours makes sense some days. This may have been one of those days. If the instructors aren't wary of this, at least the student himself has to be.
