## Artifact Spotlight: USS *Sturgeon* Sail

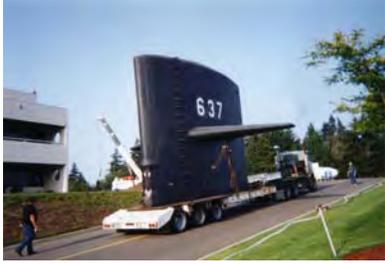
After *Sturgeon* completed the submarine recycling program at Puget Sound Naval Shipyard, her sail was transported to the Naval Undersea Museum in August 1995.

After 27 years of service, USS *Sturgeon* was decommissioned on August 1, 1994. She was dismantled at the Puget Sound Naval Shipyard in Bremerton, Washington, through the Nuclear Powered Ship and Submarine Recycling Program. While most of her parts were carefully disposed of or recycled, the sail received a second life when it was brought to the Naval Undersea Museum in August 1995 for permanent installation.

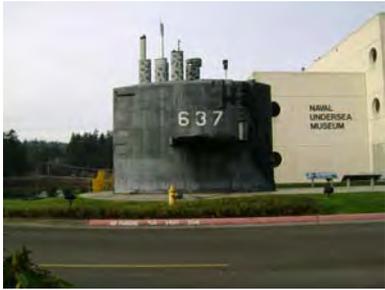
The sail from USS *Sturgeon* is on permanent display outside the Naval Undersea Museum in Keyport, Washington. The camouflage pattern painted on the masts helped the submarine remain undetected.

*Sturgeon's* sail is 30 feet long, 18 feet tall, and weighs 55 tons. In addition to housing the submarine's masts and periscopes, the sail supported fairwater planes used to control depth. These dive planes could also rotate vertically to break through ice when surfacing in Arctic regions. Today the sail is on permanent exhibit outside the museum as the only fast attack submarine sail on display in the country.
